# 2013 Ponds Certifications

City of Kenosha, Wisconsin

July 9, 2014

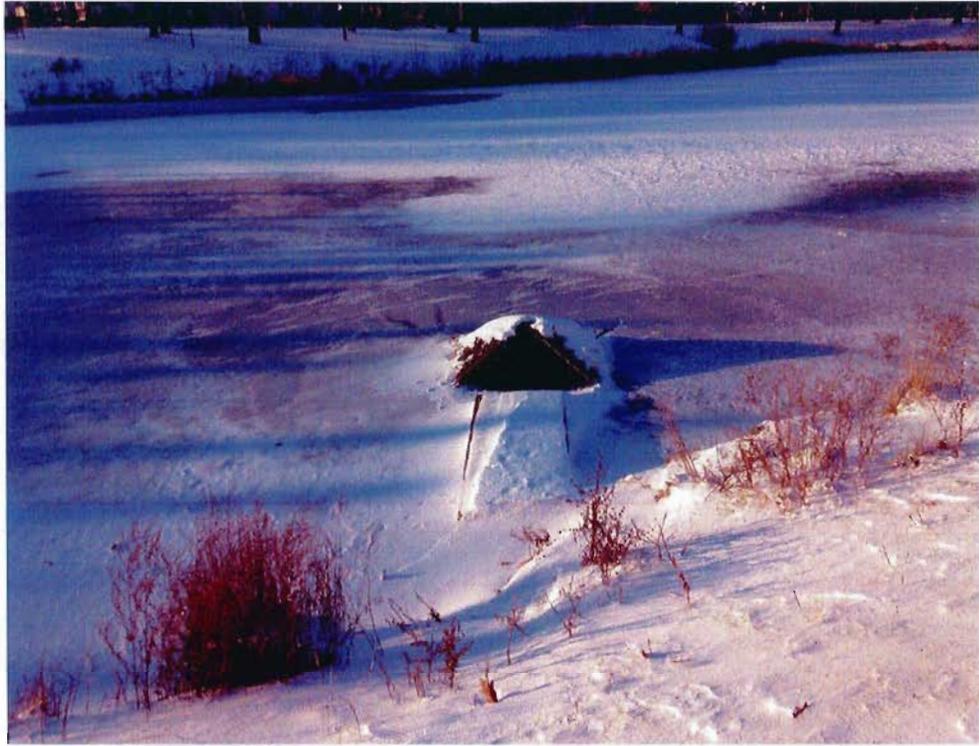
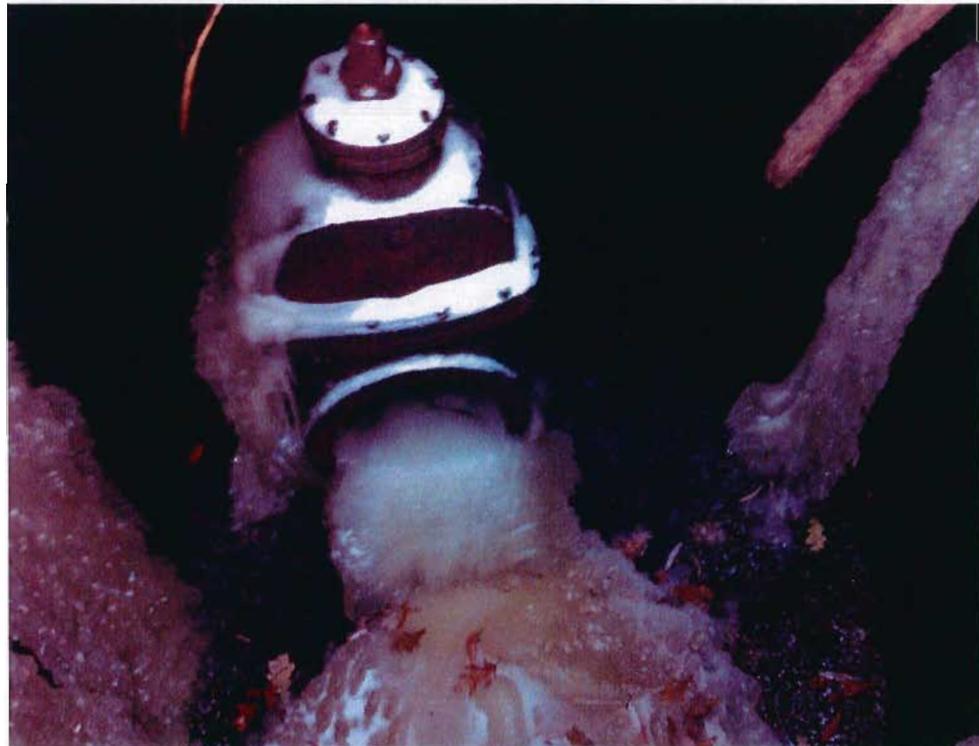
1. The measured water depth in July of 2013 varied between 2.6 feet and 5.6 feet. The original design plans were not available.
2. The inlets and outlets were inspected and were in good condition.
3. Sediment build-up varied between 0.6 and 2.5 feet, with the thicker silt at the north end of the pond.
4. There is thick cattail growth at the north end of the pond and also in the inlet channel at the south end of the pond. Algae covered most of the pond.
5. The function of the outlet structure is unclear.

1. The water depth should be measured in 2018 to compare to the post-dredging measurements. This will provide a comparable depth to determine the rate of sediment accumulation as well as an anticipated date for the next sediment removal.
2. The outlet structure requires further investigation. Replacement may be necessary if the structure is not functional.
3. The cattails and willows should be cleared from both the north end and the inlet channel.
4. Dredge to remove sediment.

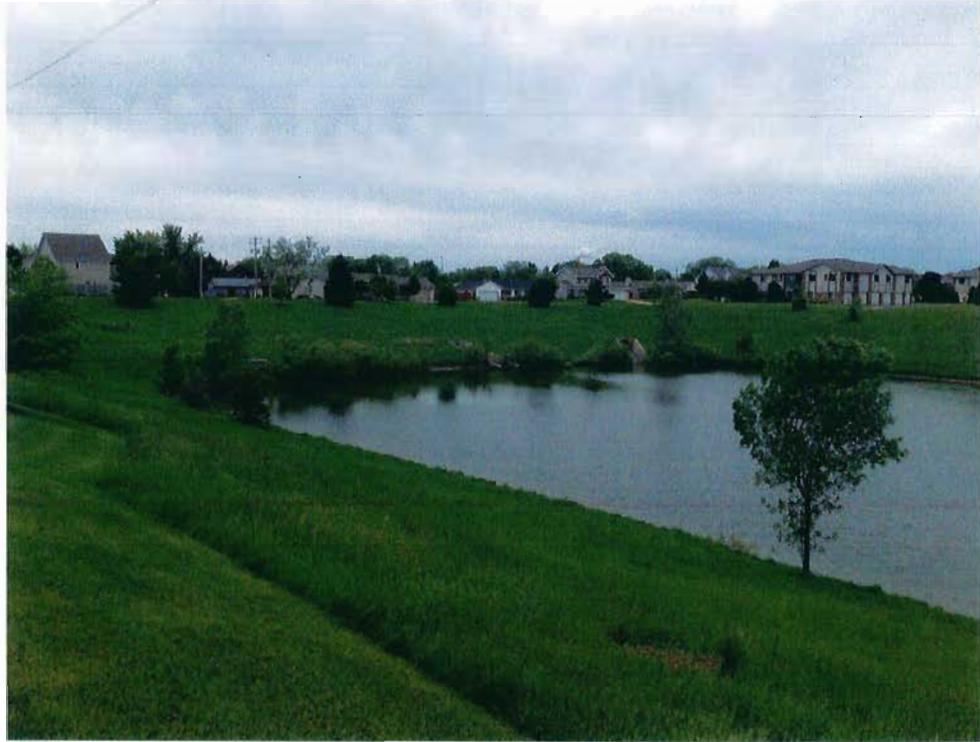
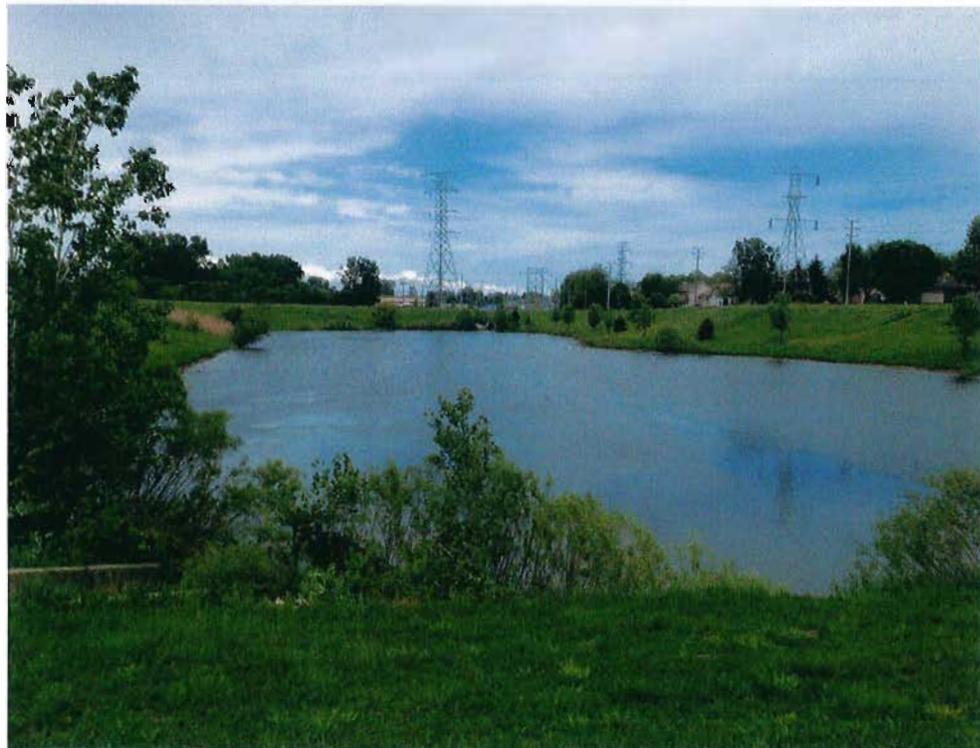
1. The designed water depth of the pond is 4.4 feet. The measured water depth in May of 2013 varied between 5.6 and 6.6 feet.
2. There is a broken orifice opening in the lower outlet structure. There was also some brush and debris buildup at the outlet structure.
3. Sediment build-up varied between 0 and 0.8 feet.
4. The pond perimeter has been mowed occasionally.
5. Soft ground was found on the west side of the pond, indicating groundwater seepage.
6. The water level is higher than the knee wall of the inlet structure.

1. The water depth should be measured in 2018 to compare to the 2013 measurements. This will provide a comparable depth to determine the rate of sediment accumulation as well as an anticipated date for sediment removal.
2. Brush should be removed near the outlet structure and the orifice opening should be repaired. The outlet should be kept clean.
3. Remove brush as necessary around the perimeter of the pond.
4. The high water level indicates that the pond may not be draining properly. Record whether repairs to the outlet structure decrease the water level.

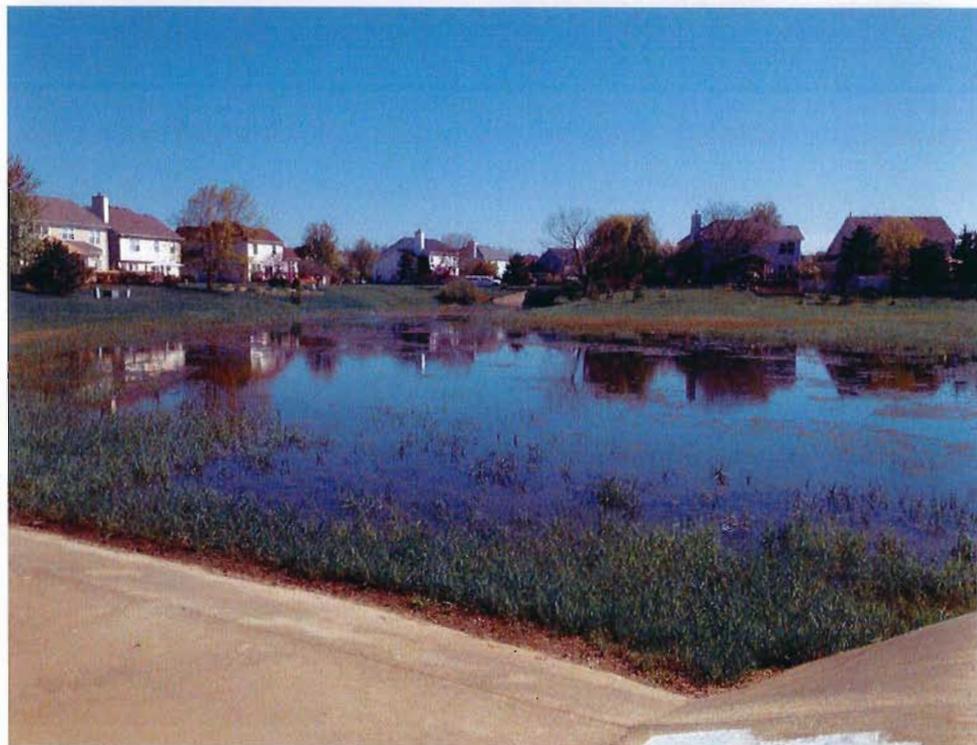
1. There was approximately 1.5 feet of standing water in this dry-bottom pond when it was inspected in May of 2013. The original design plans were not available.
2. The inlets and outlets were inspected and were found to be in good structural condition. There is standing water over the beehive structure, however, indicating it is not functioning. The outlet structure is operating, at the level of the second orifice.
3. There was approximately 1.5 feet of sediment build-up underneath the standing water.
4. The pond had not been mowed due to the wet conditions. Trees and brush are growing adjacent to the concrete spillway.

1. The pond should be inspected in 2018 to compare to the 2013 measurements.
2. All outlet structures should be cleaned and checked for possible obstructions.
3. The concrete channel should be cleaned.
4. The trees and brush near the spillway should be cleared.

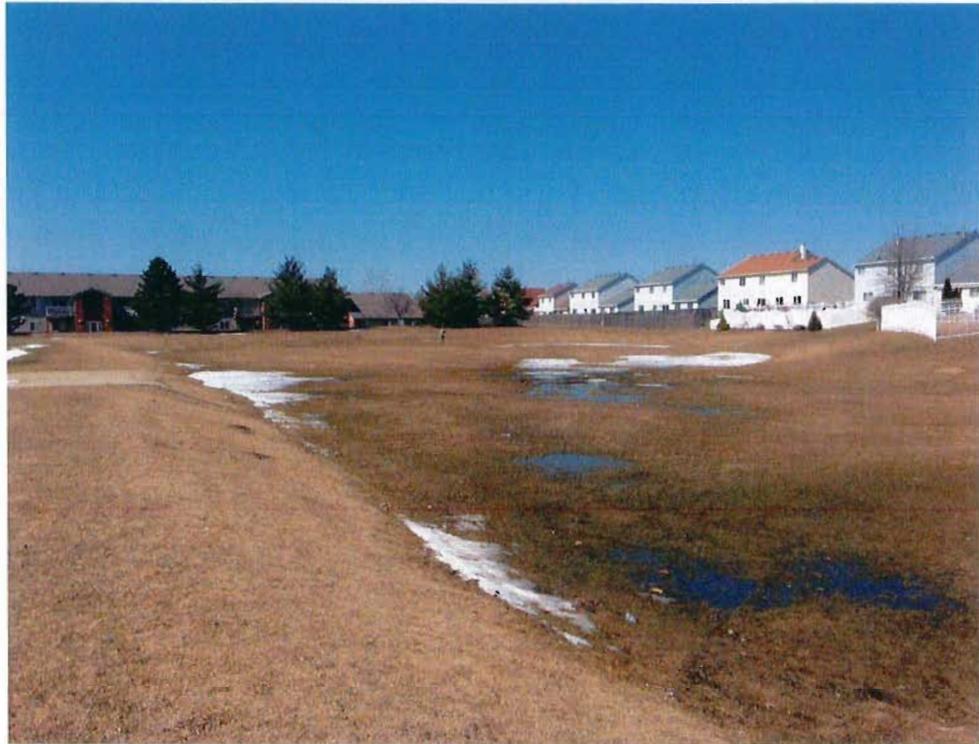
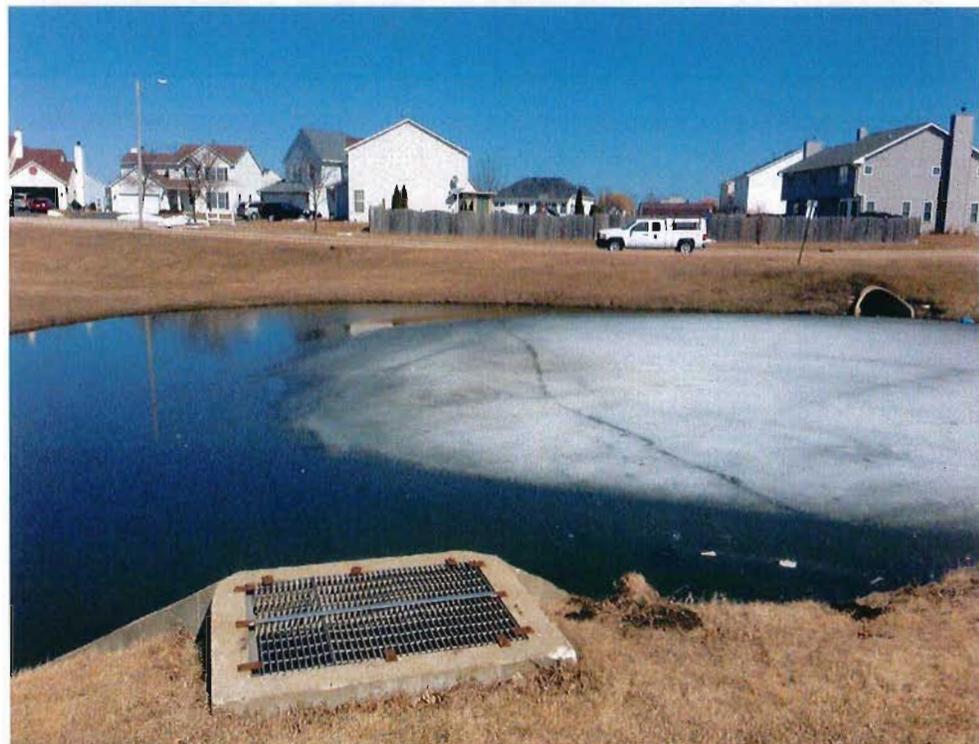
1. The designed water depth of the pond is 4 feet. The pond consists of a wet area at the east end and a dry detention area. The measured water depth in March of 2013 varied between 2.5 and 3.1 feet. The dry area had a few scattered puddles. We conclude that the pond is starting to fill up with sediment.
2. The outlet structure is in good condition but the final section of the inlet is separated from the pipe.
3. Sediment build-up in the pond averages 1.0 feet.
4. The dry detention area and the pond perimeter are mowed.

1. The water depth should be measured in 2018 to compare to the 2013 measurements. This will provide a comparable depth to determine the rate of sediment accumulation as well as an anticipated date for sediment removal.
2. When mowing, leave a grass strip around the perimeter of the pond to improve safety and deter geese.
3. Dredging of the pond should be considered.

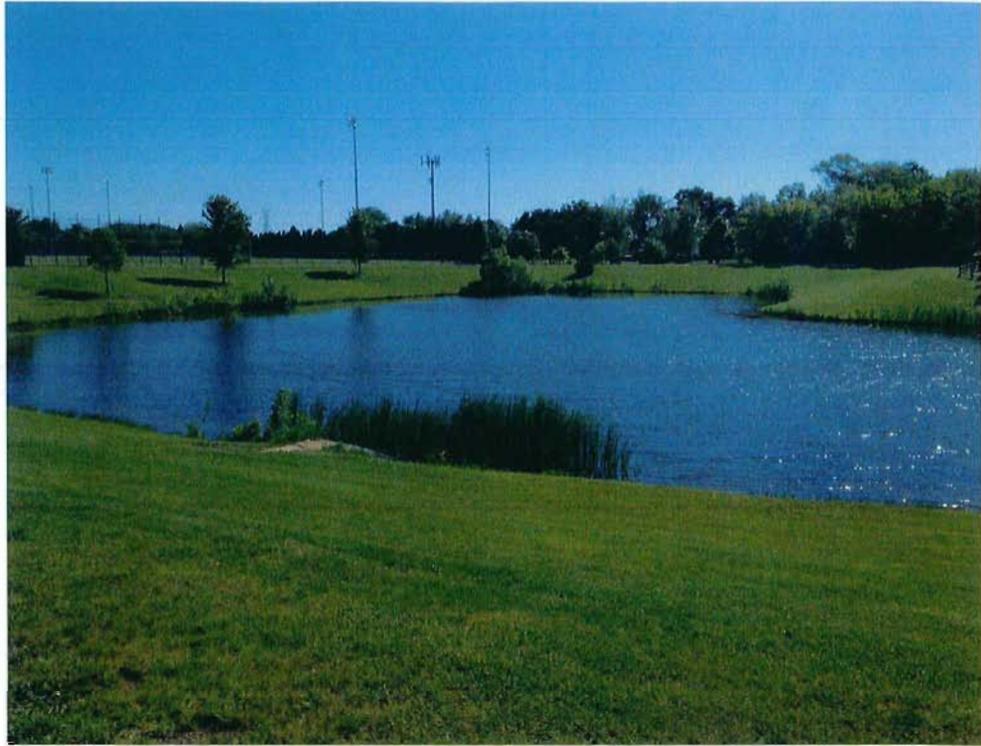
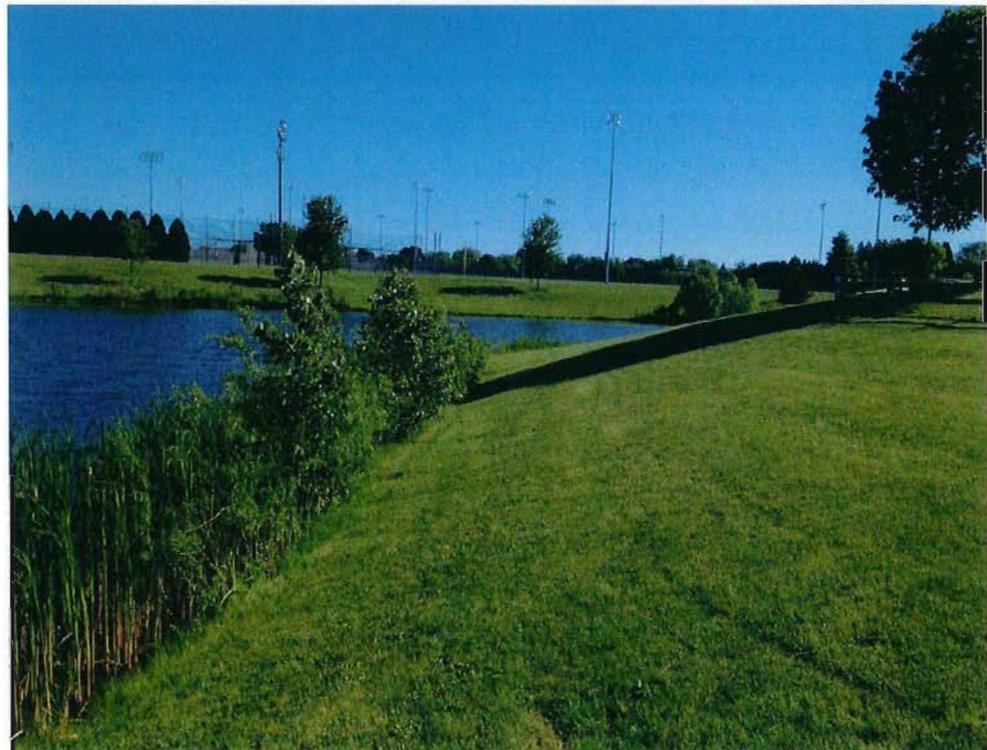
1. The designed water depth of the pond is 12 feet. The measured water depth in June of 2013 ranged between 9.0 and 12.2 feet. The south end of the pond is shallower than the rest.
2. The inlet and outlet structures were inspected and were found to be in good condition.
3. Sediment build-up of 0.4 feet was found in one location.
4. The whole pond perimeter is mowed. Vegetation has grown up in certain areas around the pond, including near the outlet and inlets.

1. The water depth should be measured in 2018 to compare to the 2013 measurements. This will provide a comparable depth to determine the rate of sediment accumulation as well as an anticipated date for sediment removal.
2. Spotty brush removal is necessary, especially around the inlet and outlet structures.
3. The south area of the pond may be filling with sediment, creating the shallower depth. Future dredging of this area may be necessary.

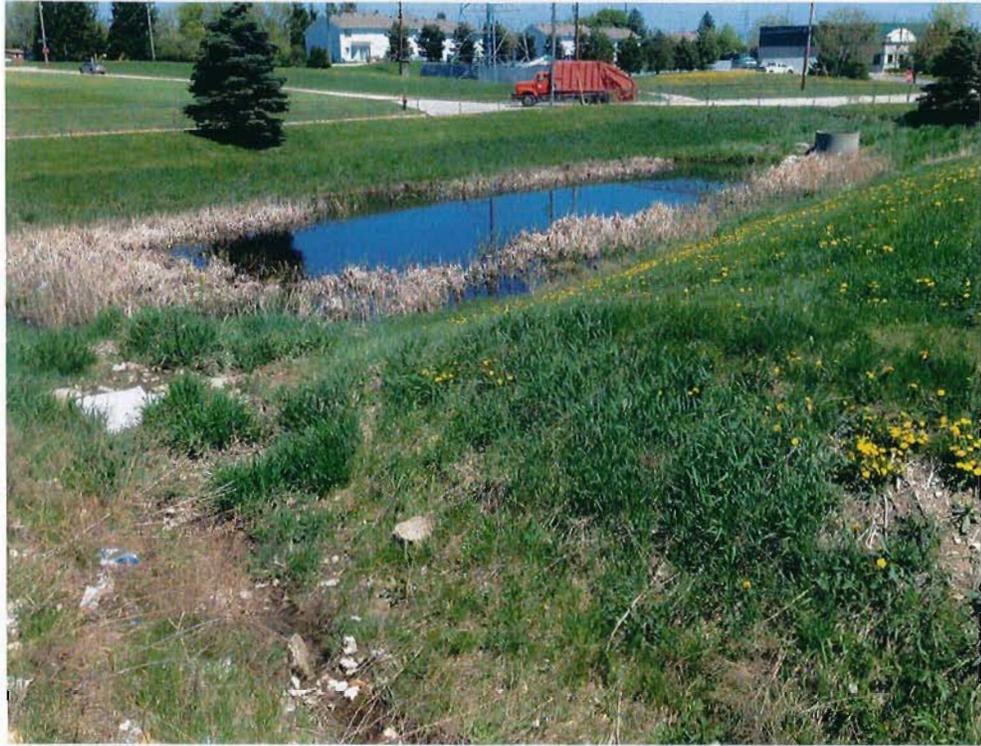
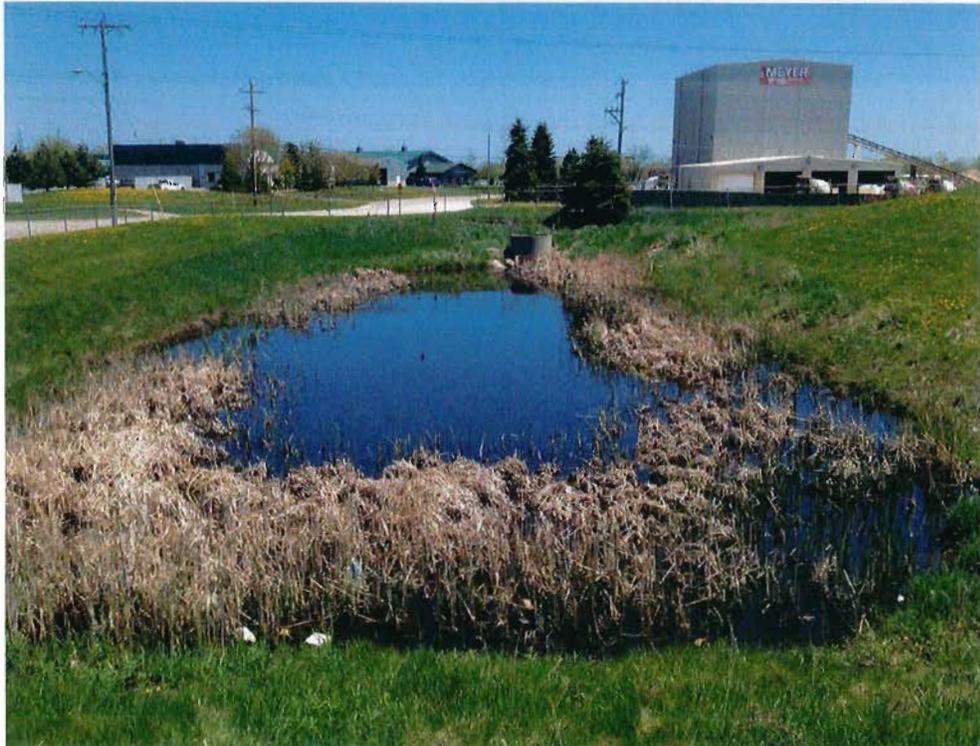
1. The designed water depth of the pond is 5 feet. The measured water depth in May of 2013 was 4.5 feet. The pond may be starting to fill with sediment.
2. The outlet pipe was inspected and was found to be in good structural condition. The structure interior was dirty.
3. An old piece of silt fence is crossing one of the drainage swales into the pond.
4. Sediment depth varied from 0.2 to 0.4 feet.
5. The pond perimeter had not been mowed. Rip-rap areas have vegetation growing in them.
6. Cattail growth is overtaking the pond.

1. The water depth should be measured in 2018 to compare to the 2013 measurements. This will provide a comparable depth to determine the rate of sediment accumulation as well as an anticipated date for sediment removal.
2. Cattails should be removed from the pond and vegetation should be removed from the rip-rap.
3. The outlet structure should be cleaned.
4. Remove the silt fence from the drainage swale.
5. Dredging of this small pond may be necessary within the next five years.

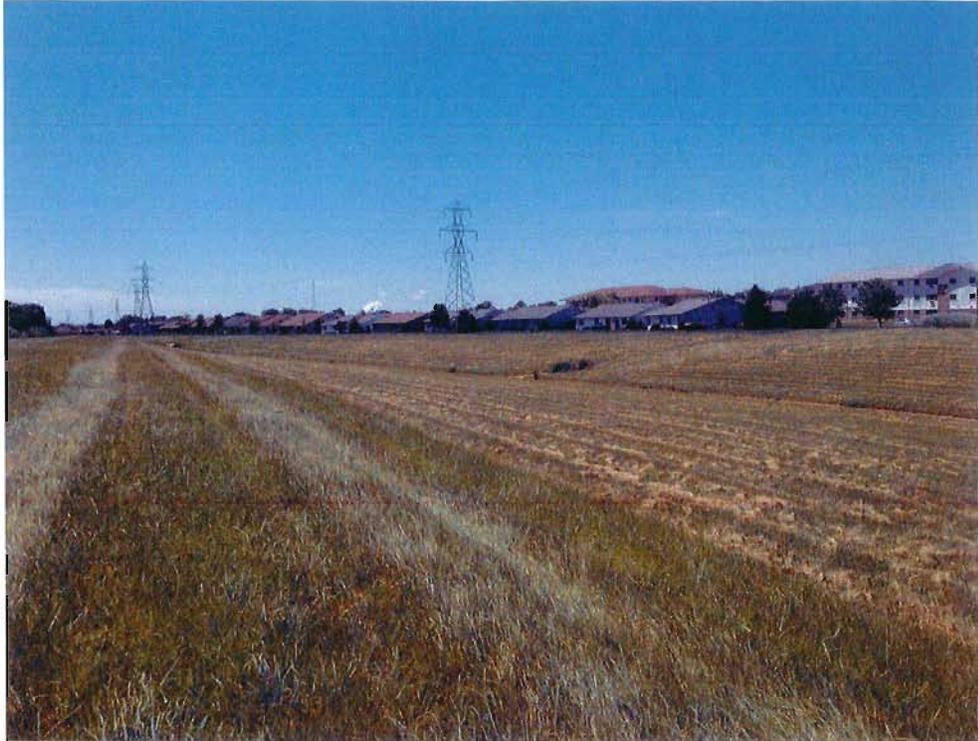
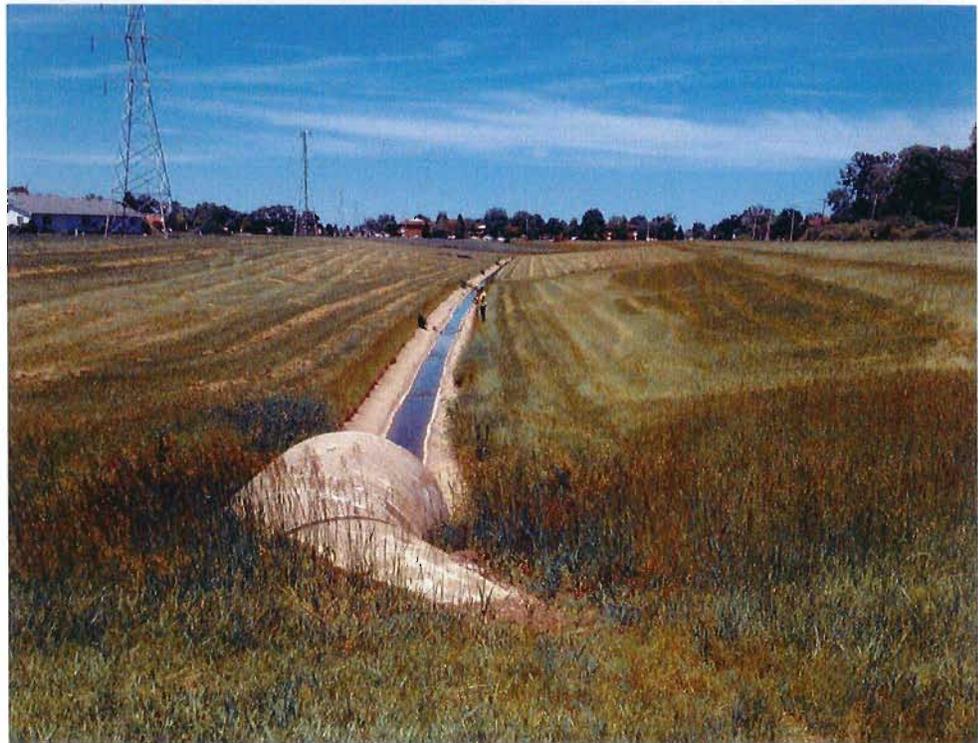
1. The original design plans for the pond were not available. This dry pond had 4.8 feet of water in the north end in June of 2013.
2. The inlet and outlet structures were inspected and were found to be in good condition. The 15-inch pipe was starting to separate.
3. There is some sediment build-up in the concrete gutters.
4. The pond area had been mowed, but not recently.

1. The water depth should be measured in 2018 to compare to the 2013 measurements. This will indicate whether sediment is accumulating in the small wet portion of the pond.
2. The concrete gutters should be cleaned.
3. Reattach 15-inch pipe.

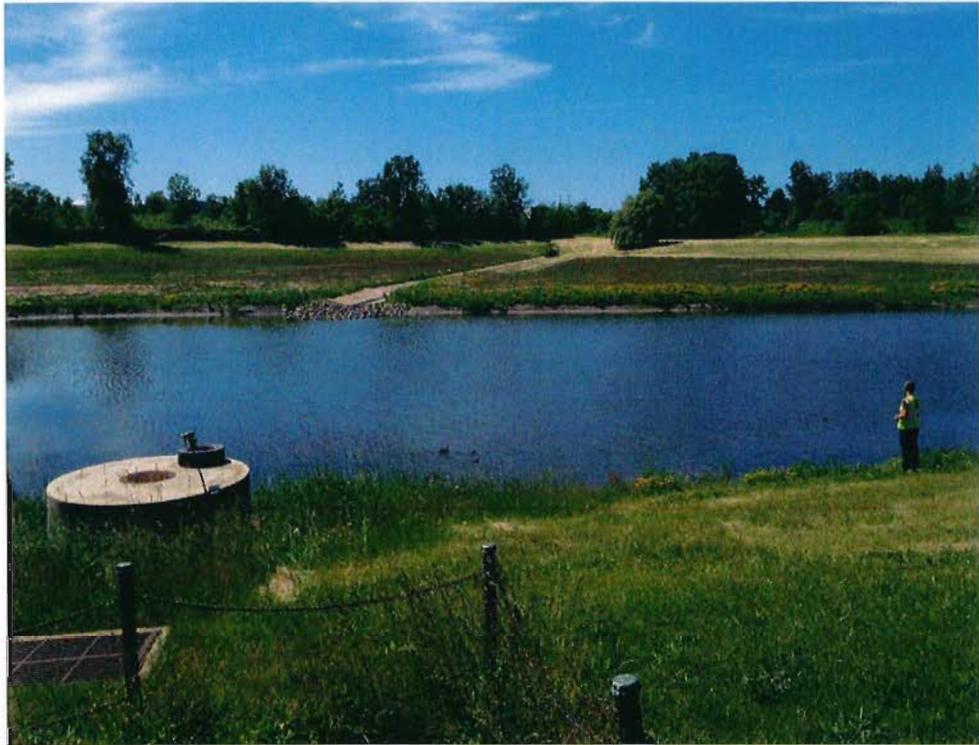
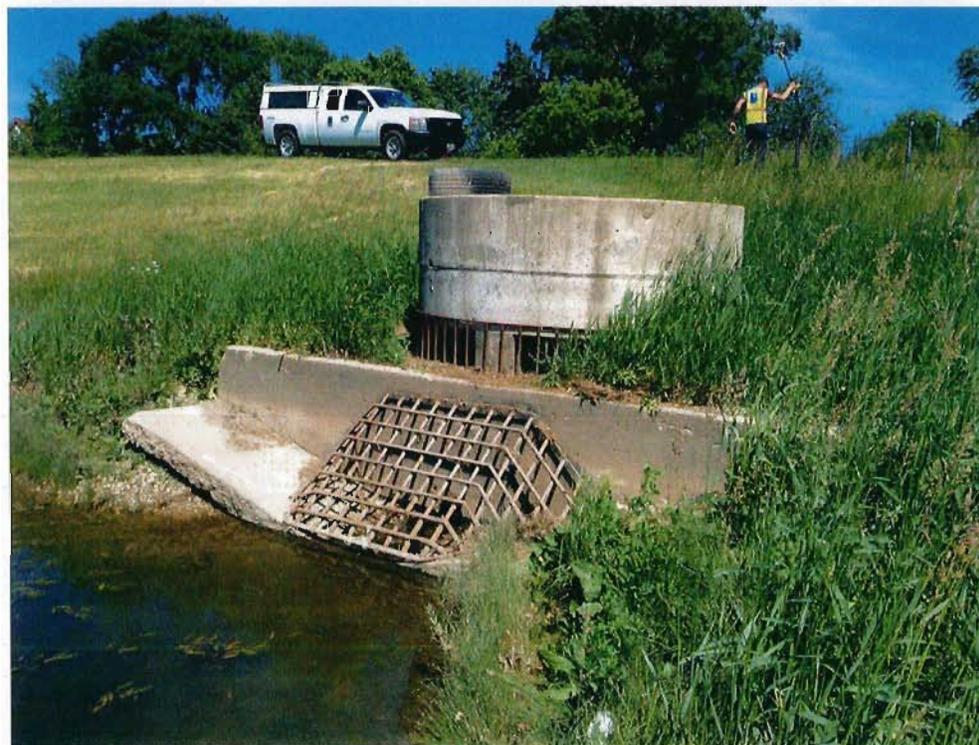
1. The designed water depth of the pond is 4.5 feet. The measured water depth in July of 2013 varied between 4.2 and 5.2 feet.
2. The inlet and outlet structures were inspected and were found to be in good condition. There was some vegetation growing around the outlet structure.
3. Sediment build-up varied between 0.4 and 0.8 feet.
4. Sections of the pond perimeter had been mowed, with the grass left longer near the pond. The rip-rap area was clear.
5. Some sediment has built up in the concrete gutters.

1. The water depth should be measured in 2018 to compare to the 2013 measurements. This will provide a comparable depth to determine the rate of sediment accumulation as well as an anticipated date for sediment removal.
2. The concrete gutters should be cleaned.
3. Vegetation should be cleared around the outlet structure.

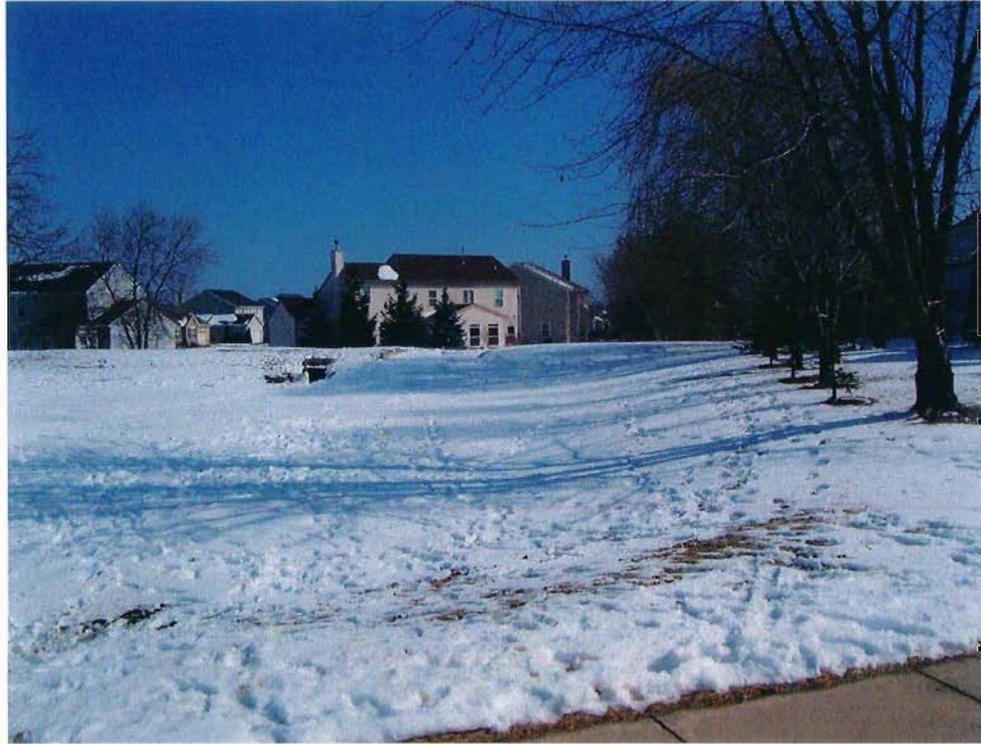
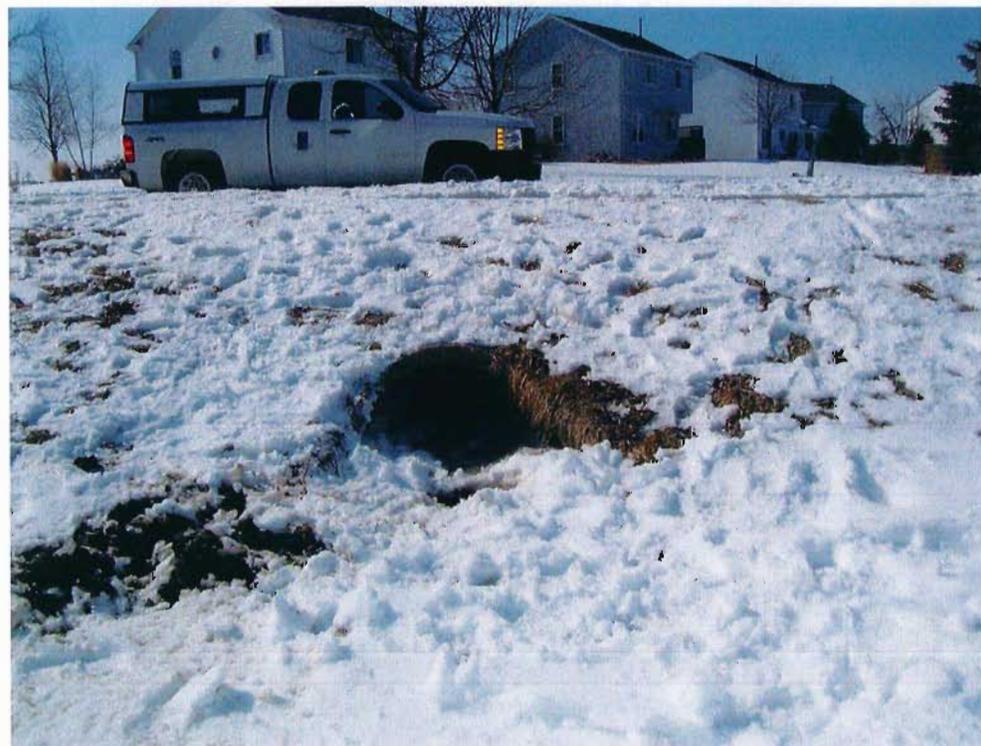
1. This dry pond was inspected in February of 2013.
2. The inlet and outlet pipes were inspected and were found to be in good structural condition.
3. Leaves and debris were built-up in front of the outlet grate to a height of about 3 feet.
4. The entire pond area is mowed.

1. Remove debris from the outlet grate periodically to prevent back-ups.
