**THE CITY OF KENOSHA, WISCONSIN  
REQUEST FOR PROPOSAL TO REMOVE AND DISPOSE  
OF ASBESTOS CONTAINING MATERIAL AND UNIVERSAL WASTE  
WITH INSTRUCTIONS TO PROPOSERS**

**PROPOSAL NO. 1-19**

**ISSUED: THURSDAY, JANUARY 10, 2019**

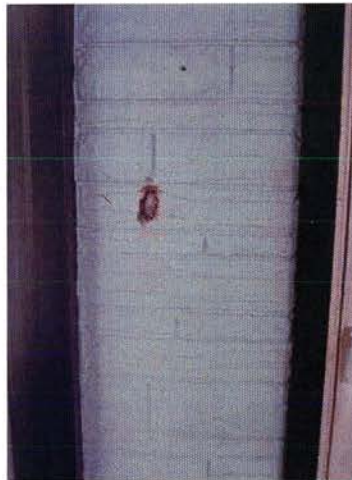
5. Sample 9109-002 location, blueish wall between restroom and south entrance door.

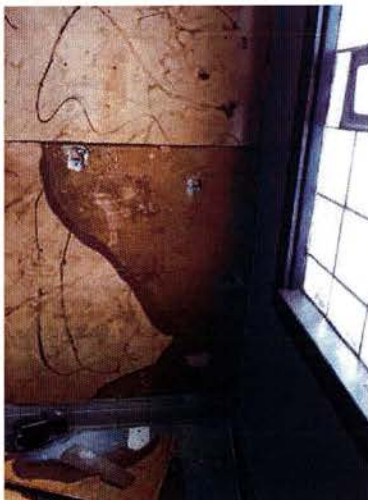
6. Sample 9109-003 location, interior of restrooms.

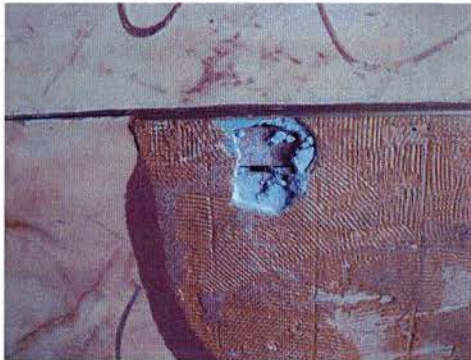
7. Close up of sample 9109-003 location, interior of restrooms.

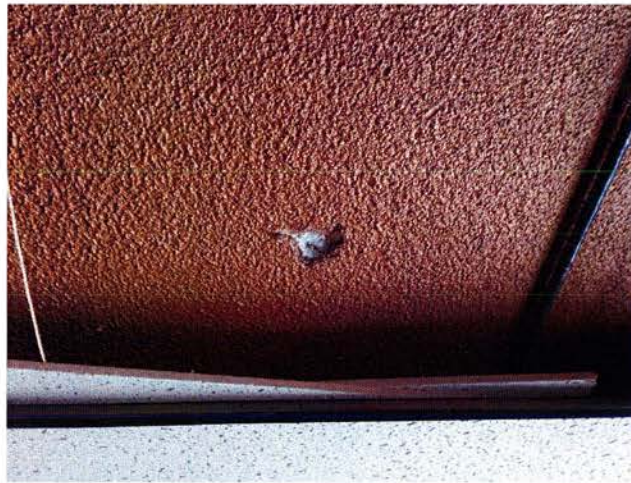
8. Sample 9109-011 location, spray-on sound proofing above suspended ceiling in bar area.

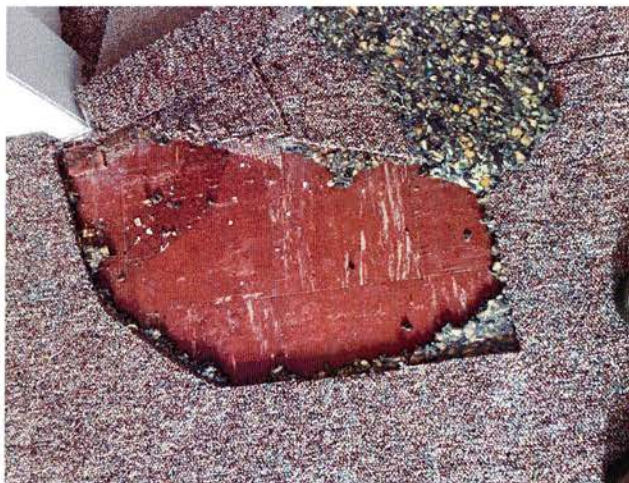
9. Sample 9109-021 location, residential area in bedroom north of kitchen.

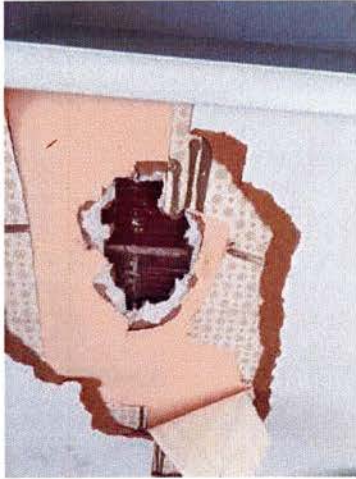
10. Sample 9109-022 location, residential area kitchen.

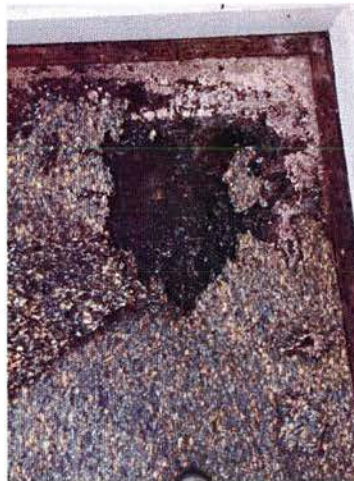
11. Sample 9109-023 location, residential area bedroom south of kitchen.

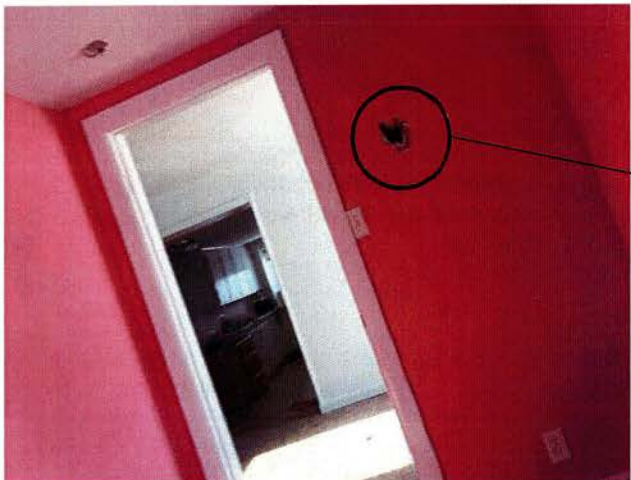
12. Sample 9109-031 location, residential area small pink bedroom.

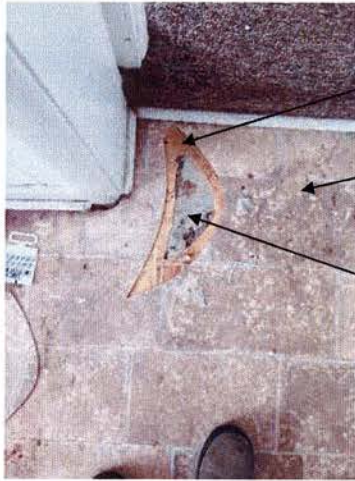
13. Samples 9109-019 and 9109-020 locations, residential area kitchen.

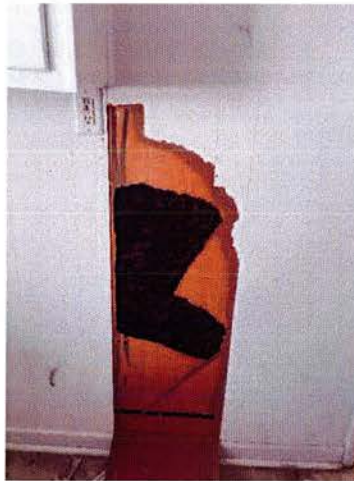
14. Sample 9109-032 location, residential area, kitchen southern wall paneling beneath wood paneling.

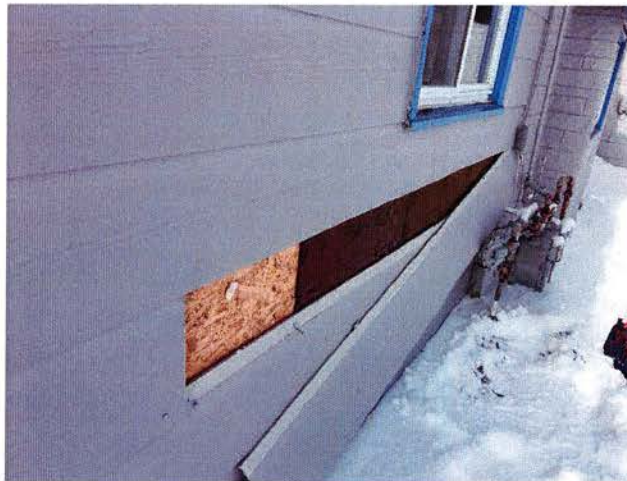
15. Sample 9109-036 location, exterior siding.
