**THE CITY OF KENOSHA, WISCONSIN
REQUEST FOR PROPOSAL TO REMOVE AND DISPOSE
OF ASBESTOS CONTAINING MATERIAL WITH INSTRUCTIONS TO PROPOSERS**

**STRUCTURE(S) REQUIRING REMOVAL AND DISPOSAL OF ASBESTOS
CONTAINING MATERIAL**

Subject Property: 912 47th Street
 PIN: 12-223-31-131-013

Single Family Residence
912 47th Street
Kenosha, Wisconsin

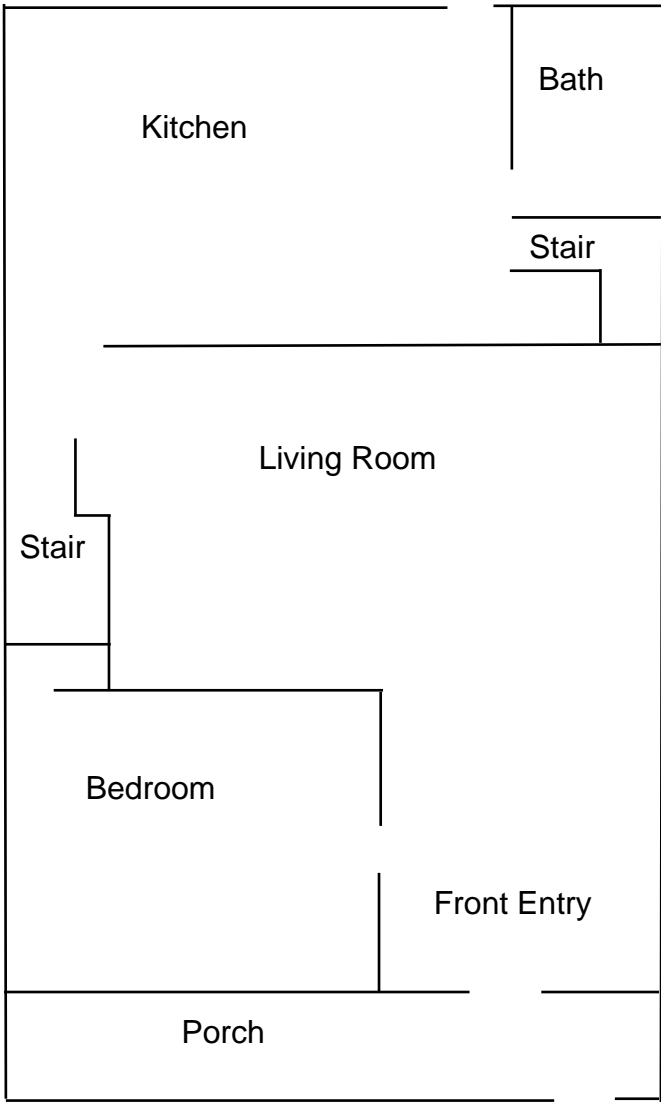
1st Floor

Material	Homogeneous Code	Location	Approximate Quantity	Condition
Tar on Roof Tar Paper	MPT	Roof Under Asphalt Shingles	920 SF	Fair
Roof Flashing	MRF	Roof at Chimneys	8 SF	Fair
9” White Floor Tile & Black Mastic	MF9w	Kitchen 5 th Layer on Wood	180 SF	Fair

The tar on tar paper, roof flashing, and 9” white floor tile and black mastic are category I non-friable asbestos containing materials. They were in fair (non-friable) condition at the time of the inspection. If these materials are subjected to sanding, grinding, cutting or abrading during demolition, they would be then be defined as regulated asbestos containing material (RACM) under NR 447 of the Wisconsin Administrative Code.

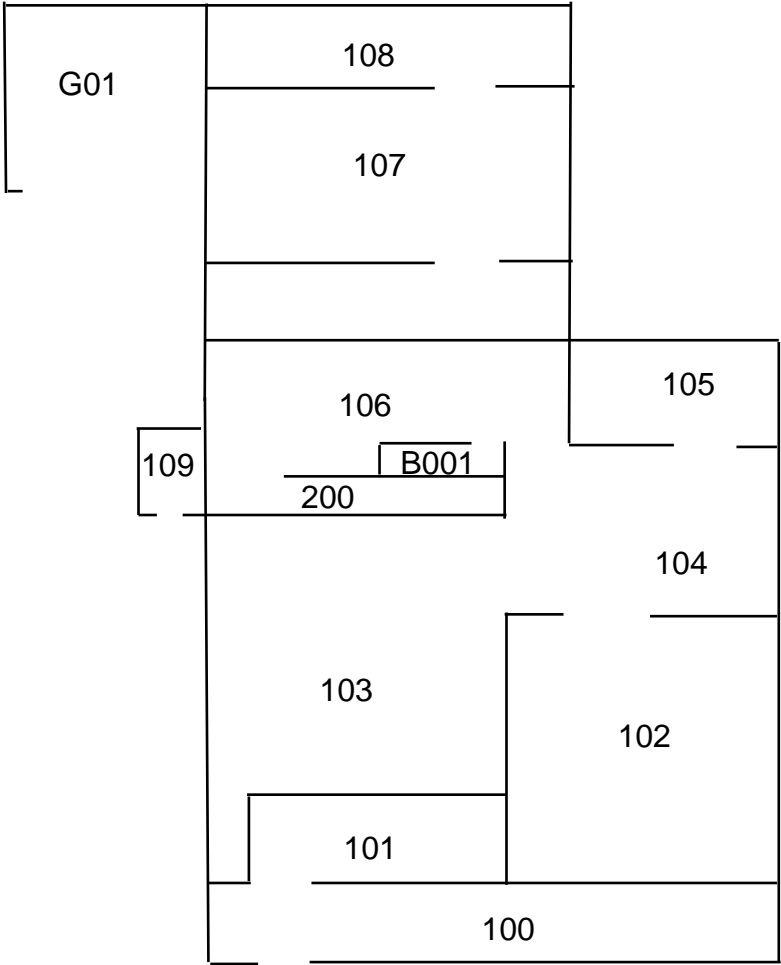
1st Floor

Material	Homogeneous Code	Location	Approximate Quantity	Condition
12” White Floor Tile	MF12w	1 st Floor Room 106	180 SF	Fair
Transite Panel	MTP	Basement Room 002 on Ceiling	200 SF	Fair
Flue Packing	TFP	Basement Room 001 on Chimney	3 SF	Fair
Duct Wrap	TDW	Basement Room 001 – Center on Beam	4 SF	Fair
Roof Flashing	MRF	House Roof At Chimney & Pipe Penetrations Garage Roof Around Edges of Roof	6 SF 25 SF	Good

The roof flashing and 12” white floor tile are category I non-friable asbestos containing materials. They were in fair (non-friable) condition at the time of the inspection. If these materials are subjected to sanding, grinding, cutting or abrading during demolition, they would be then be defined as regulated asbestos containing material (RACM) under NR 447 of the Wisconsin Administrative Code.

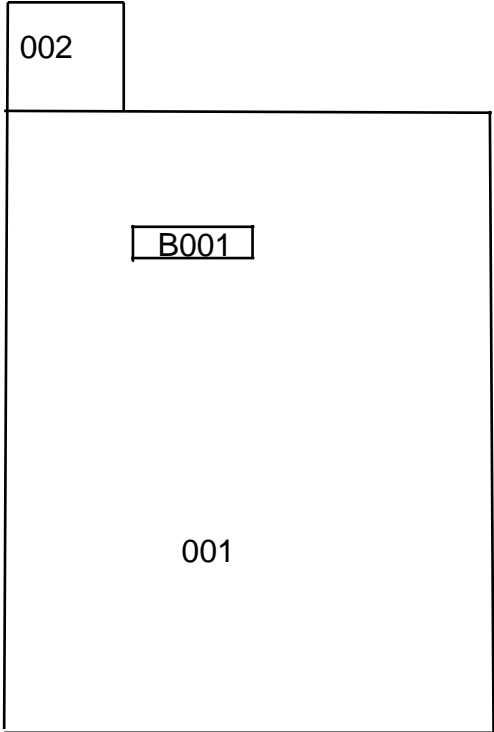
Basement

The flue packing and duct wrap are friable asbestos containing materials. They were in fair condition at the time of the inspection and meet the definition of a regulated asbestos containing material (RACM) as defined under NR 447 of the Wisconsin Administrative Code.

The transite panels are a category II non-friable asbestos containing material. They were in fair (non-friable) condition at the time of the inspection. If they become crumbled, pulverized or reduced to powder during demolition they will become RACM as defined under NR 447.

- Painted brick was observed on the basement walls. The white paint on the brick walls does not contain lead.

- Painted brick was observed on basement walls. Lead was detected in the gray paint on the brick walls but less than the 0.5% lead based paint standard.
