# 2013 Ponds Certifications

City of Kenosha, Wisconsin

July 9, 2014

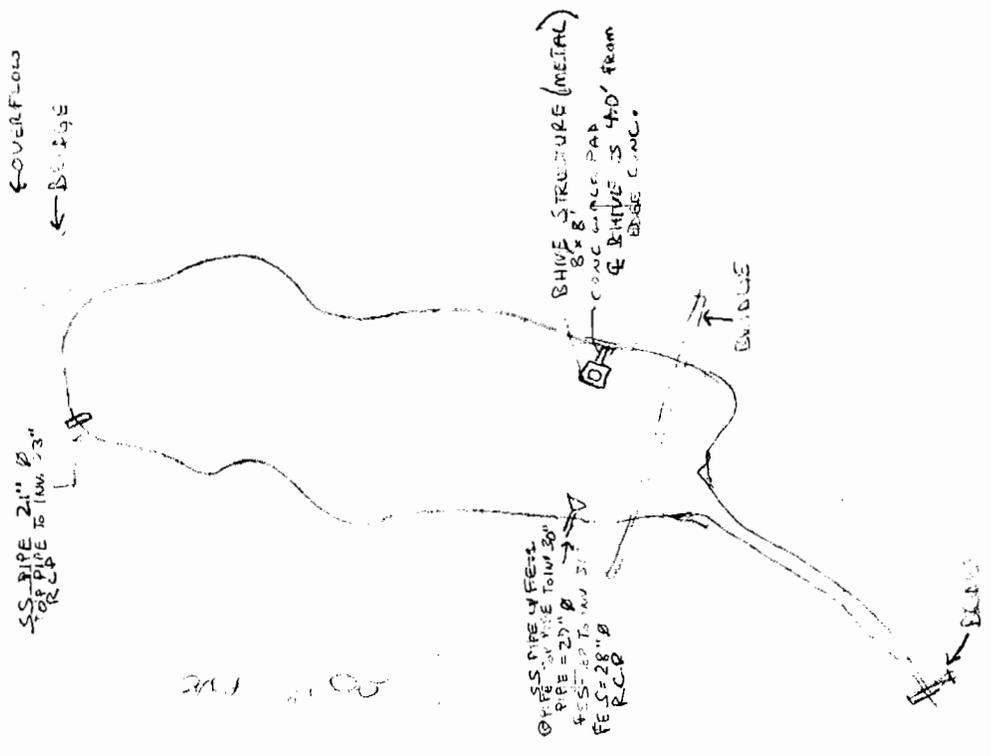
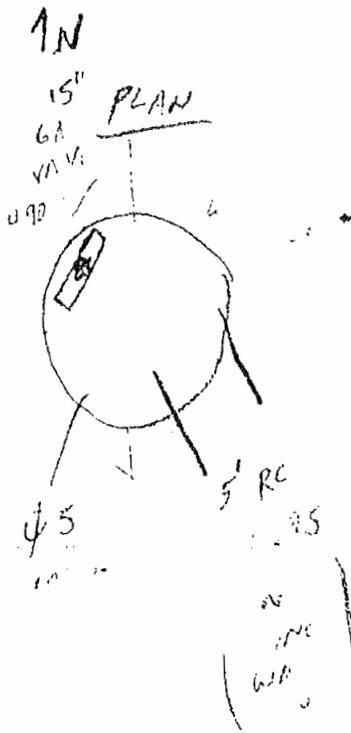
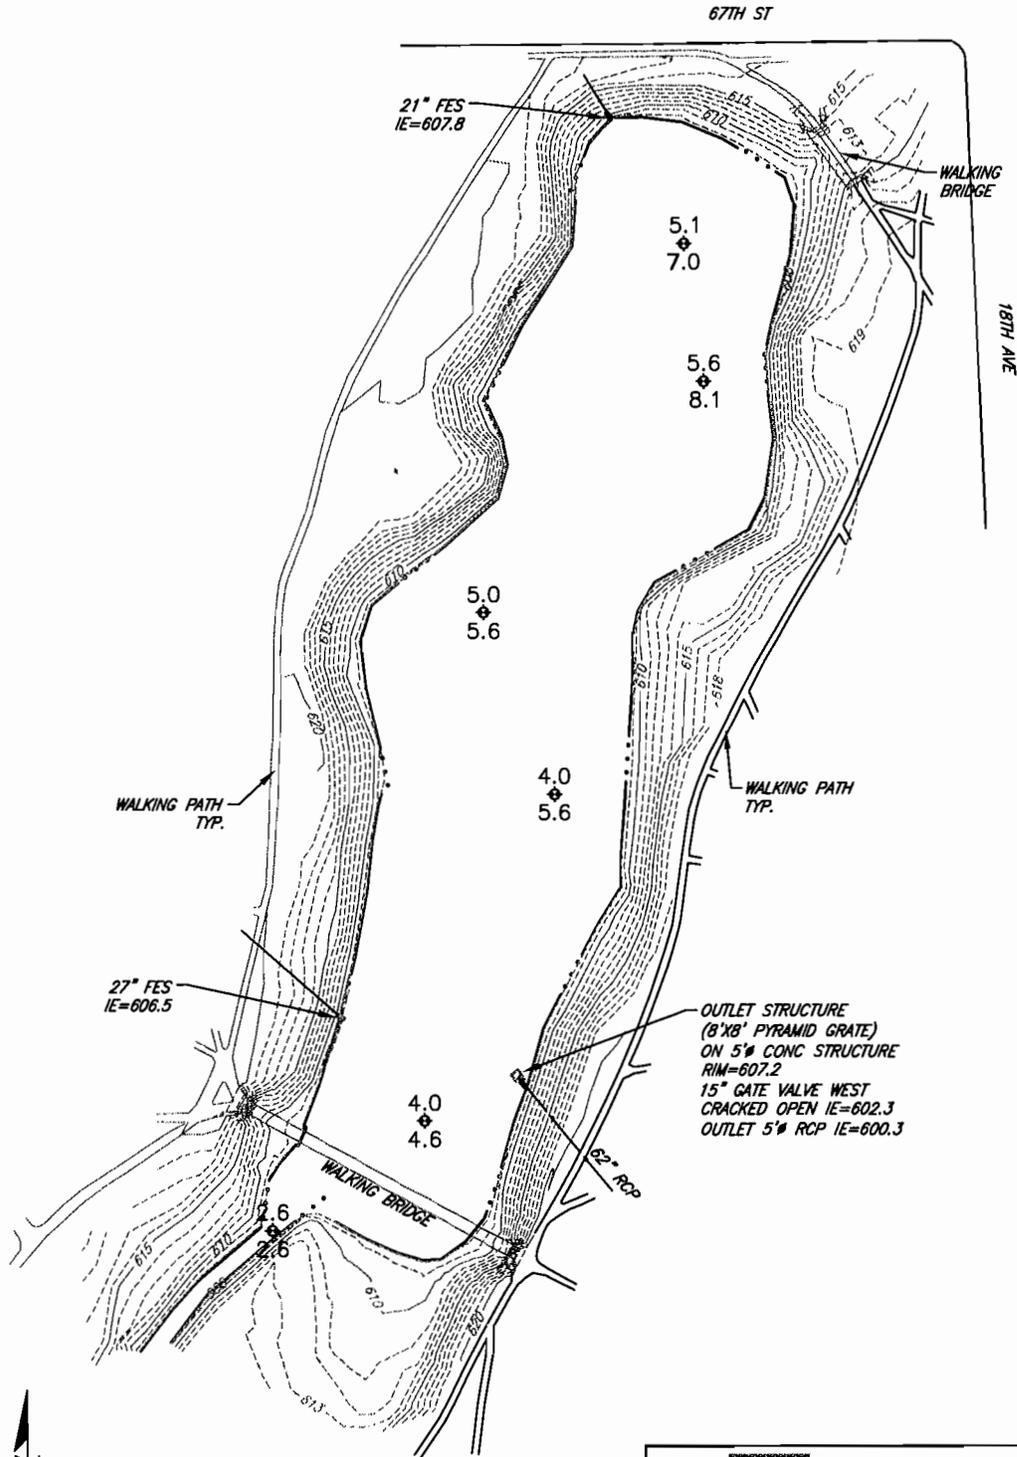
LINCOLN PARK LAGOON

1. The measured water depth in July of 2013 varied between 2.6 feet and 5.6 feet. The original design plans were not available.
2. The inlets and outlets were inspected and were in good condition.
3. Sediment build-up varied between 0.6 and 2.5 feet, with the thicker silt at the north end of the pond.
4. There is thick cattail growth at the north end of the pond and also in the inlet channel at the south end of the pond. Algae covered most of the pond.
5. The function of the outlet structure is unclear.

EAST SIDE INTAKE - SEE NO. (N) OF BRIDGE  
ON -- OF POND.

1. The water depth should be measured in 2018 to compare to the post-dredging measurements. This will provide a comparable depth to determine the rate of sediment accumulation as well as an anticipated date for the next sediment removal.
2. The outlet structure requires further investigation. Replacement may be necessary if the structure is not functional.
3. The cattails and willows should be cleared from both the north end and the inlet channel.
4. Dredge to remove sediment.

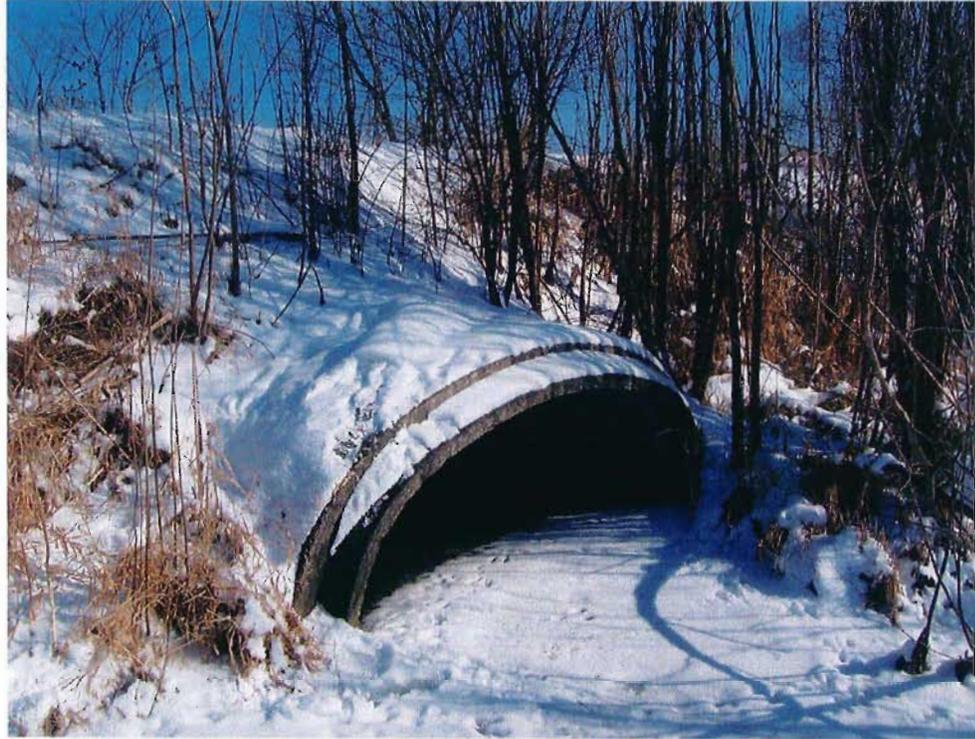
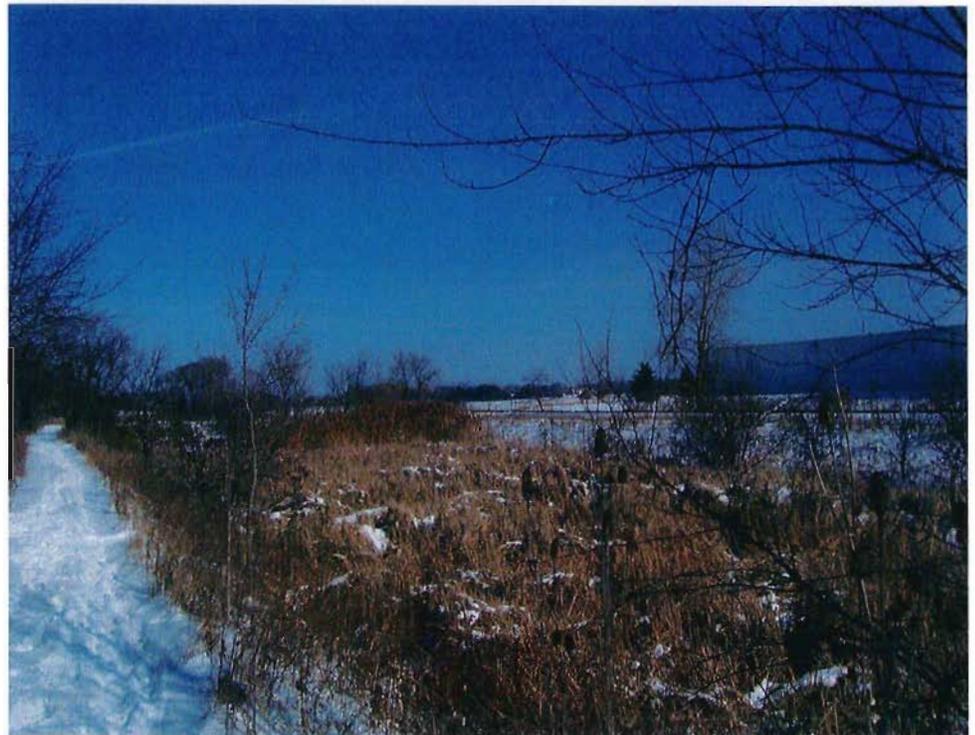
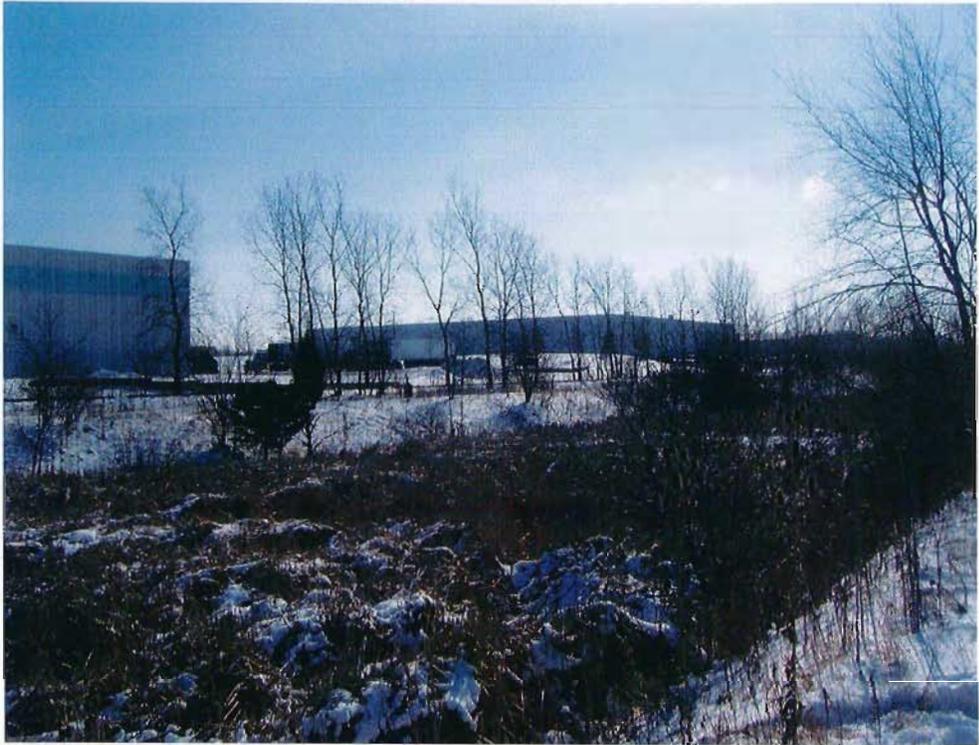
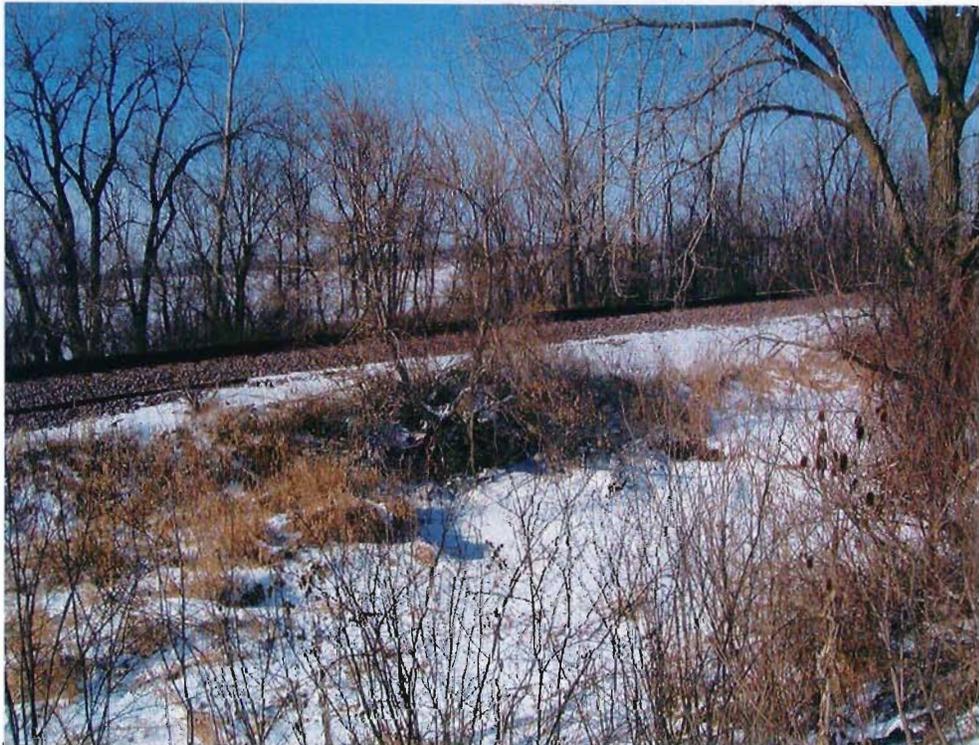
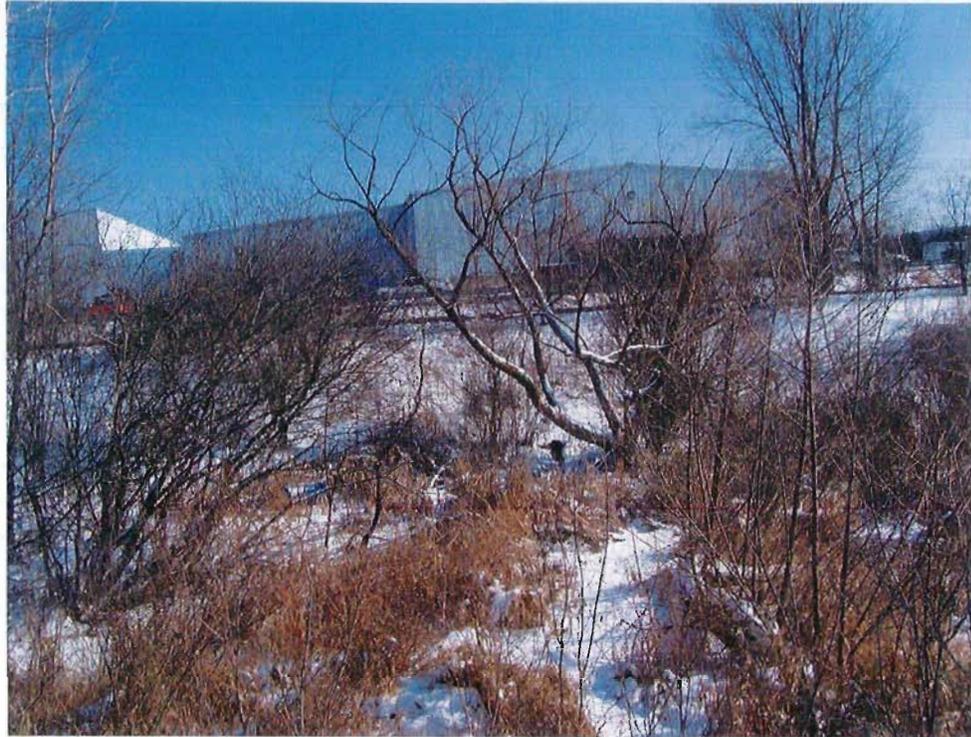
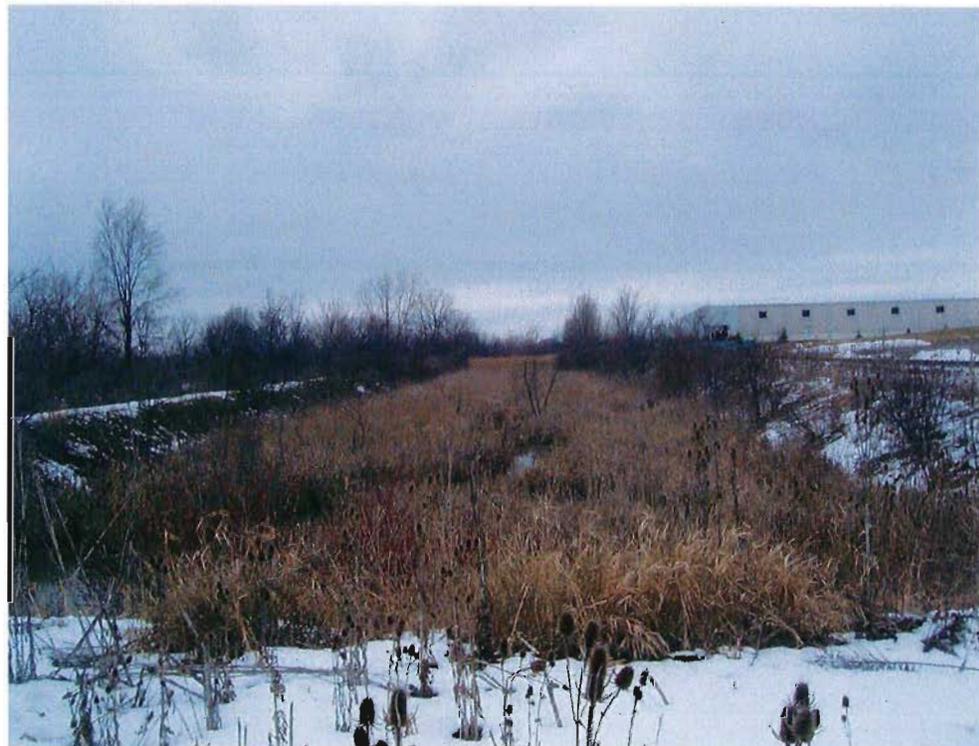
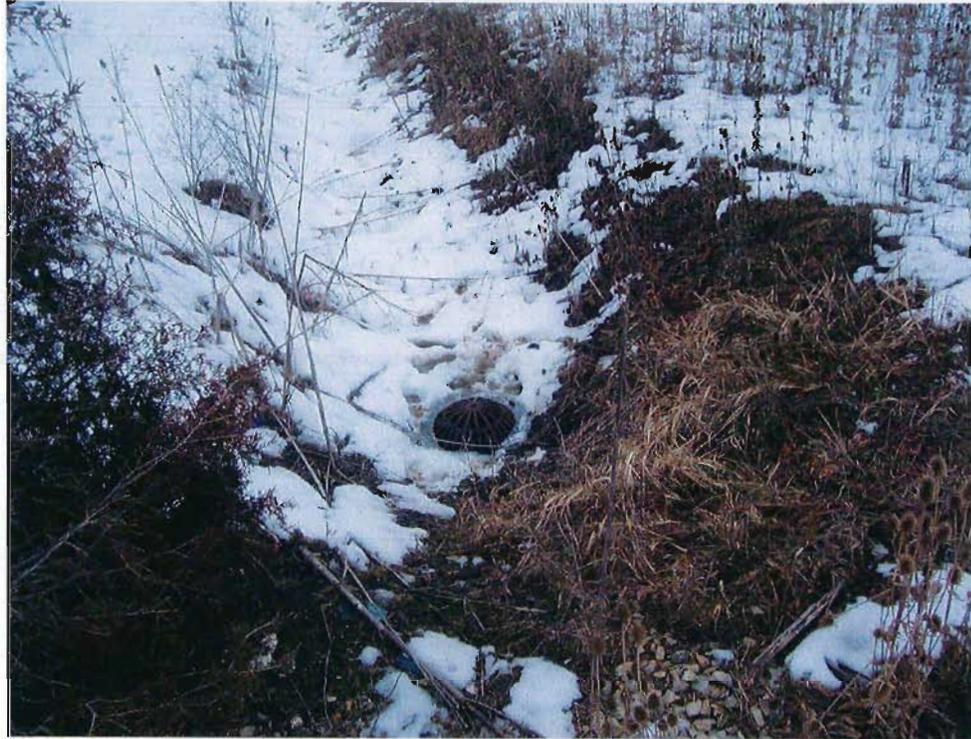
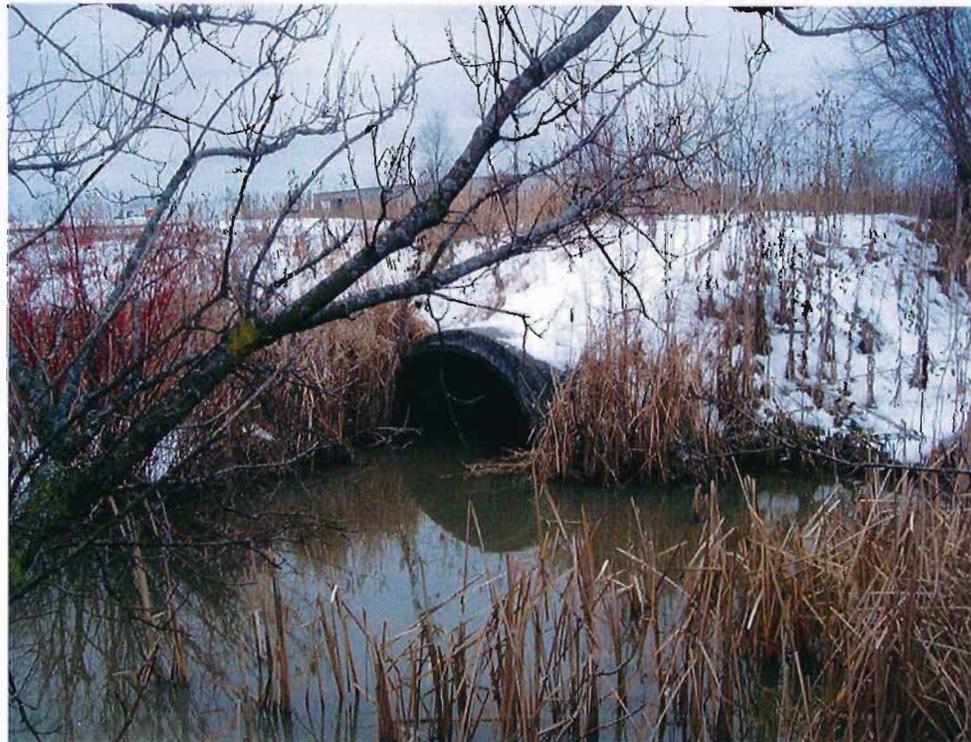
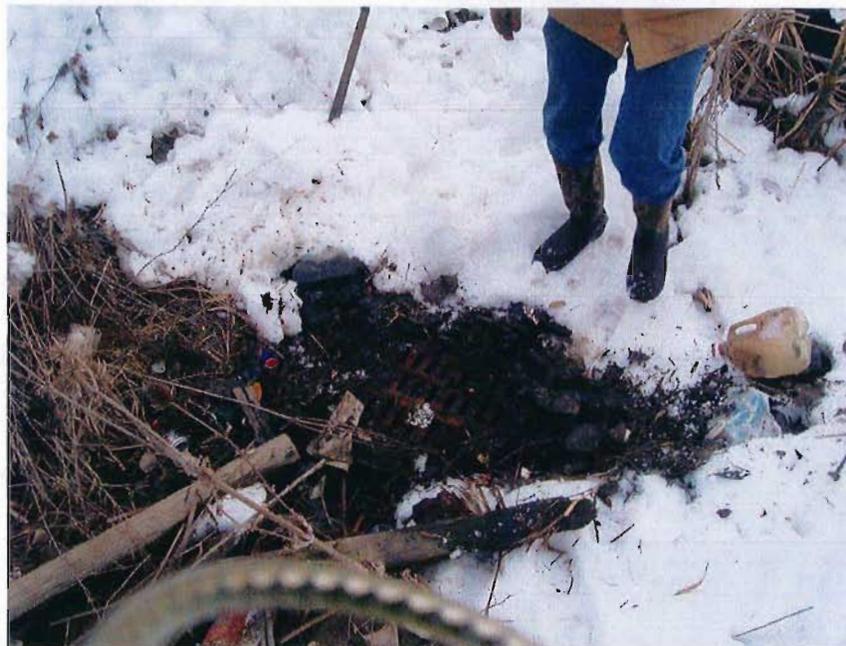
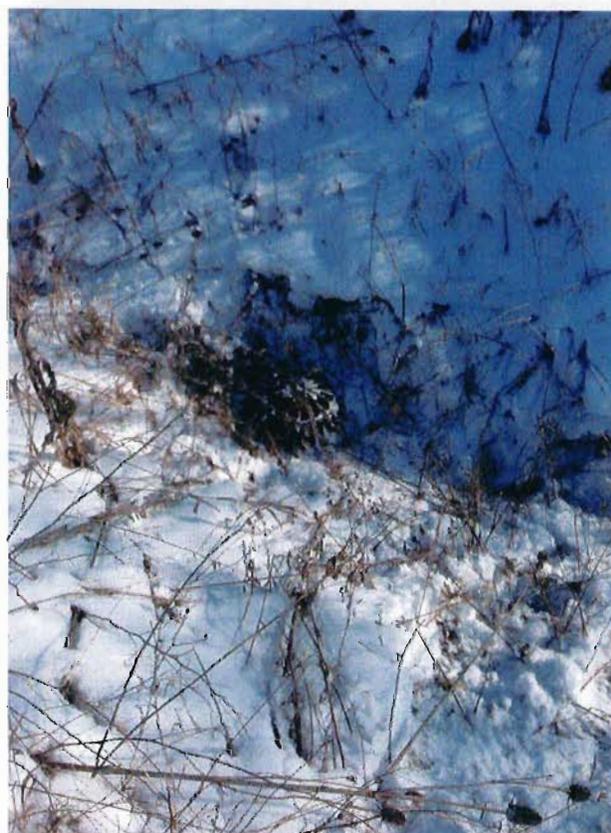
GENERAL INDUSTRIAL PARK

1. The designed water depth of the pond is approximately 4 feet; the design plans are not clear. The measured water depth in February of 2013 varied between 1 and 1.5 feet. We conclude that the pond is filling with sediment.
2. The pond does not seem to be functioning correctly. The area around the outlet pipe was dry while there was stagnant water in the ends of the pond.
3. The inlet and outlet structures were inspected and were found to be in good structural condition.
4. Sediment build-up varies between 1 and 1.5 feet.
5. The pond is completely full of cattails and there is extensive brush growth on the edges. Vegetation has also grown up around the inlets and outlets.

\* HOW IS POND SUPPOSED TO WORK?  
(DOX LEAKS NEAR CURB, SWAMPY WATER  
E FENDS)

1. The water depth should be measured in 2018 to compare to the 2013 measurements.
2. Since the pond is no longer functioning, it should be recut to its original design elevations. Further investigation into the original design of the pond is needed.
3. The cattails and brush within and surrounding the pond should be removed.

- RE-CUT POND

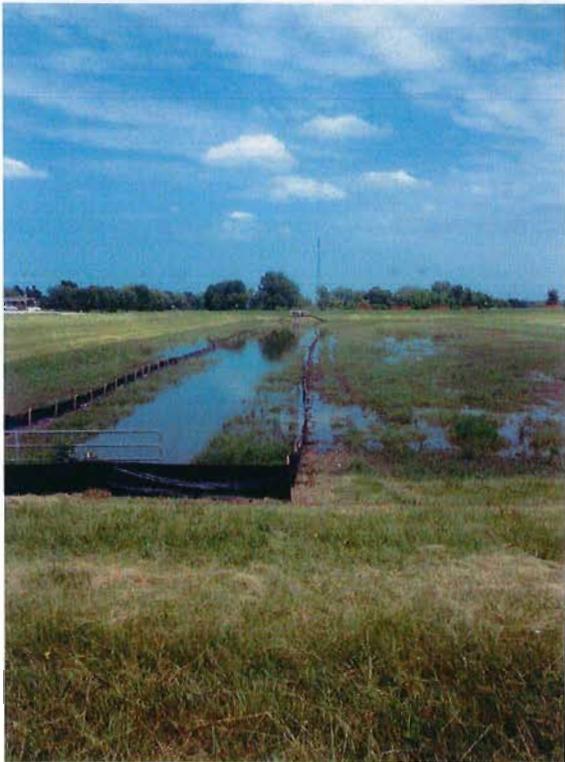
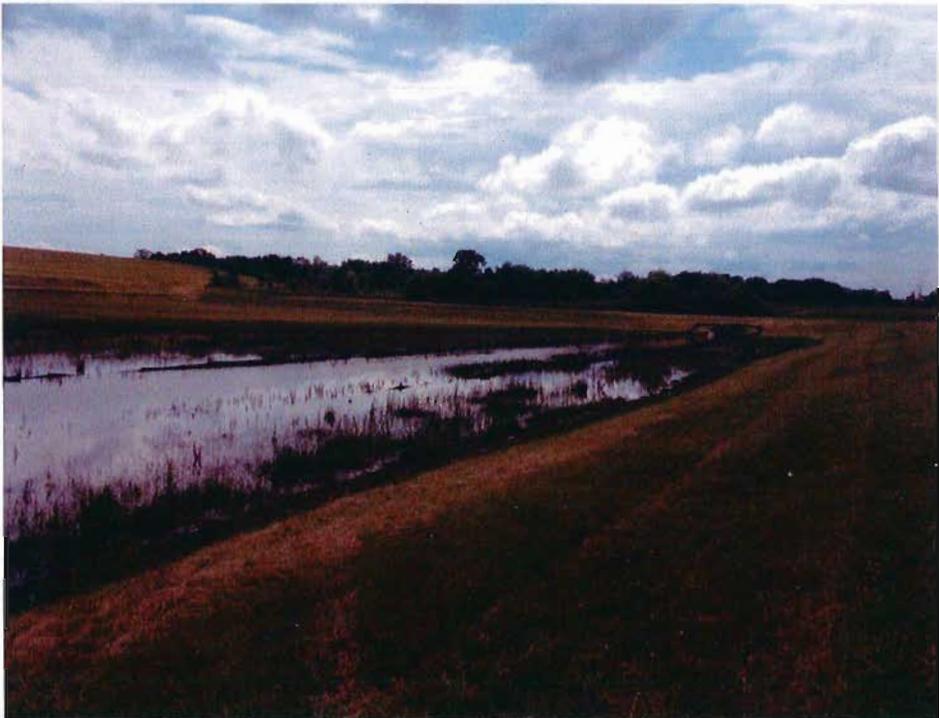
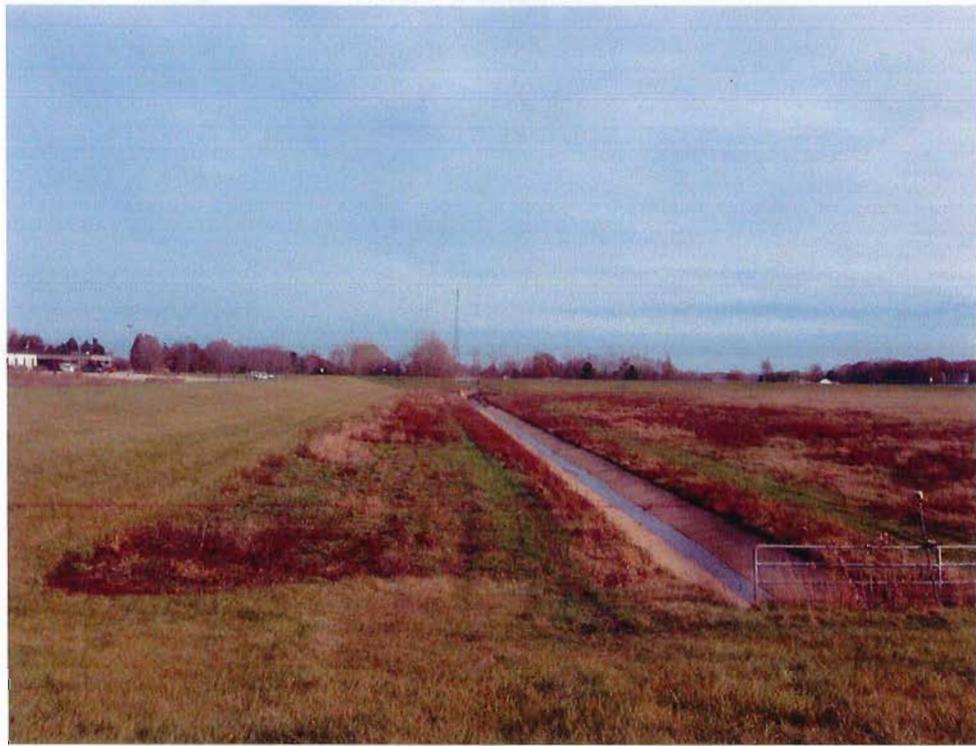
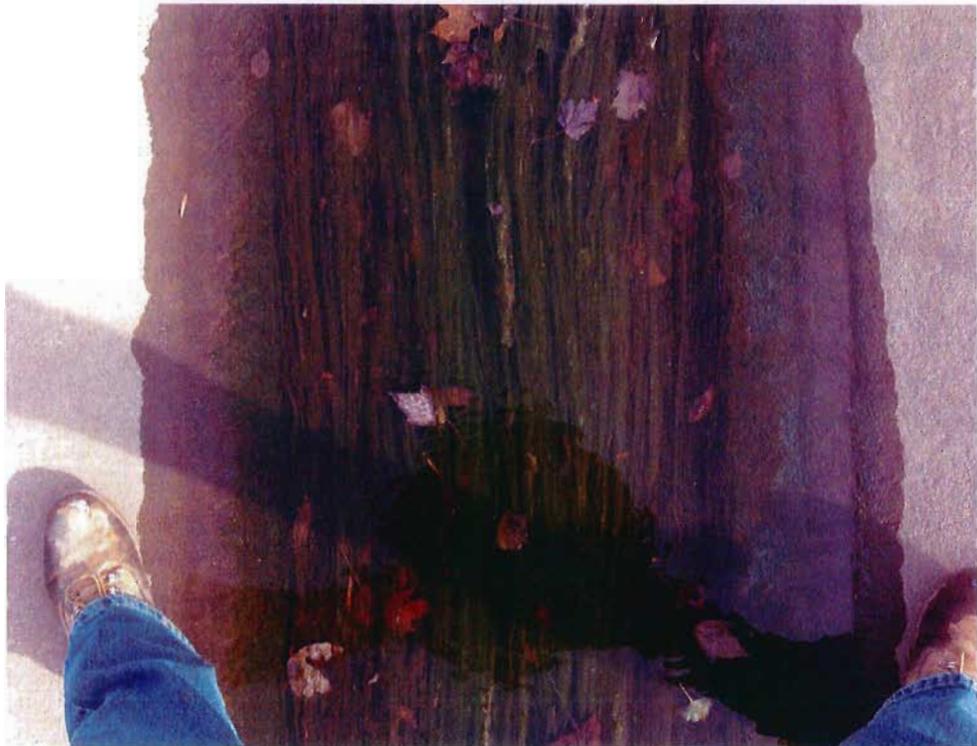
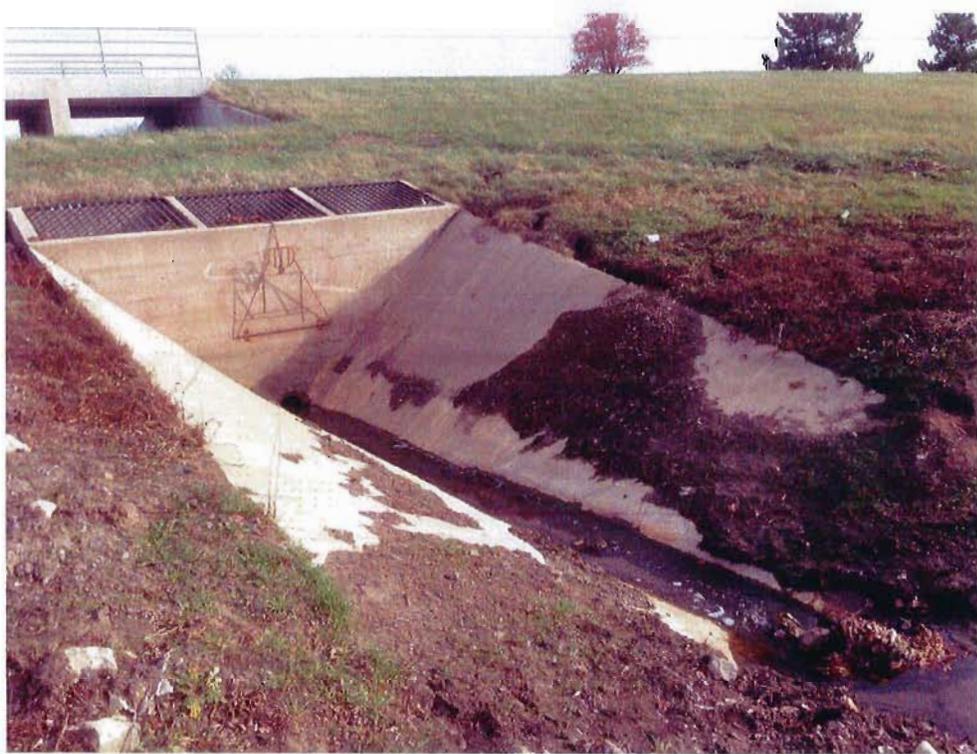
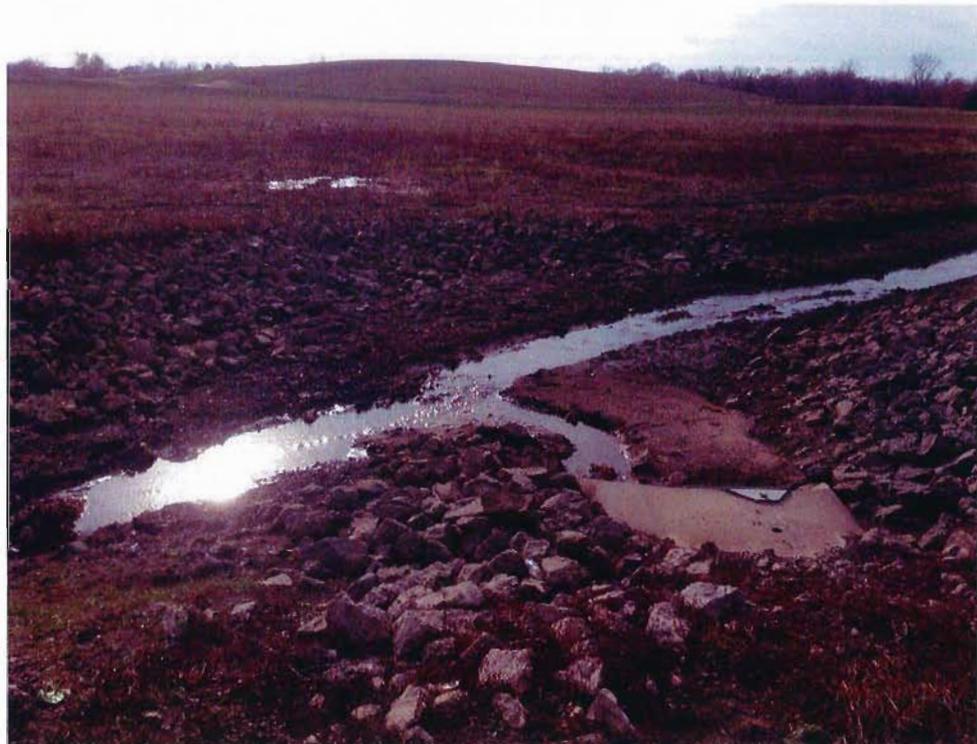
8/22 Channel & Structures still flooded  
overflow structure seems clogged at orifice

1. The pond should be inspected again in 2018.
2. The outlet structure should be inspected to determine if there is a clog at the orifice and if additional actions are needed.
3. The flow channel should be cleaned.
4. Cleaning and maintenance is required at the outlet structure to remove the built-up sediment and silt.

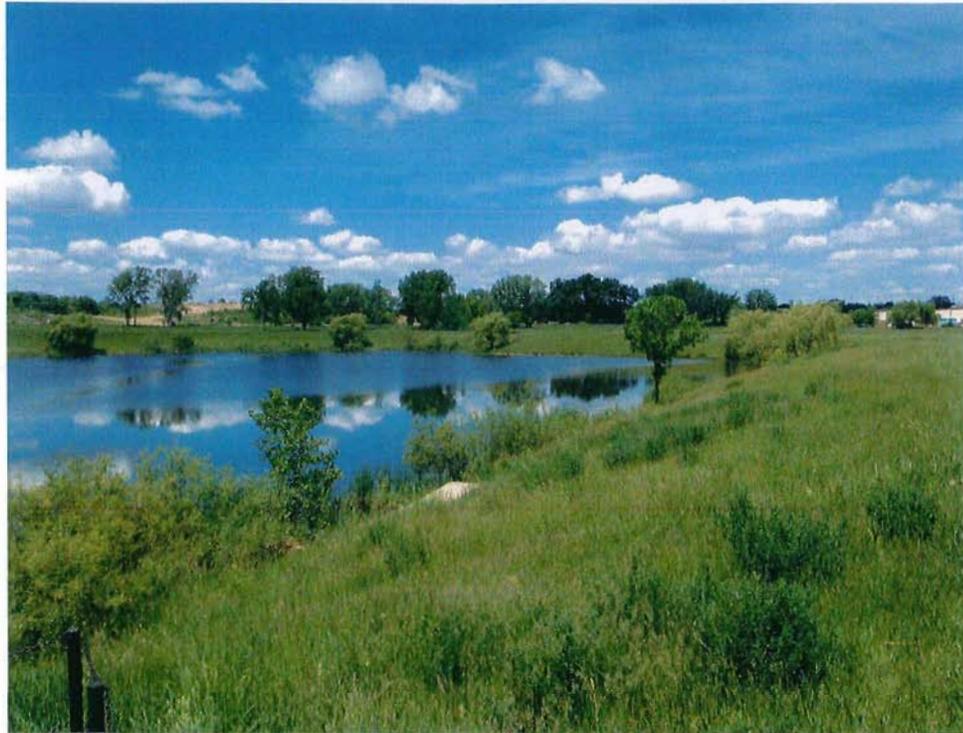
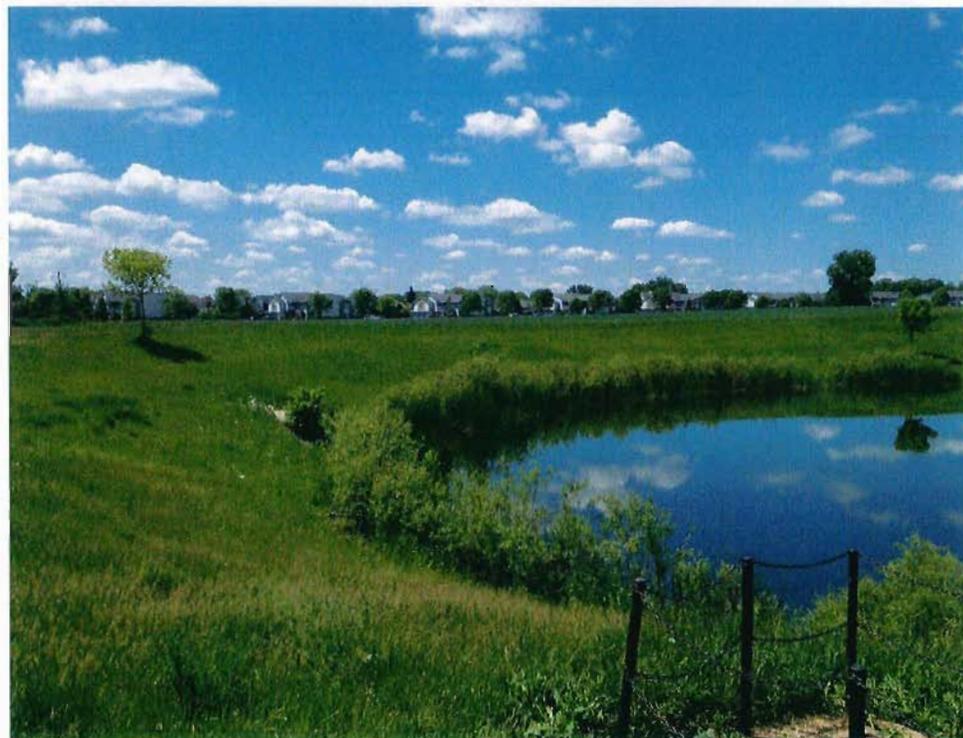
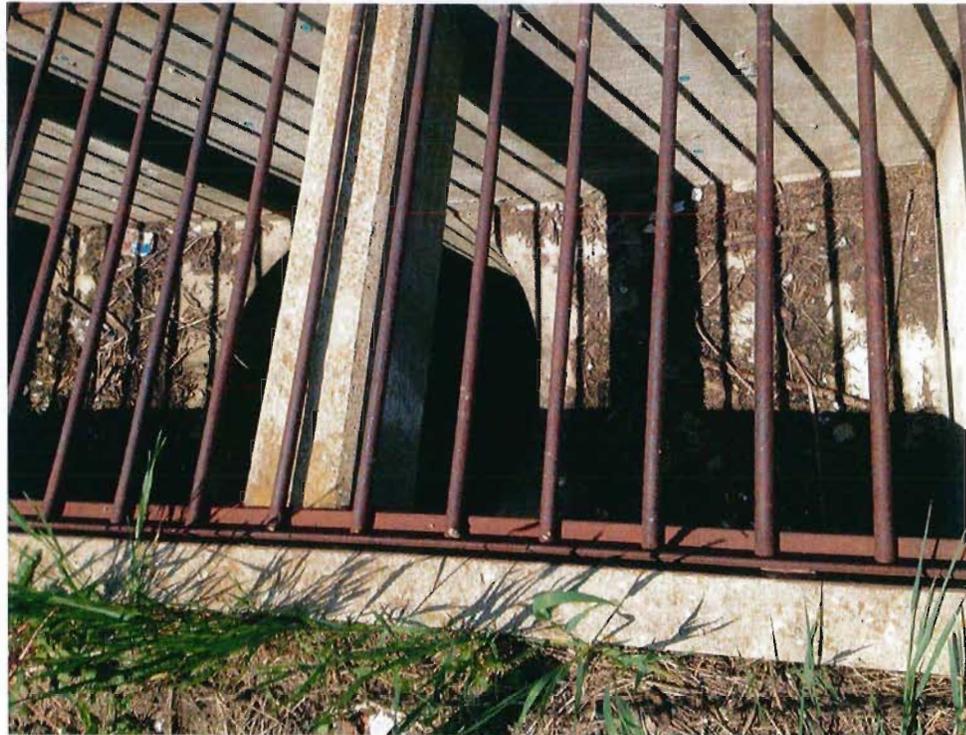
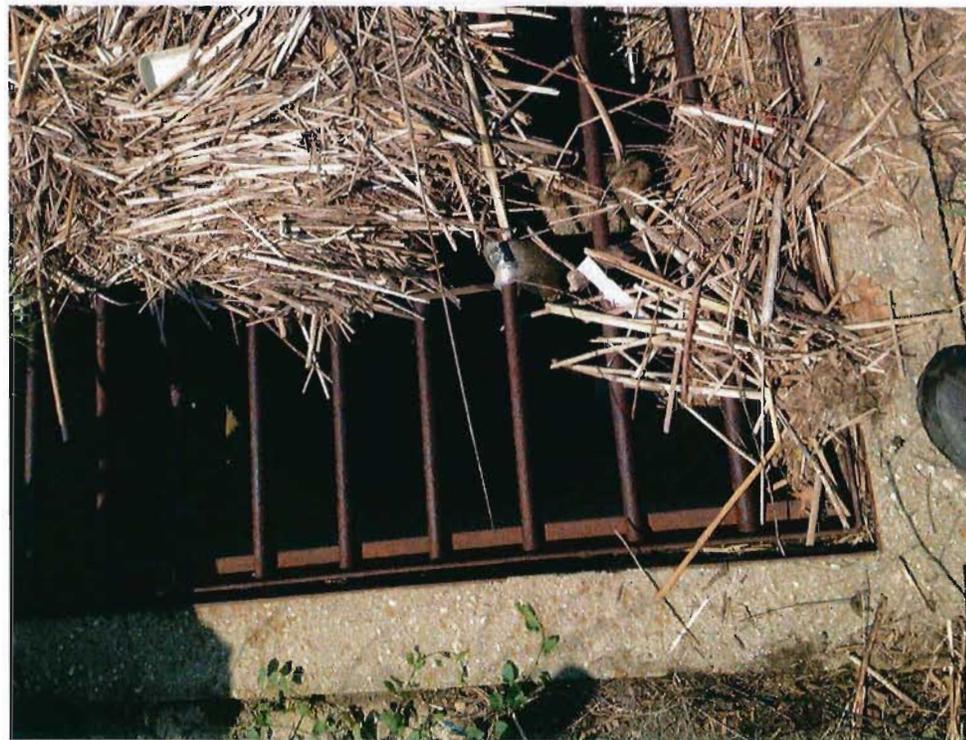
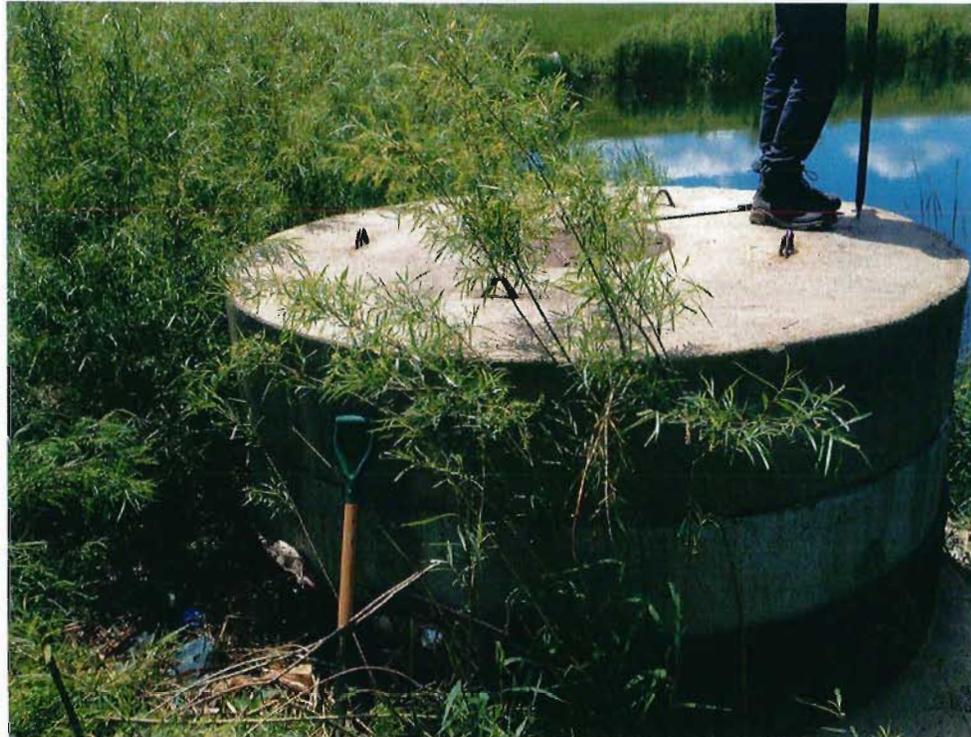
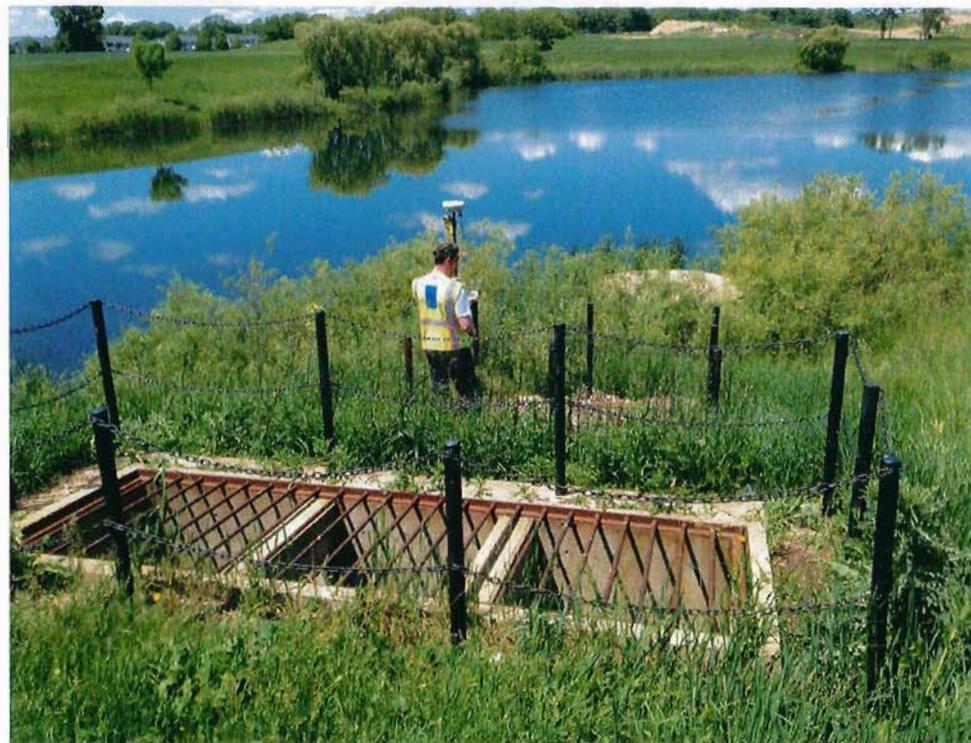
1. The designed water depth of most of the pond is 5 feet, with a section designed for a normal depth of 13 feet. The measured water depth in June of 2013 varied between 5.4 and 15.8 feet. We conclude that the pond was over-excavated at the time of construction.
2. One orifice opening in the outlet structure is broken. There is also heavy brush and plant growth around the outlet structure.
3. The west inlet structure is full of clay silt. This indicates an erosion issue.
4. Sediment build-up varied between 0.3 and 1.4 feet.
5. The pond perimeter area is occasionally mowed. Brush has grown up around most of the pond.

1. The water depth should be measured in 2018 to compare to the 2013 measurements. This will provide a comparable depth to determine the rate of sediment accumulation as well as an anticipated date for sediment removal.
2. Repair the orifice opening in the outlet structure.
3. Clear the brush from the outlet structure and remove other growth around the pond as necessary.
4. Investigate and repair the cause of the siltation problem at the west inlet structure.
