# 2013 Ponds Certifications

City of Kenosha, Wisconsin

July 9, 2014

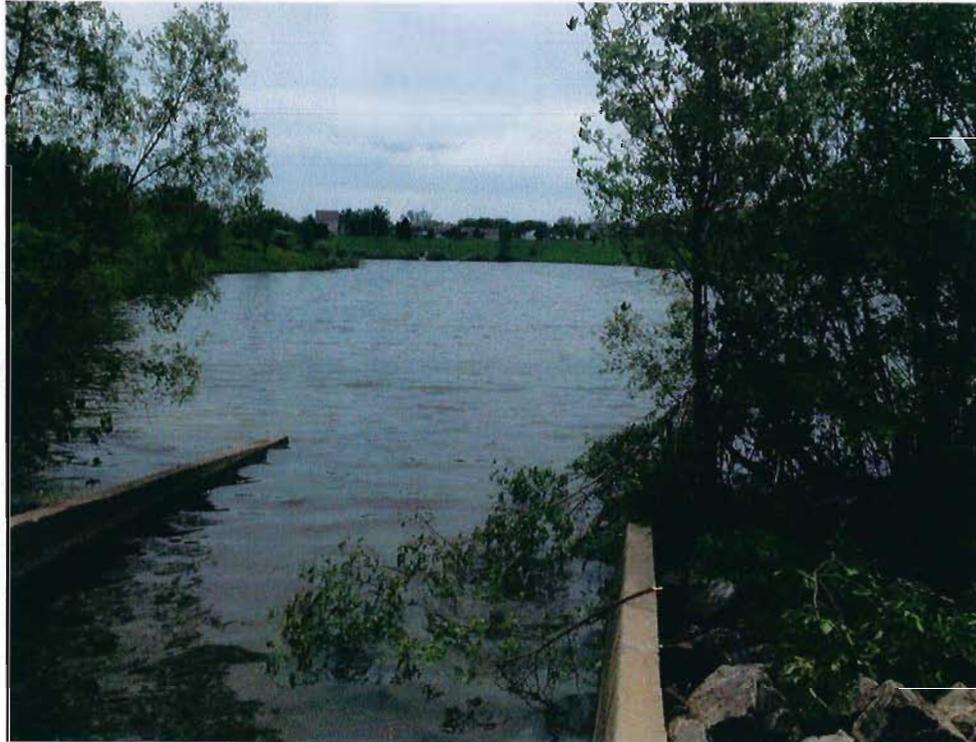
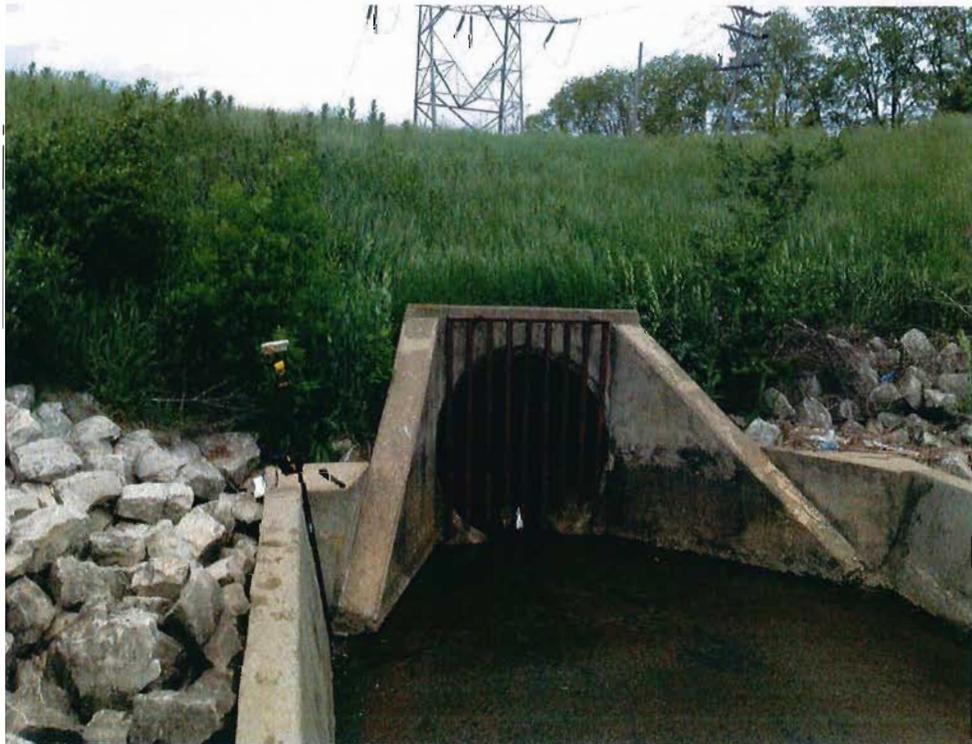
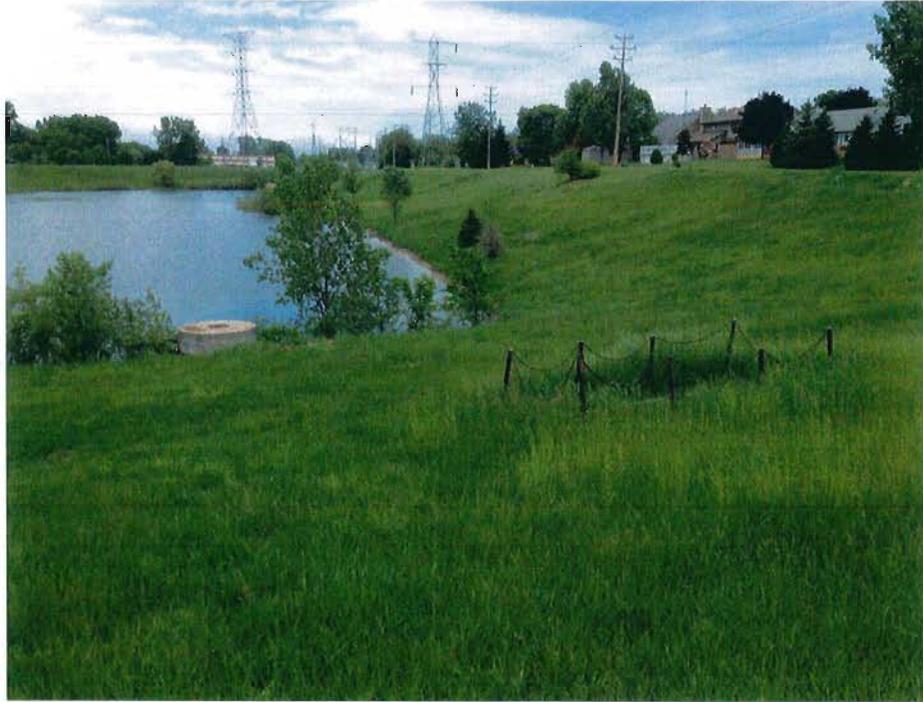
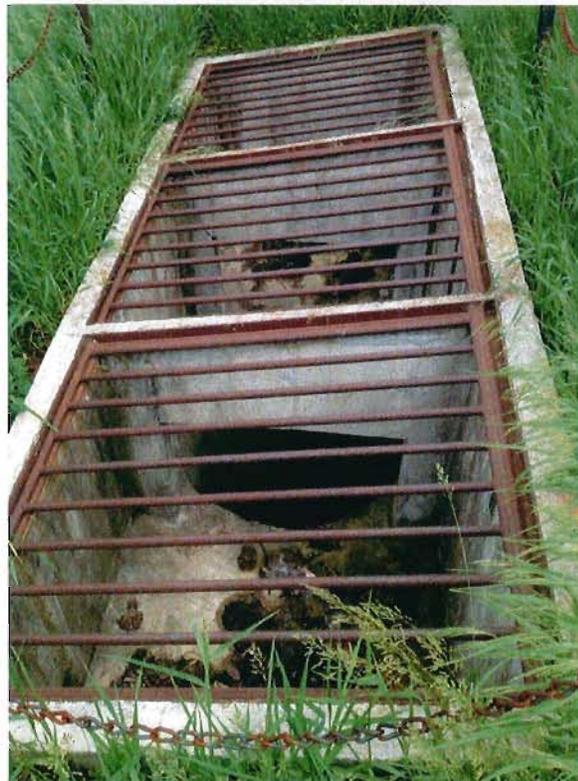
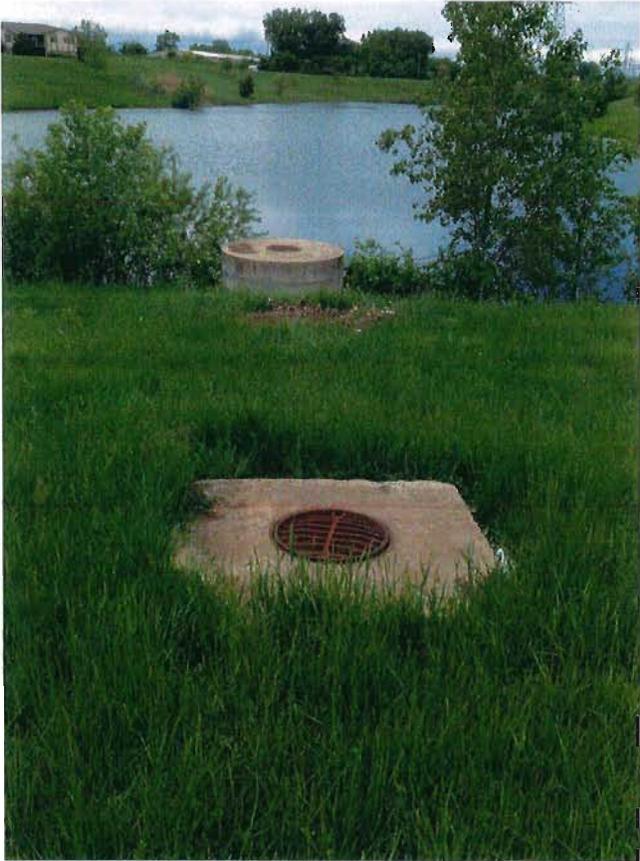
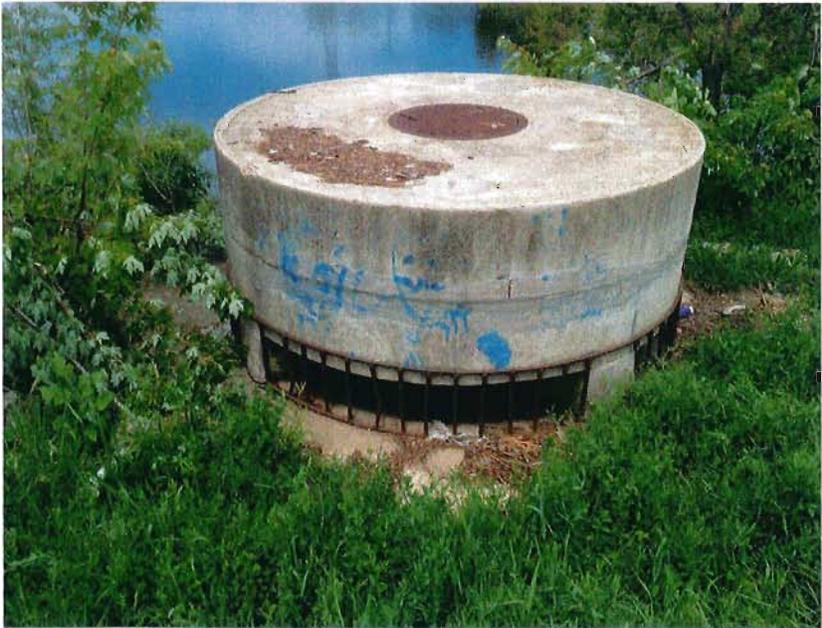
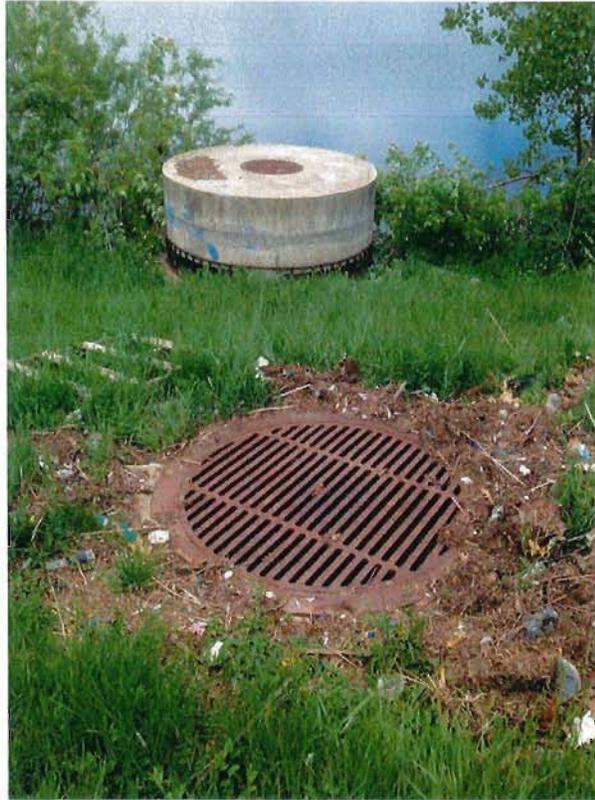
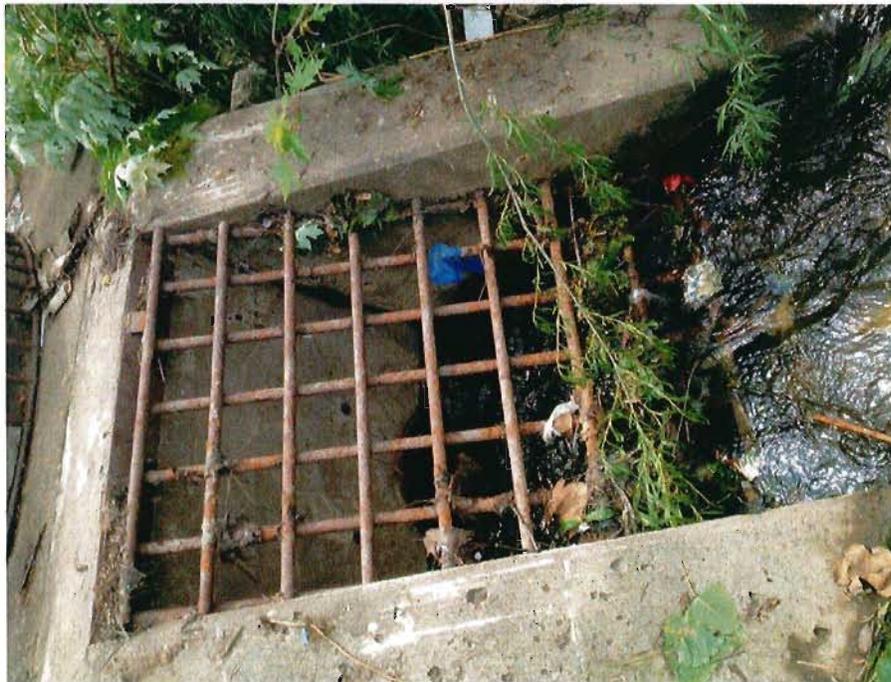
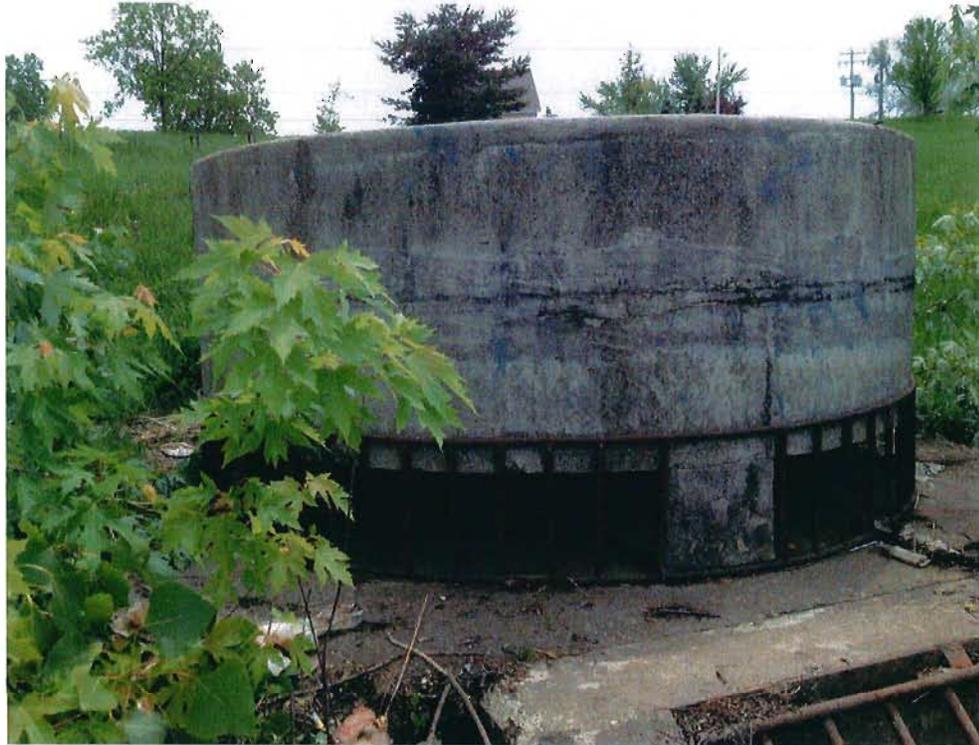
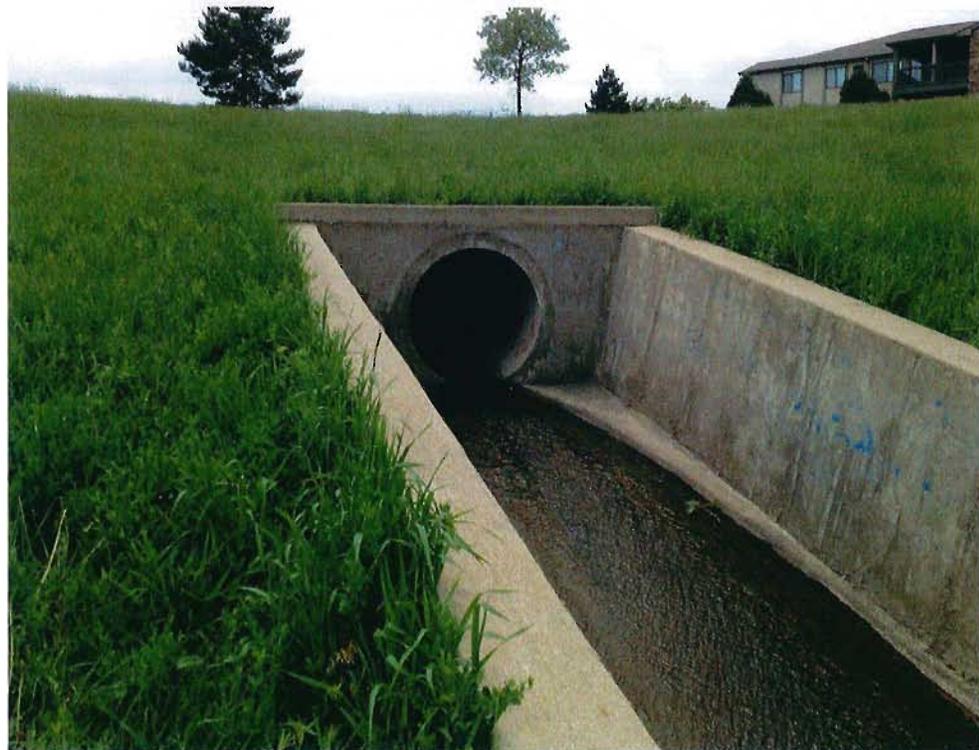
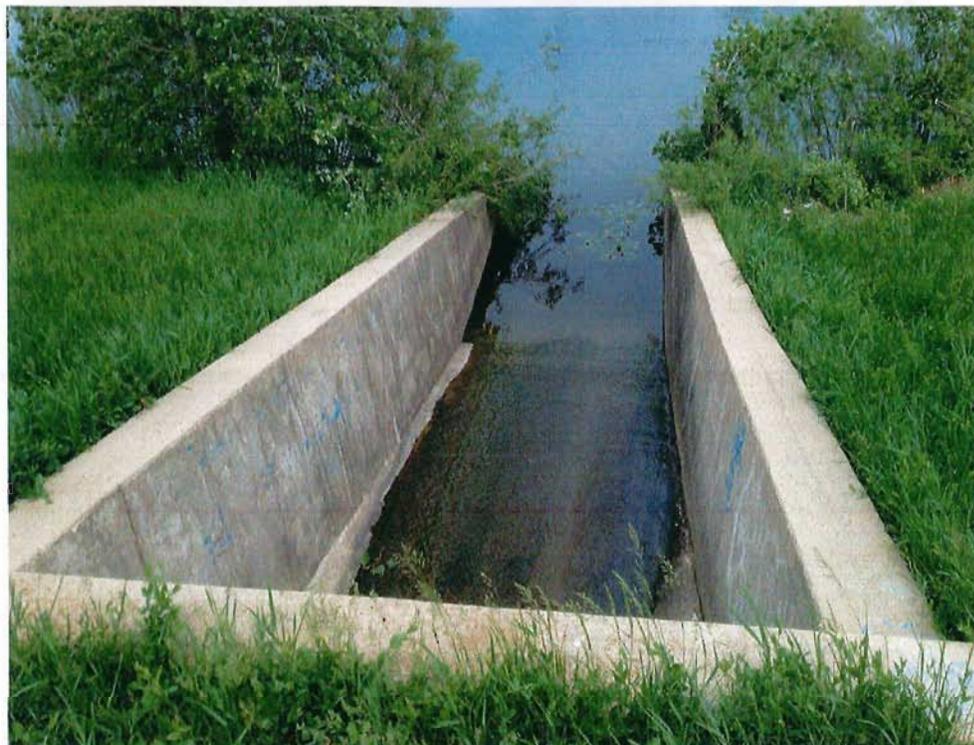
1. The designed water depth of the pond is 4.4 feet. The measured water depth in May of 2013 varied between 5.6 and 6.6 feet.
2. There is a broken orifice opening in the lower outlet structure. There was also some brush and debris buildup at the outlet structure.
3. Sediment build-up varied between 0 and 0.8 feet.
4. The pond perimeter has been mowed occasionally.
5. Soft ground was found on the west side of the pond, indicating groundwater seepage.
6. The water level is higher than the knee wall of the inlet structure.

1. The water depth should be measured in 2018 to compare to the 2013 measurements. This will provide a comparable depth to determine the rate of sediment accumulation as well as an anticipated date for sediment removal.
2. Brush should be removed near the outlet structure and the orifice opening should be repaired. The outlet should be kept clean.
3. Remove brush as necessary around the perimeter of the pond.
4. The high water level indicates that the pond may not be draining properly. Record whether repairs to the outlet structure decrease the water level.

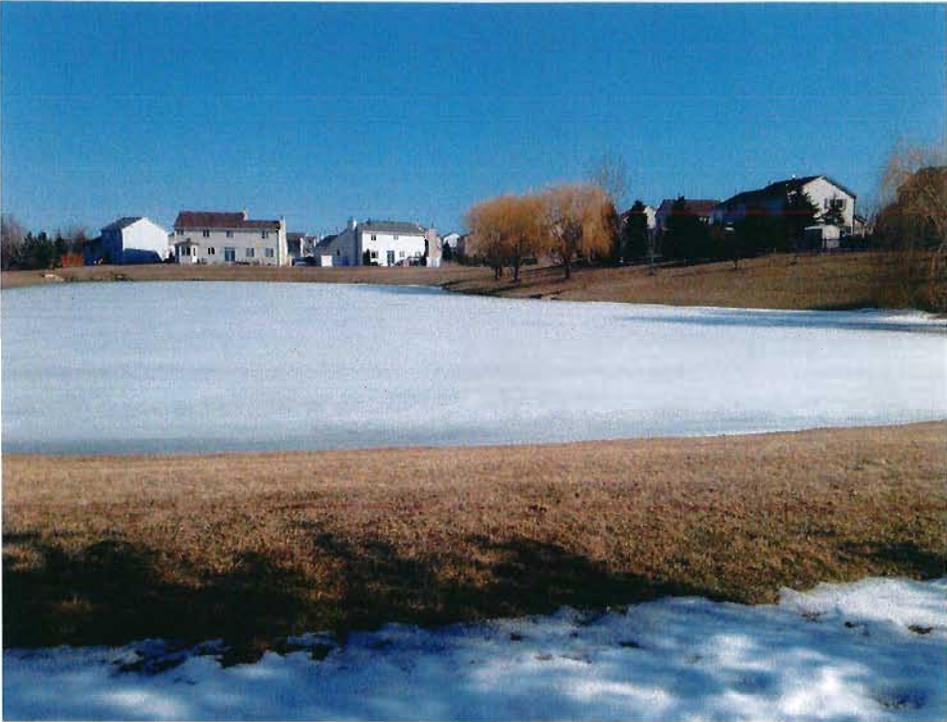
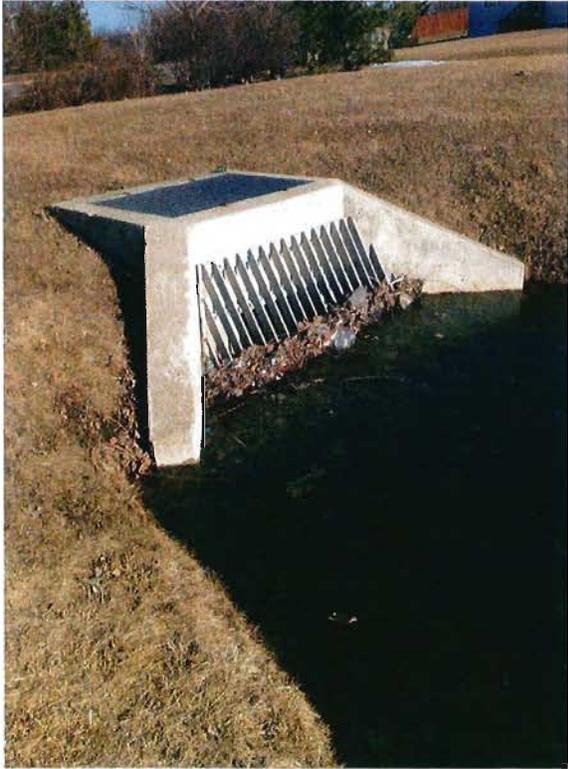
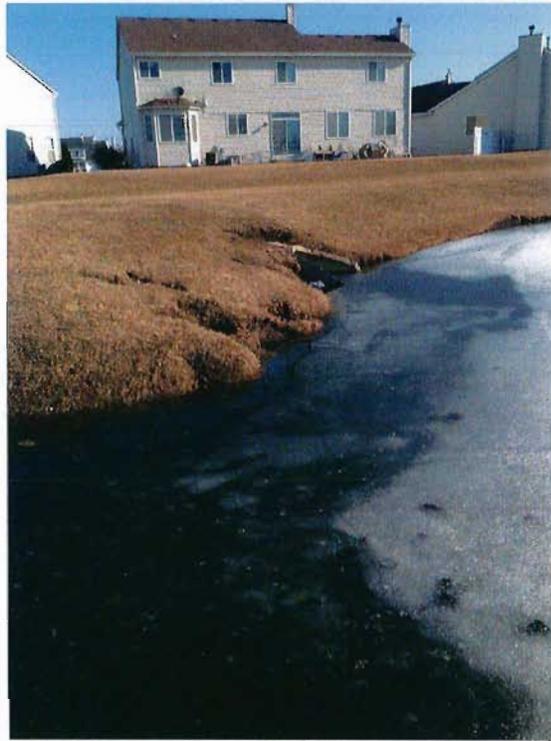
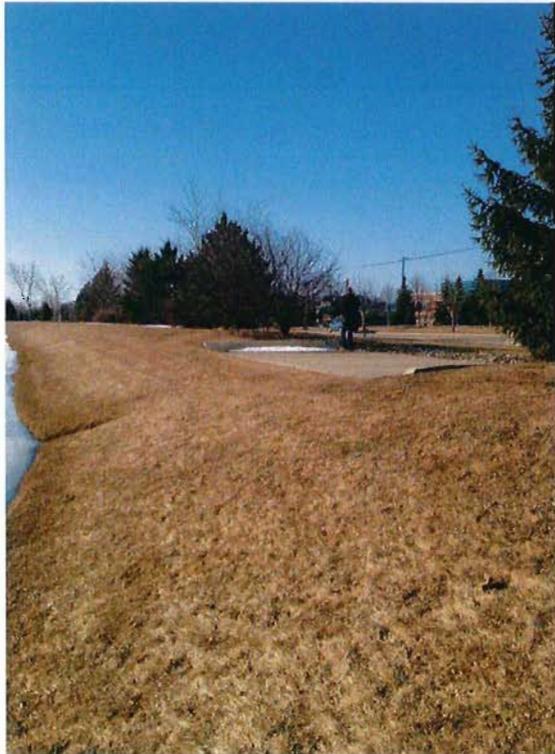
- \* DRAINAGE & OUTLET (GREASE & SLUDGE)
- \* OUTLET LOWER ORIFACE PLUGGED, D.I REDUCER SIZE 3" x 5" φ
- \* 30" x 18" F.E.S. SEPARATED 18" IS COMPLETELY "
- \* POND IS FUNCTIONING & 2<sup>ND</sup> MAX. O/FLOW LEVEL
- OTHERWISE POND IN GOOD SHAPE

1. The water depth should be measured in 2018 to compare to the 2013 measurements. This will provide a comparable depth to determine the rate of sediment accumulation as well as an anticipated date for sediment removal.
2. Perform dredging at the outlet to remove clogging materials.
3. Make repairs to the end sections on the 18" and 30" pipes.
4. When mowing, leave a grass strip around the pond to improve safety and deter geese.

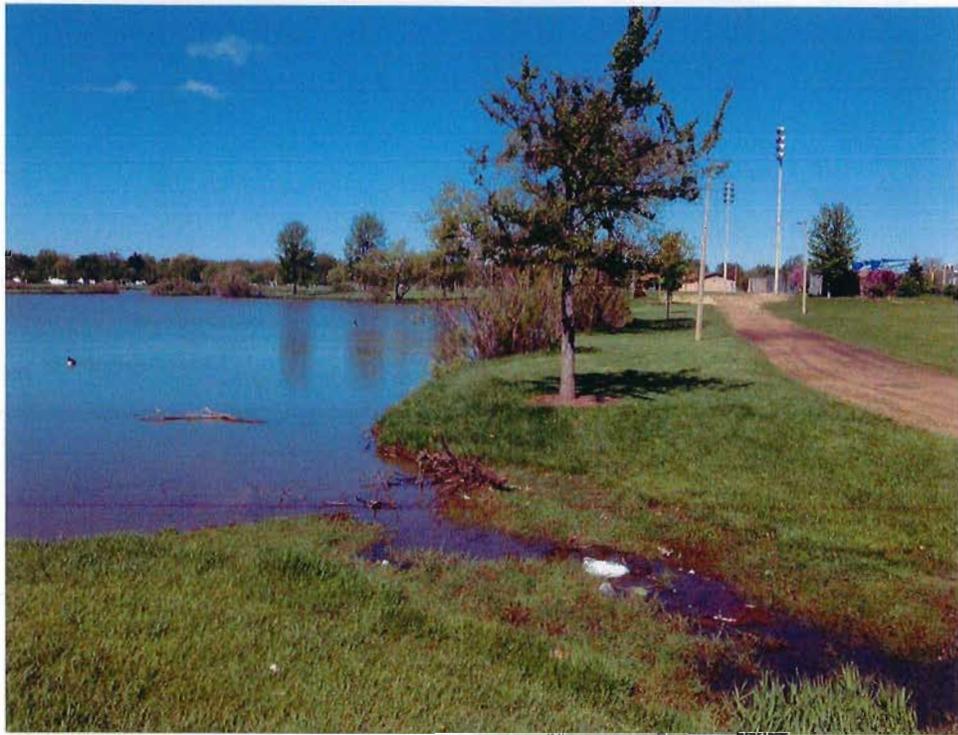
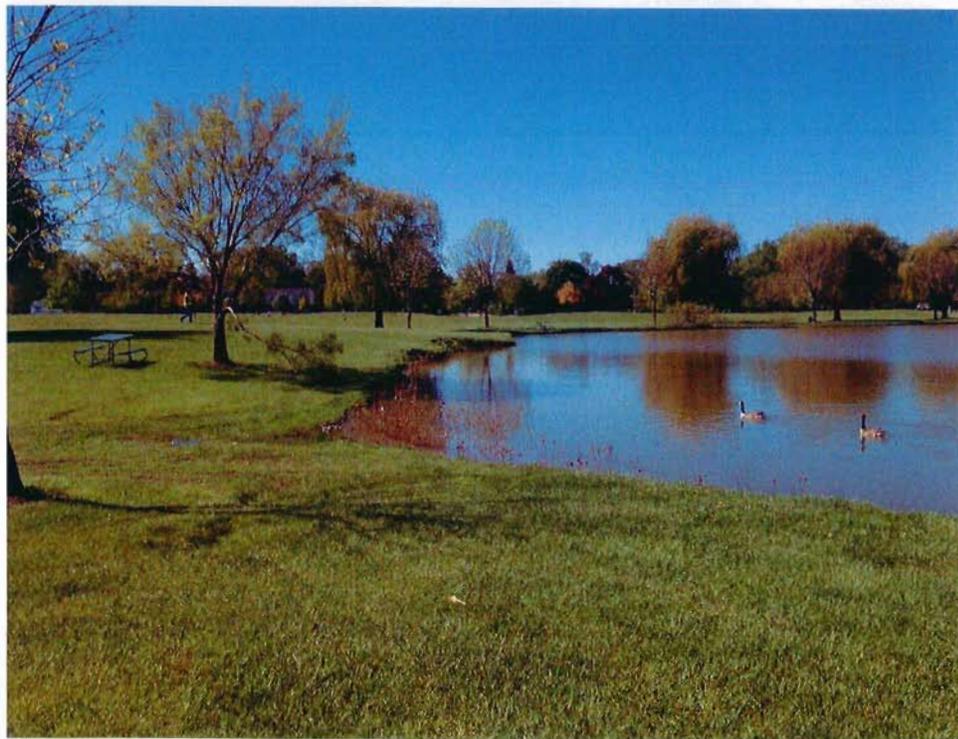
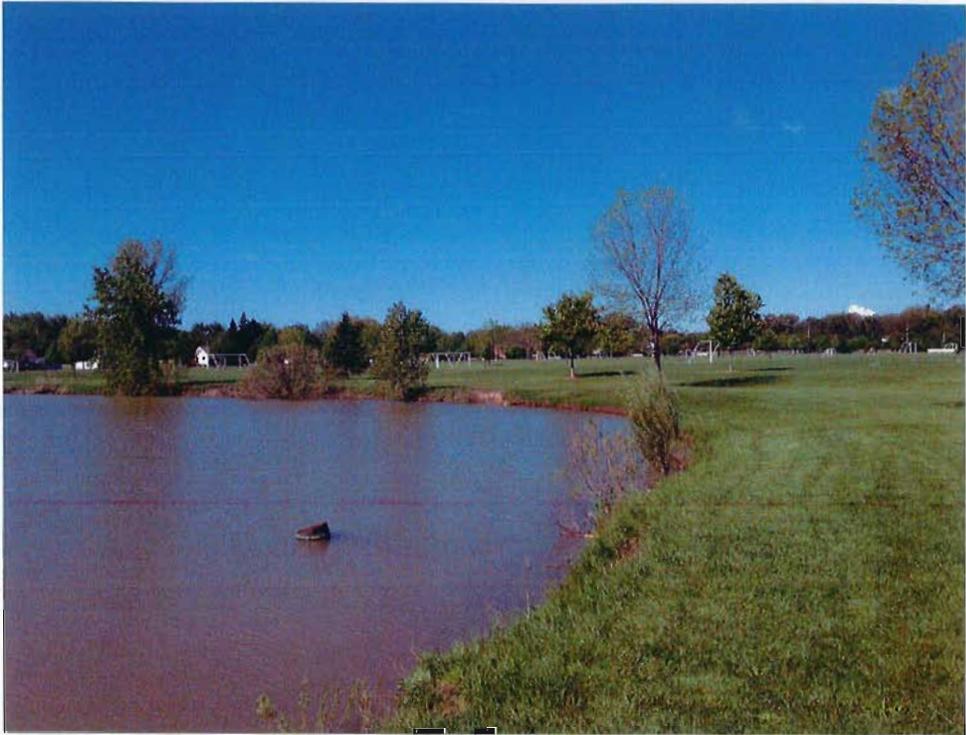
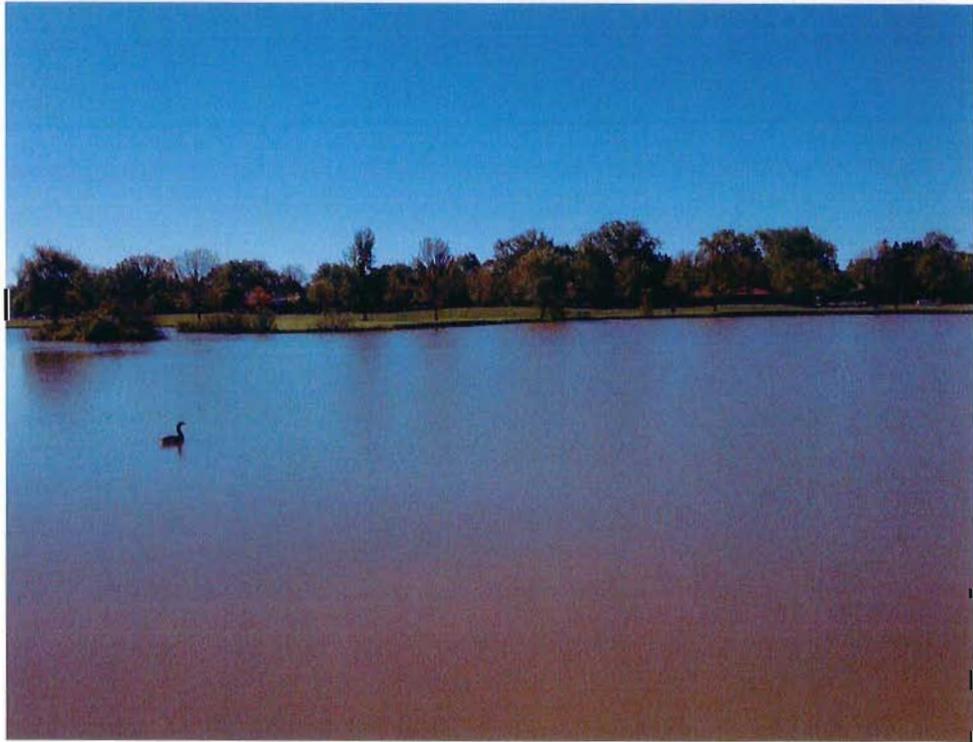
1. The measured water depth in May of 2013 varied between 4.9 to 8.0 feet. The original design plans were not available.
2. The structures were inspected. One submerged inlet pipe was found. No outlet structure was visible. There is also no spillway.
3. Sediment build-up varied between 0.3 and 2.3 feet.
4. The whole pond perimeter is mowed. There are some pockets of willow scrub.
5. The water level appeared high. Water had overflowed the pond in one area.

1. The water depth should be measured in 2018 to compare to the 2013 measurements. This will provide a comparable depth to determine the rate of sediment accumulation as well as an anticipated date for sediment removal.
2. Further investigation is necessary to locate the outlet structure and determine why it is not functioning properly.
3. Leave a one-foot wide strip around the pond when mowing to deter geese.

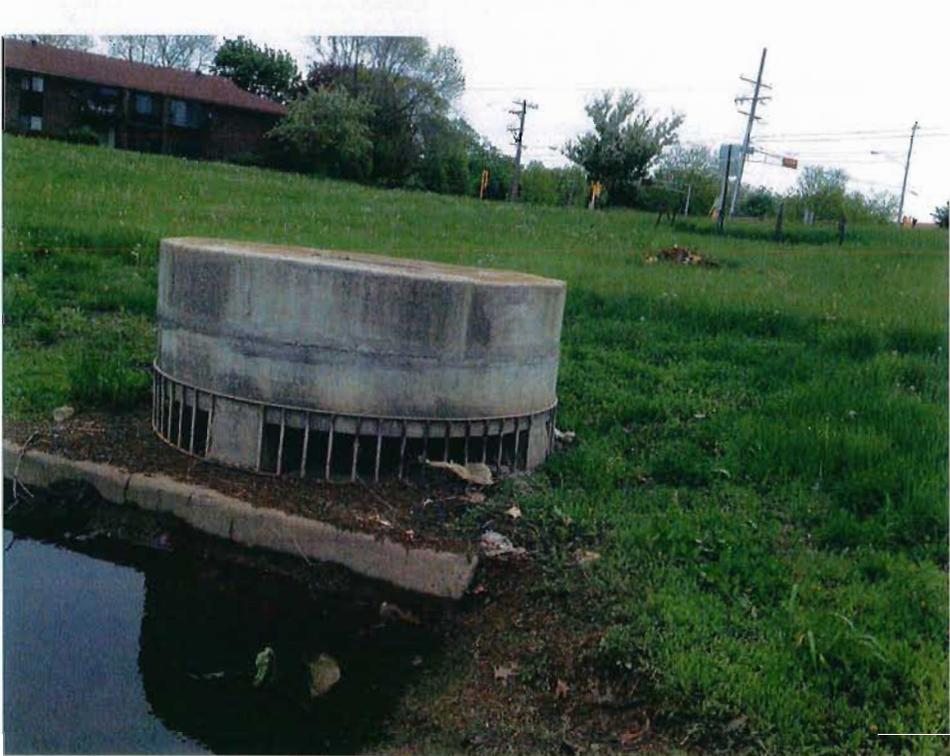
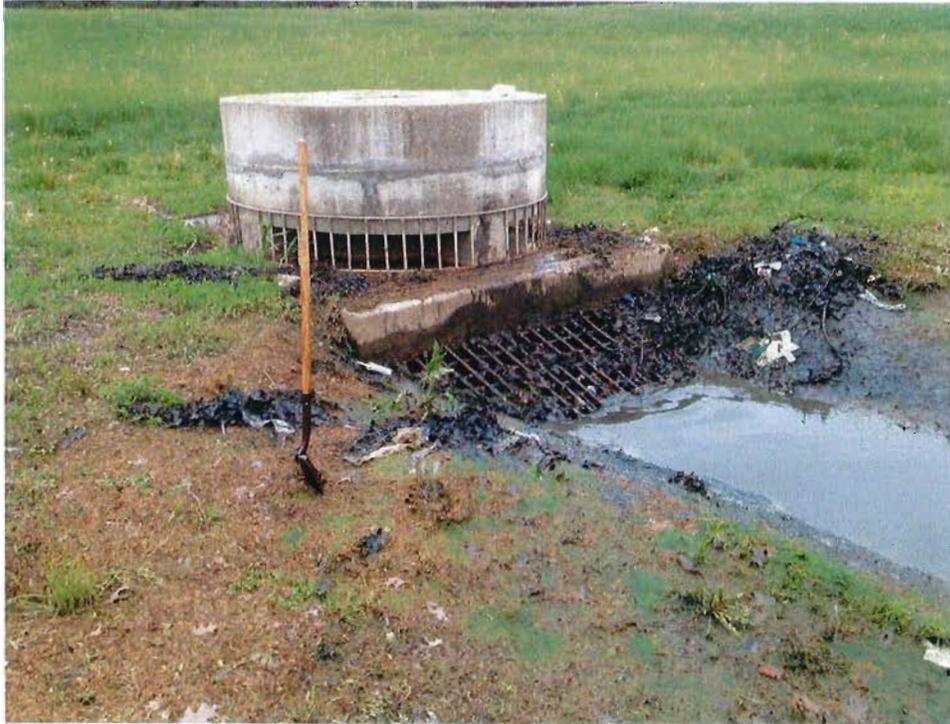
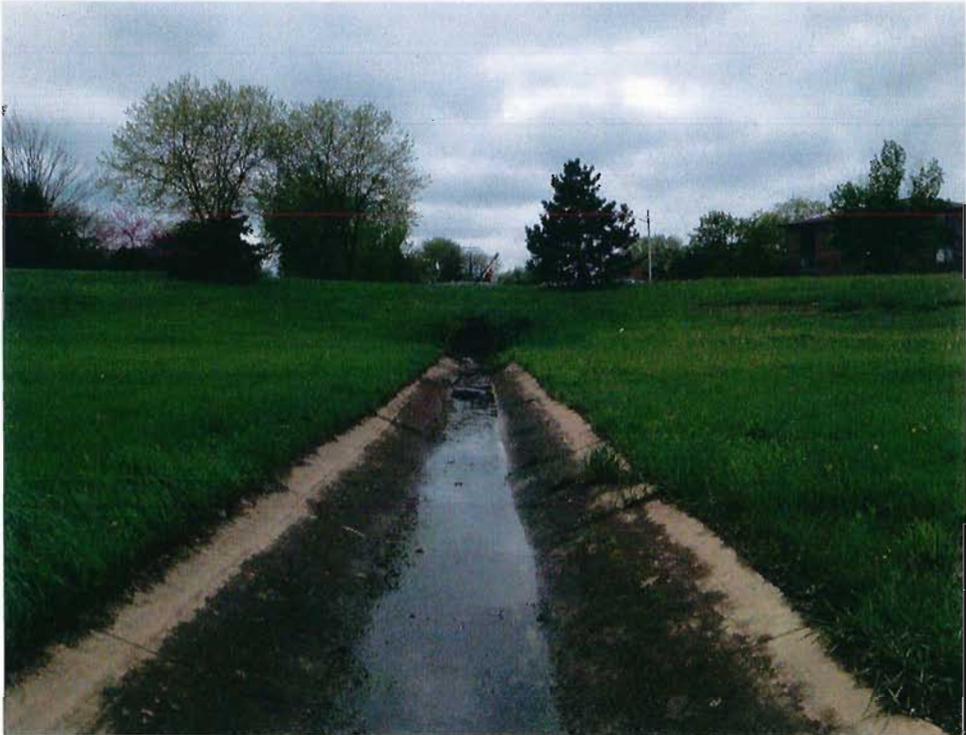
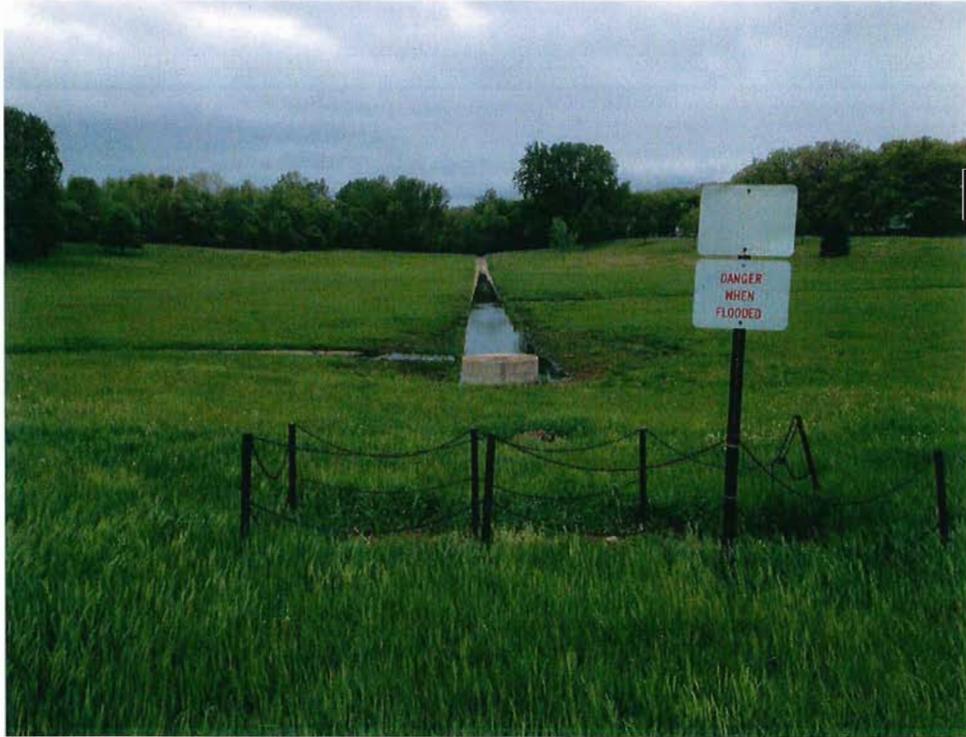
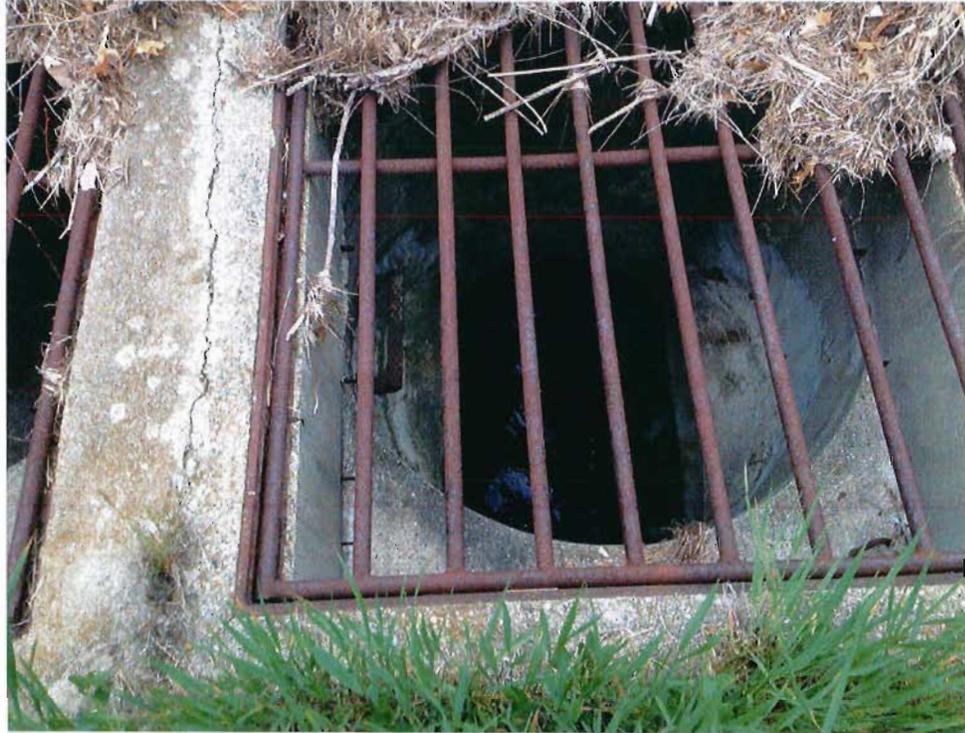
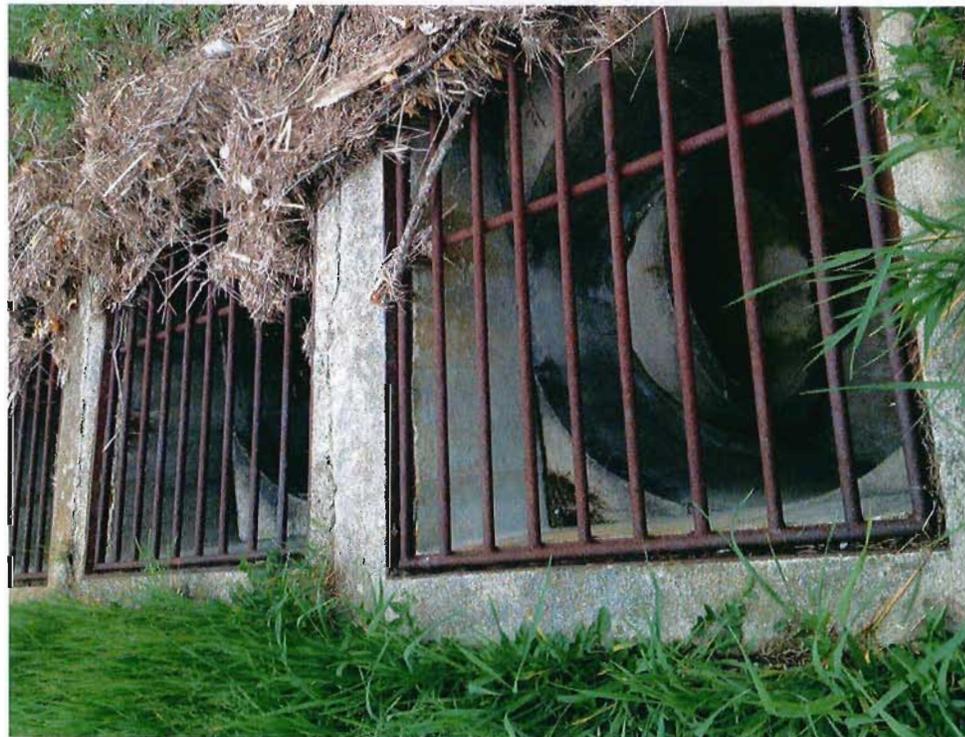
1. This dry-bottom pond was inspected in May of 2013.
2. The first orifice opening on the outlet structure is broken.
3. The inlet and outlet structures were clogged with grass clippings and debris.
4. The pond area had been mowed earlier in the spring.
5. The concrete channels were coated with mud.
6. The frame on the 18" inlet pipe was offset, creating a dangerous condition.

1. The pond should be inspected in 2018 to compare to the 2013 findings.
2. The concrete channels should be scraped clean.
3. The inlet and outlet structures should be cleaned and maintained regularly.
4. The first orifice in the outlet should be repaired.
5. Repair the 18" inlet pipe.
6. Remove grass clippings from the structures after mowing.

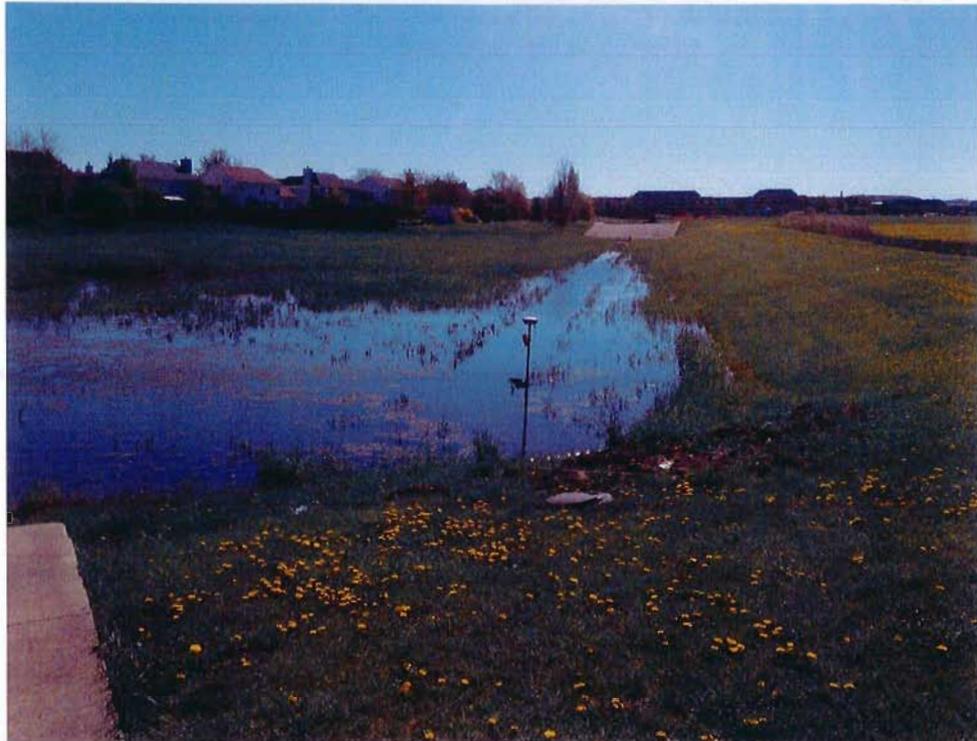
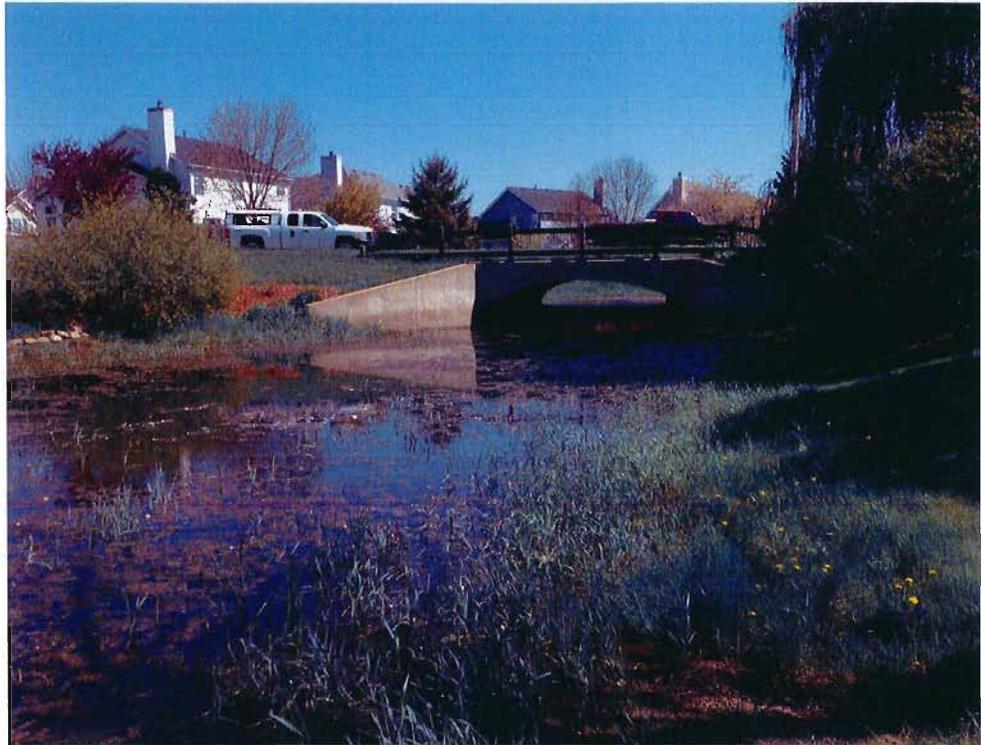
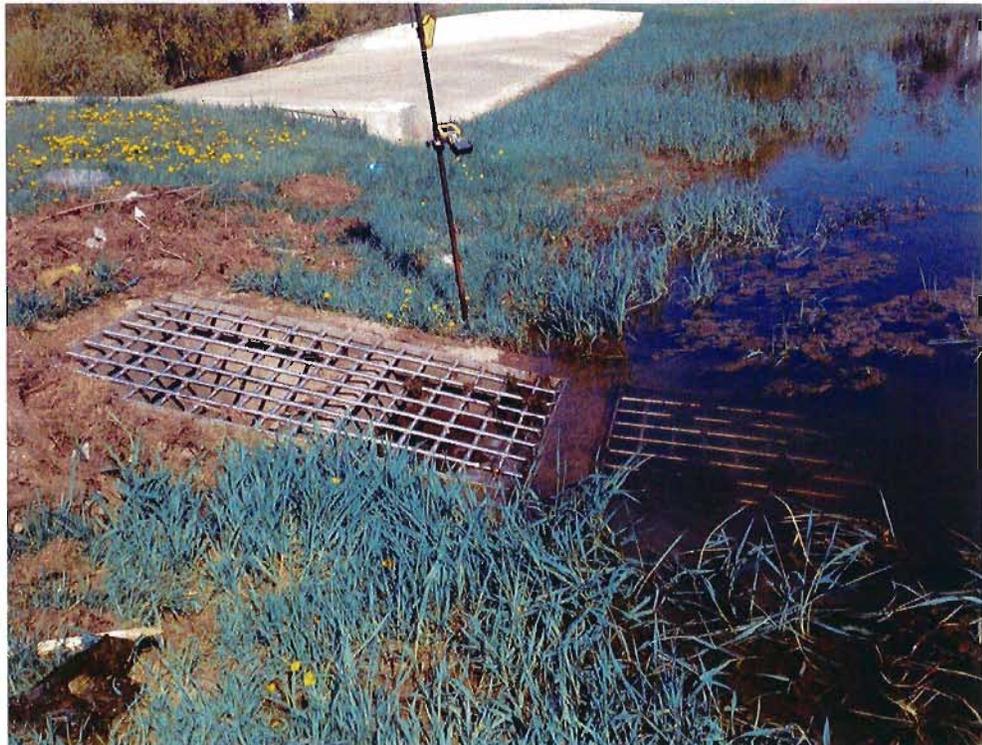
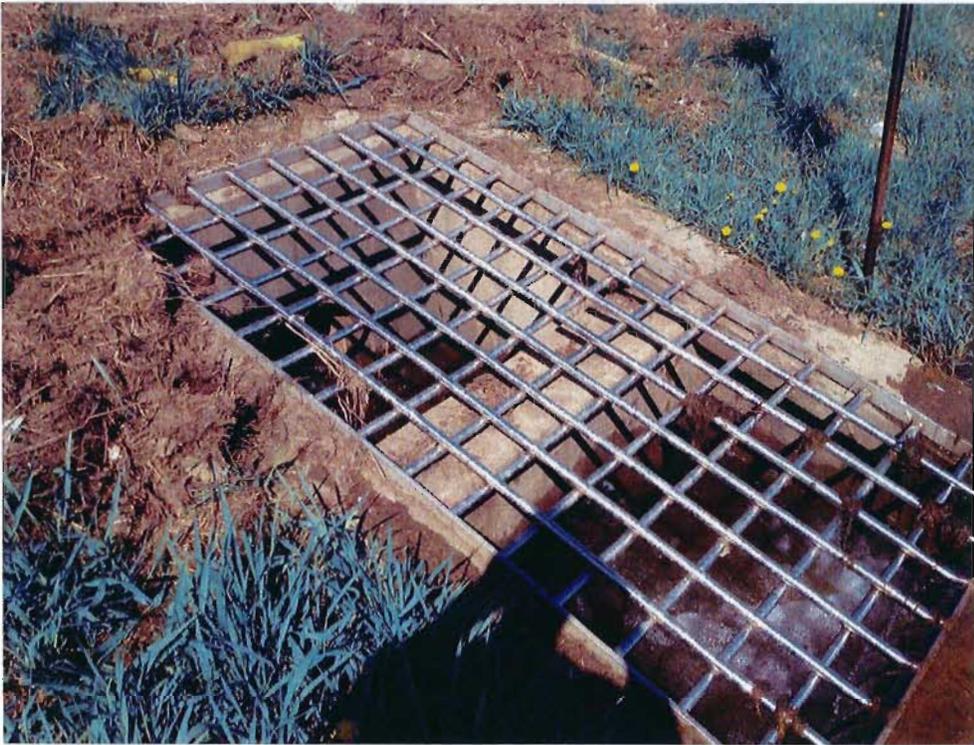
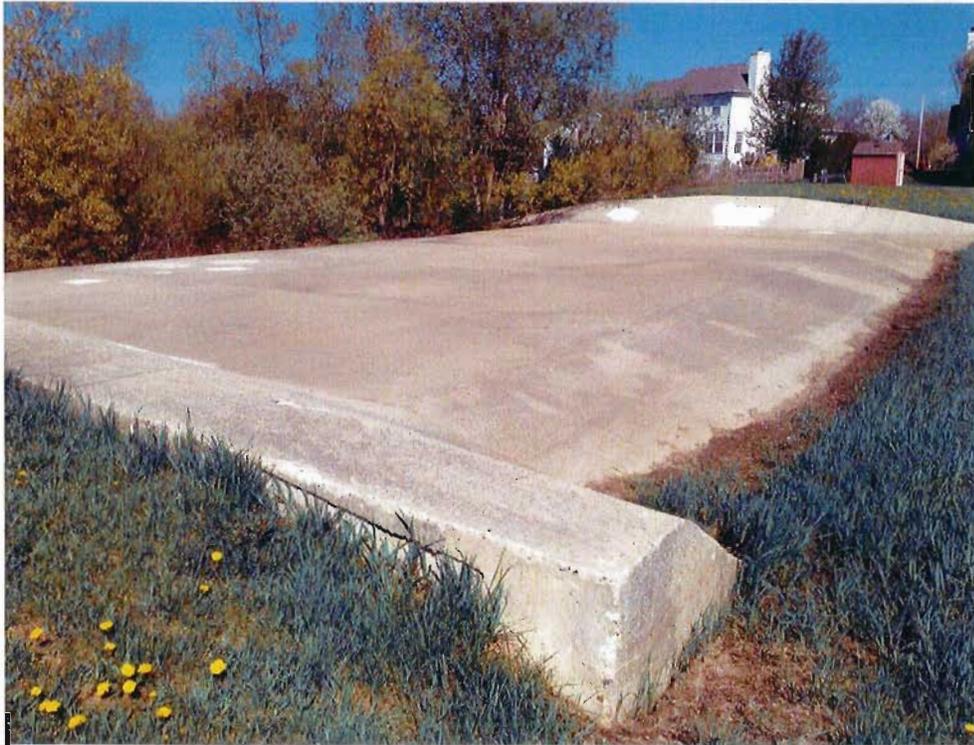
1. There was approximately 1.5 feet of standing water in this dry-bottom pond when it was inspected in May of 2013. The original design plans were not available.
2. The inlets and outlets were inspected and were found to be in good structural condition. There is standing water over the beehive structure, however, indicating it is not functioning. The outlet structure is operating, at the level of the second orifice.
3. There was approximately 1.5 feet of sediment build-up underneath the standing water.
4. The pond had not been mowed due to the wet conditions. Trees and brush are growing adjacent to the concrete spillway.

1. The pond should be inspected in 2018 to compare to the 2013 measurements.
2. All outlet structures should be cleaned and checked for possible obstructions.
3. The concrete channel should be cleaned.
4. The trees and brush near the spillway should be cleared.
