# 2013 Ponds Certifications

City of Kenosha, Wisconsin

July 9, 2014

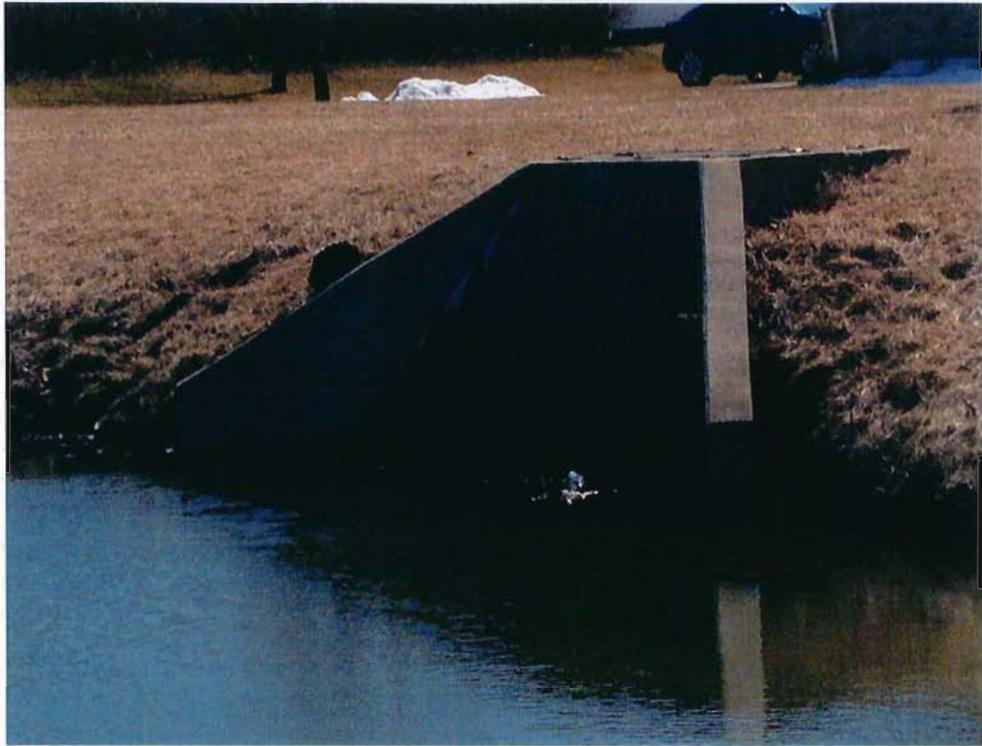
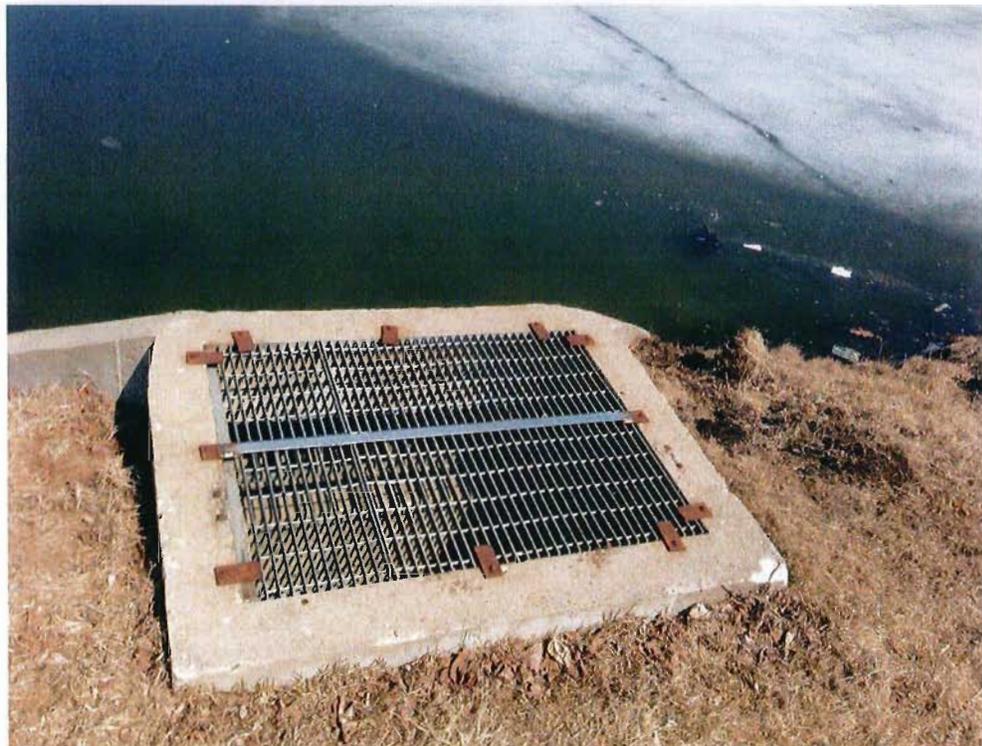
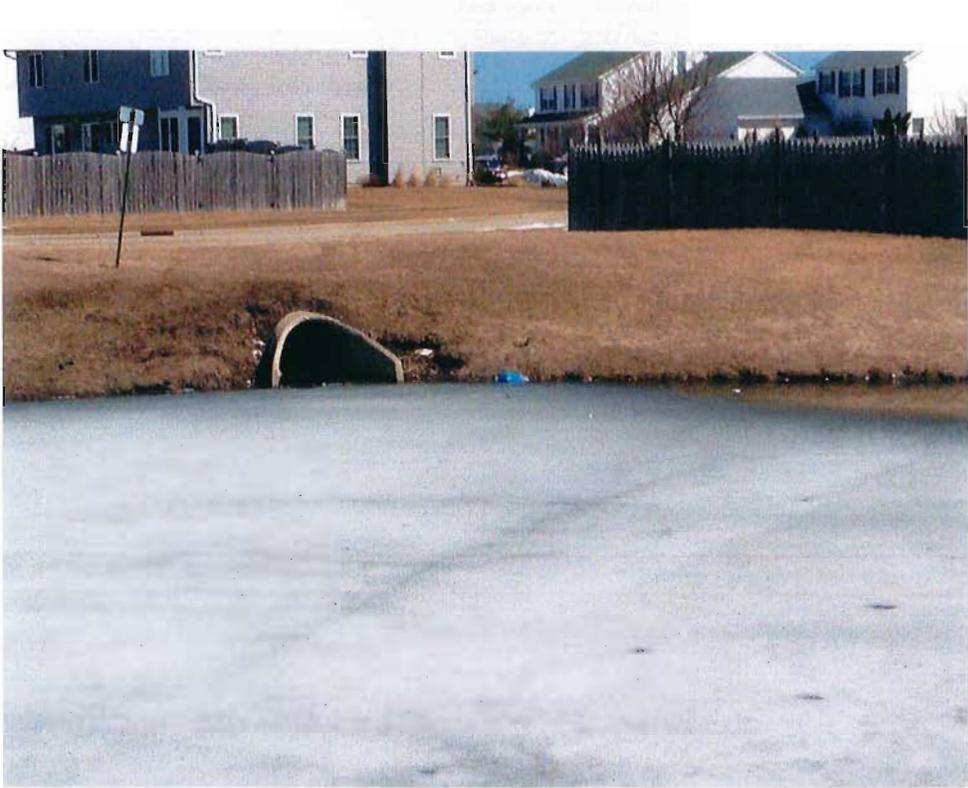
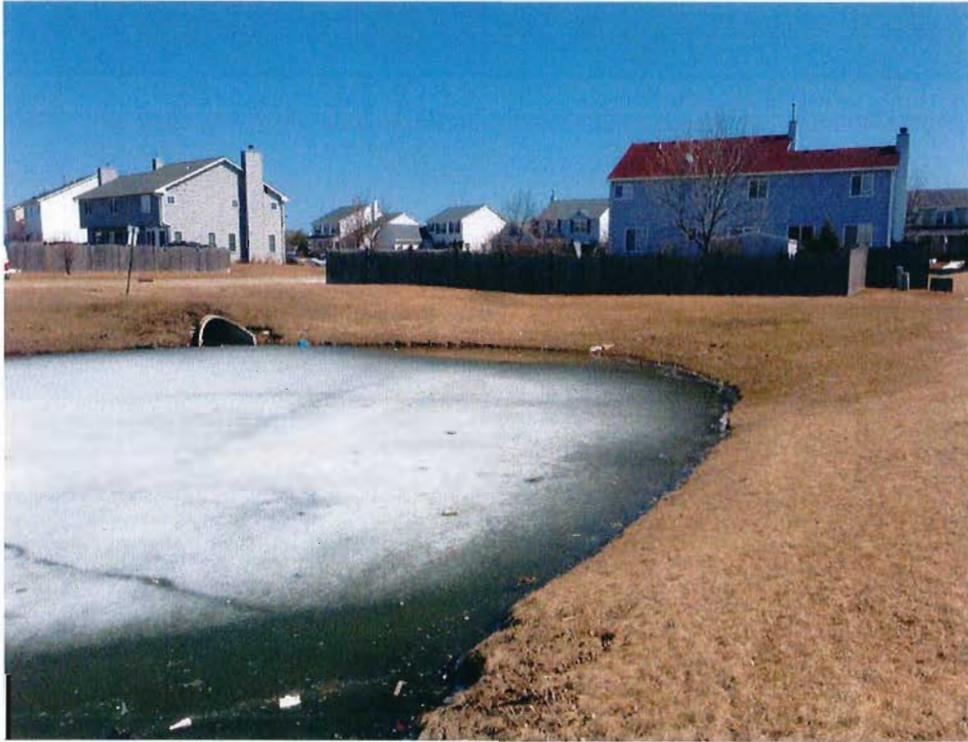
1. The designed water depth of the pond is 4 feet. The pond consists of a wet area at the east end and a dry detention area. The measured water depth in March of 2013 varied between 2.5 and 3.1 feet. The dry area had a few scattered puddles. We conclude that the pond is starting to fill up with sediment.
2. The outlet structure is in good condition but the final section of the inlet is separated from the pipe.
3. Sediment build-up in the pond averages 1.0 feet.
4. The dry detention area and the pond perimeter are mowed.

1. The water depth should be measured in 2018 to compare to the 2013 measurements. This will provide a comparable depth to determine the rate of sediment accumulation as well as an anticipated date for sediment removal.
2. When mowing, leave a grass strip around the perimeter of the pond to improve safety and deter geese.
3. Dredging of the pond should be considered.

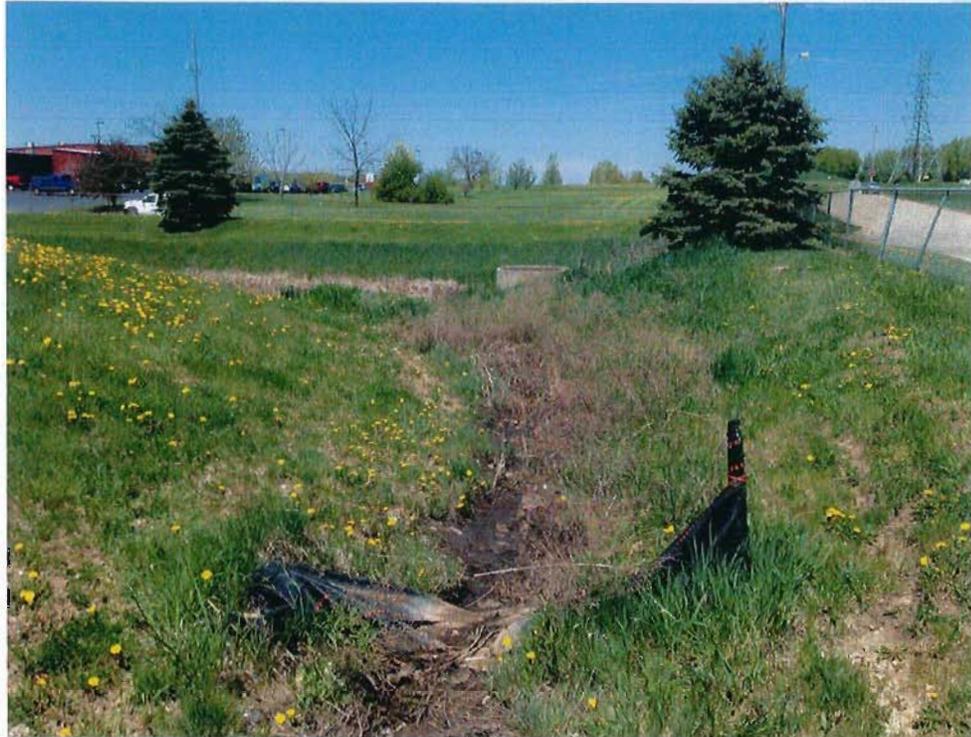
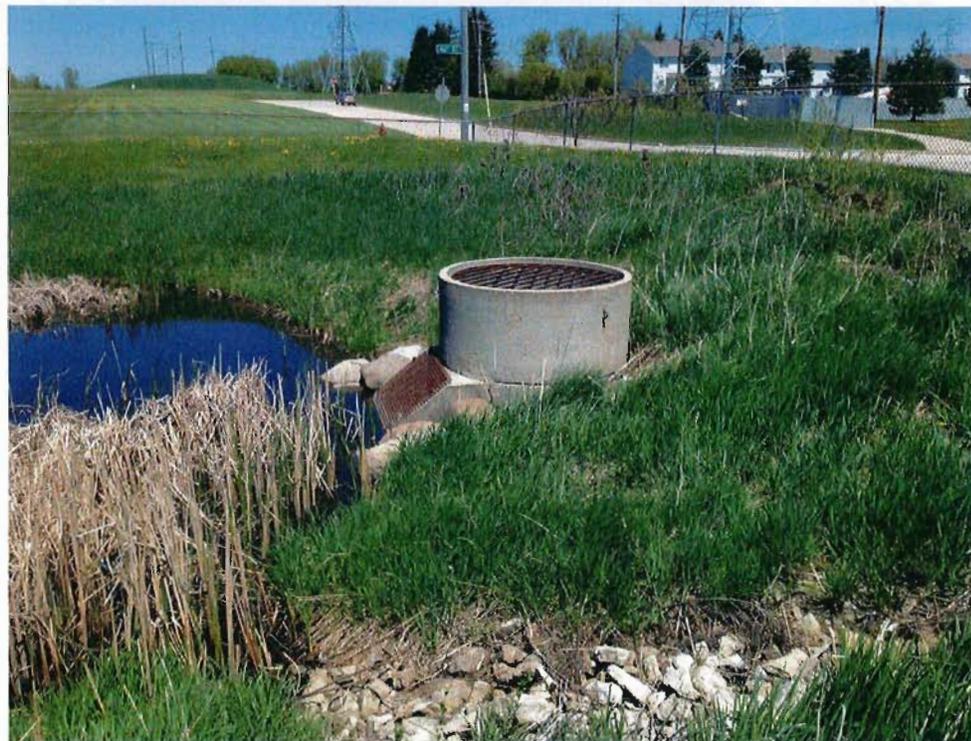
1. The designed water depth of the pond is 5 feet. The measured water depth in May of 2013 was 4.5 feet. The pond may be starting to fill with sediment.
2. The outlet pipe was inspected and was found to be in good structural condition. The structure interior was dirty.
3. An old piece of silt fence is crossing one of the drainage swales into the pond.
4. Sediment depth varied from 0.2 to 0.4 feet.
5. The pond perimeter had not been mowed. Rip-rap areas have vegetation growing in them.
6. Cattail growth is overtaking the pond.

1. The water depth should be measured in 2018 to compare to the 2013 measurements. This will provide a comparable depth to determine the rate of sediment accumulation as well as an anticipated date for sediment removal.
2. Cattails should be removed from the pond and vegetation should be removed from the rip-rap.
3. The outlet structure should be cleaned.
4. Remove the silt fence from the drainage swale.
5. Dredging of this small pond may be necessary within the next five years.

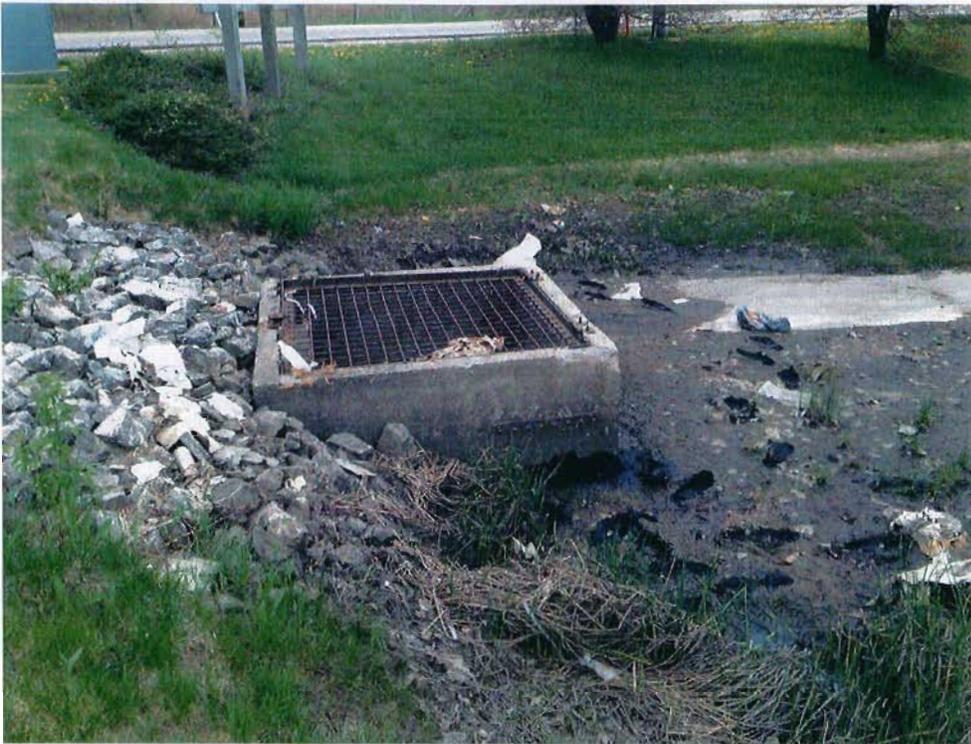
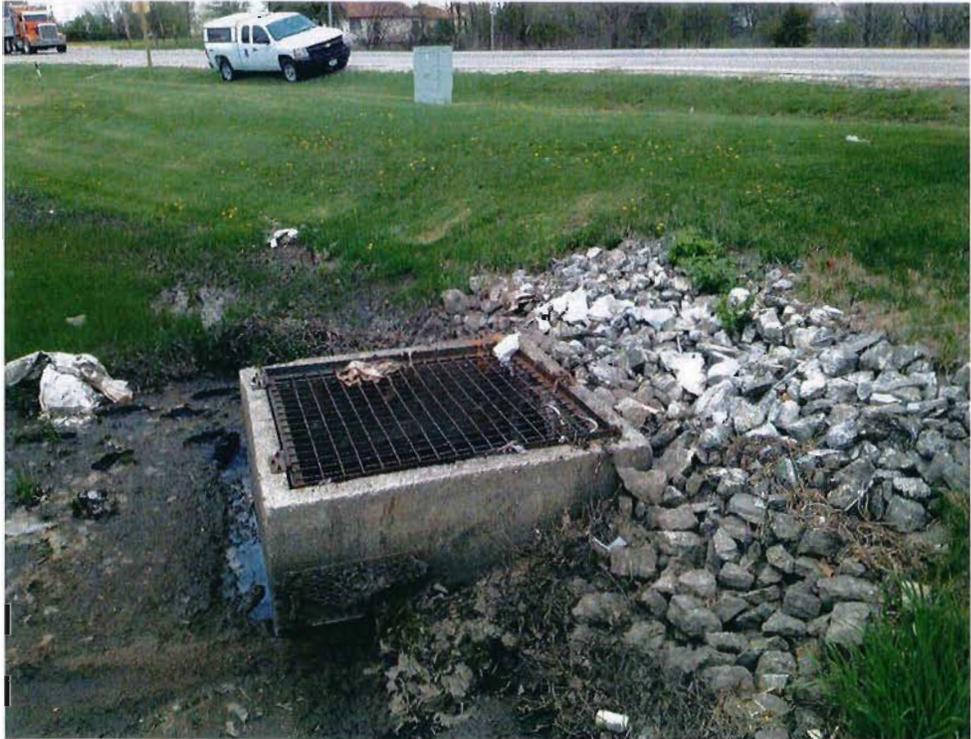
1. This dry bottom pond was inspected in February of 2013.
2. The inlet and outlet structures were inspected and were in good condition.
3. Some muck has built up around the structures and plugged the holes on the sides.
4. The pond area is mowed.

1. The pond should be inspected again in 2018.
2. Long grass, vegetation, and muck should be cleared away from the structures as necessary.

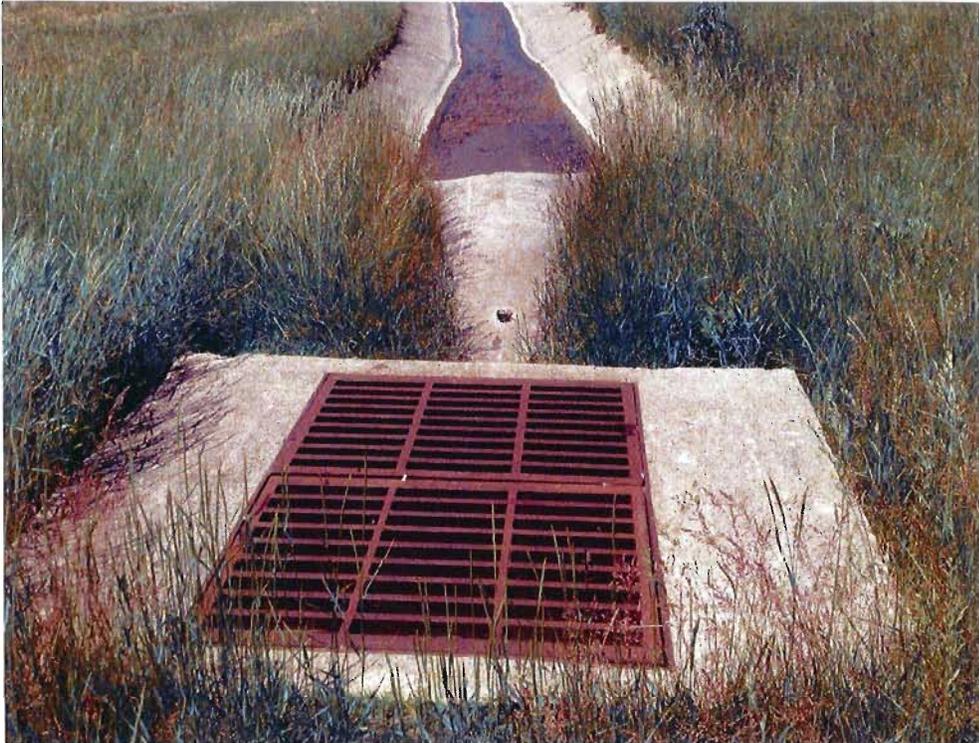
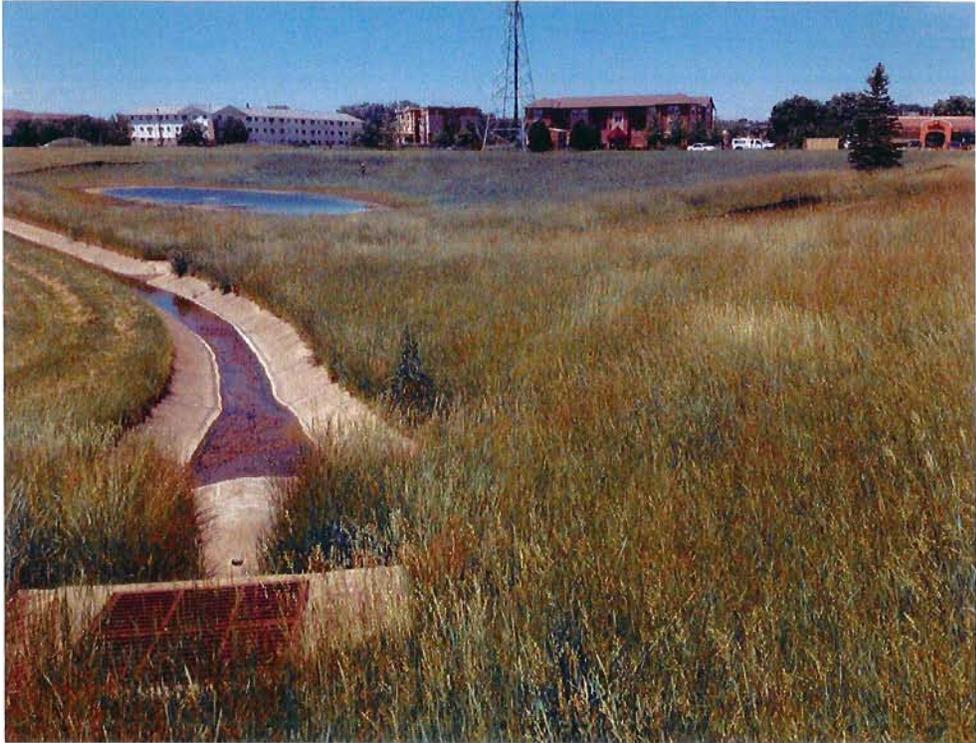
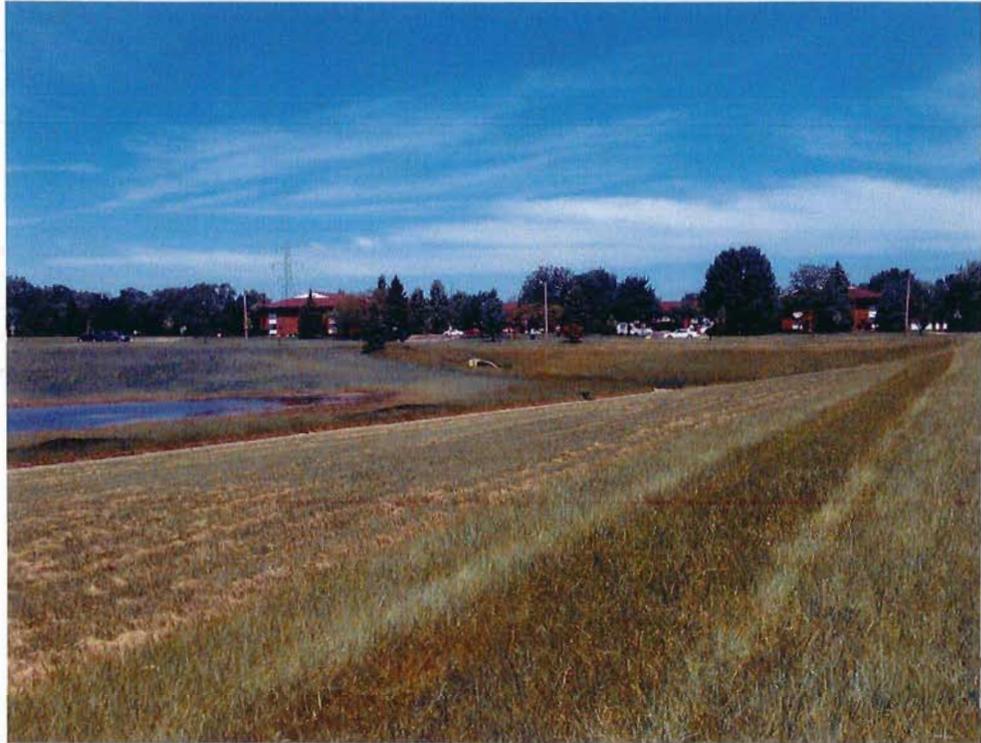
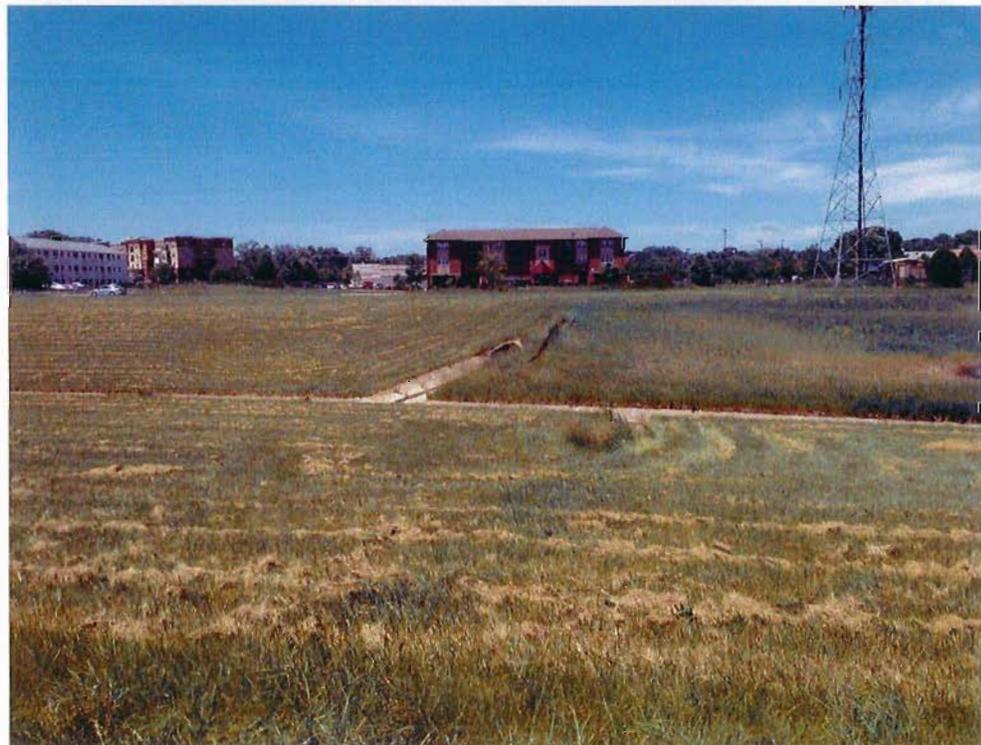
1. The original design plans for the pond were not available. This dry pond had 4.8 feet of water in the north end in June of 2013.
2. The inlet and outlet structures were inspected and were found to be in good condition. The 15-inch pipe was starting to separate.
3. There is some sediment build-up in the concrete gutters.
4. The pond area had been mowed, but not recently.

1. The water depth should be measured in 2018 to compare to the 2013 measurements. This will indicate whether sediment is accumulating in the small wet portion of the pond.
2. The concrete gutters should be cleaned.
3. Reattach 15-inch pipe.

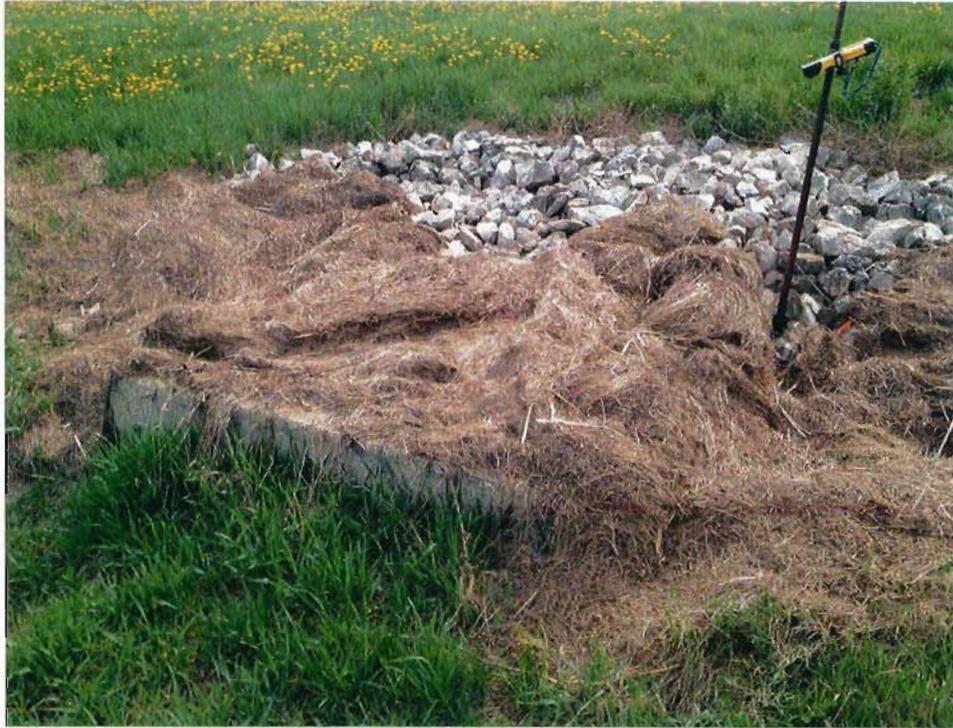
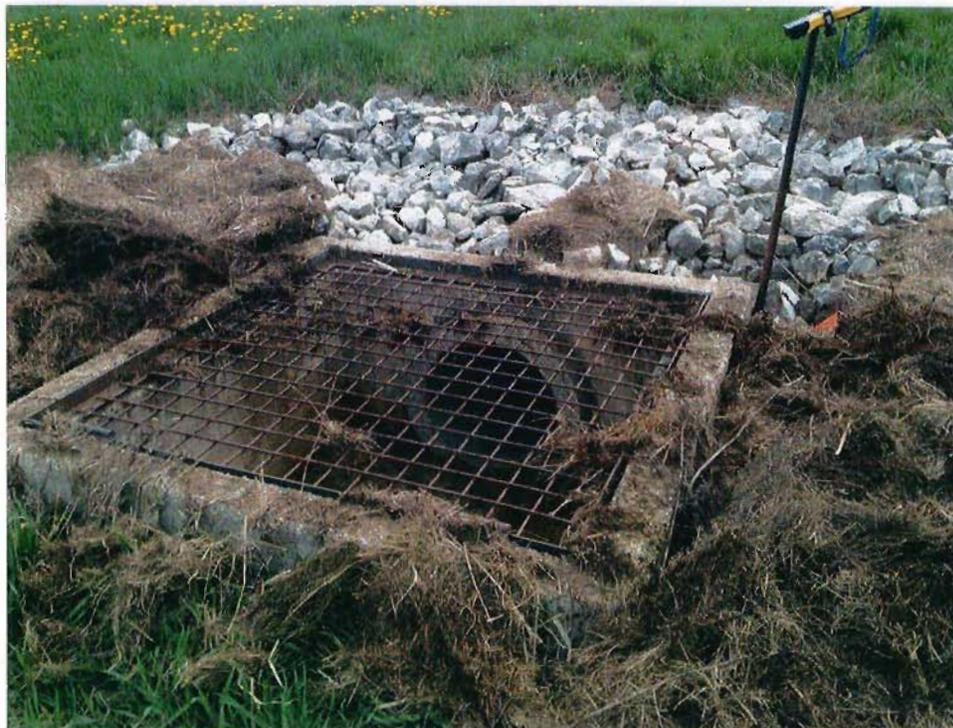
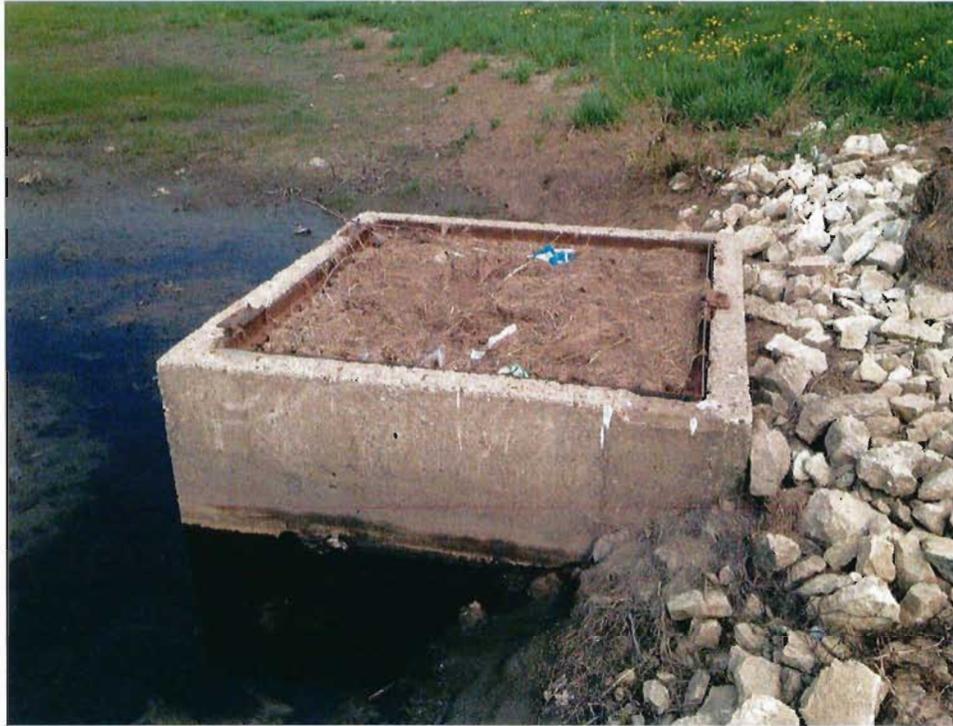
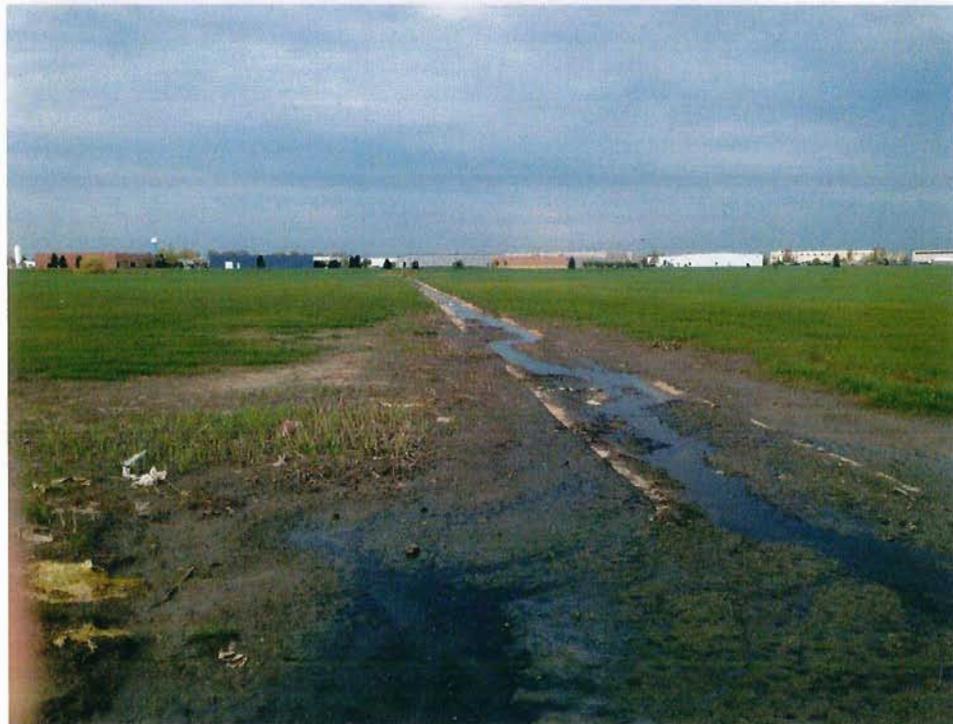
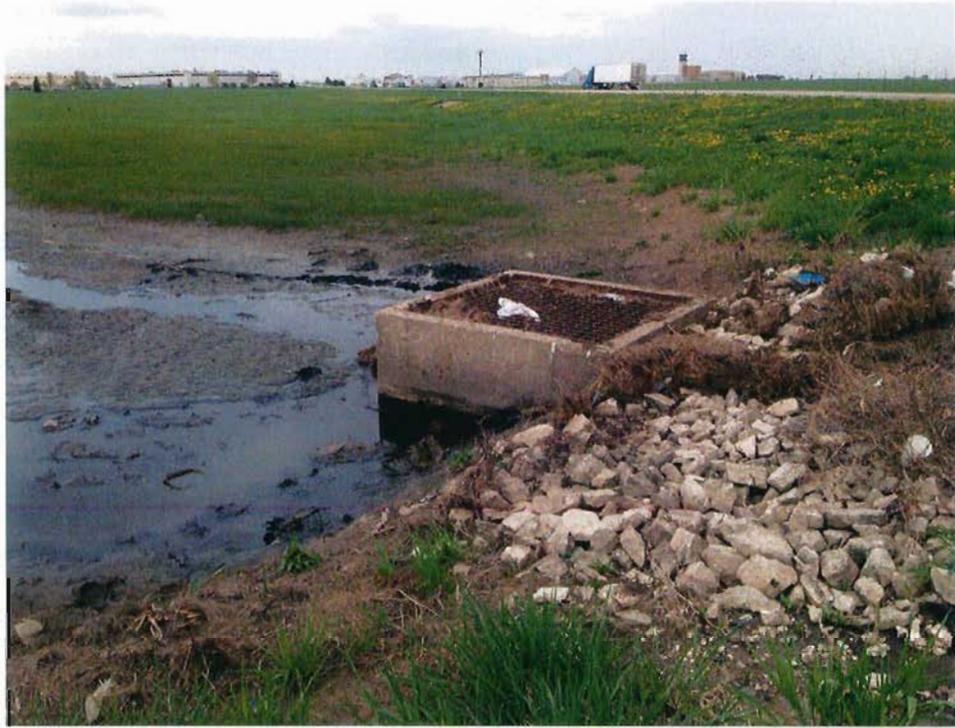
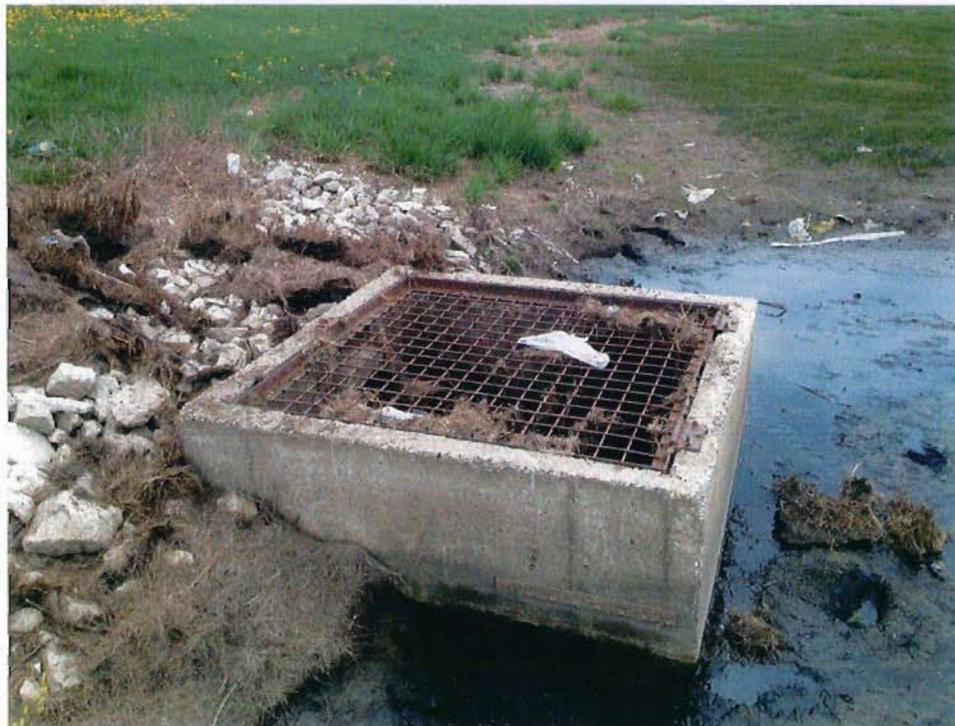
1. This dry bottom pond was inspected in February of 2013.
2. The inlets and outlets were inspected and were found to be in good structural condition.
3. Grass clippings were completely covering some of the structures.
4. The whole pond area was mowed, with some willow brush. The low end of the concrete channel was covered in muck.

1. The pond should be inspected again in 2018.
2. Remove grass clippings from the inlet and outlet structures after mowing.
3. Clear willow brush as necessary.

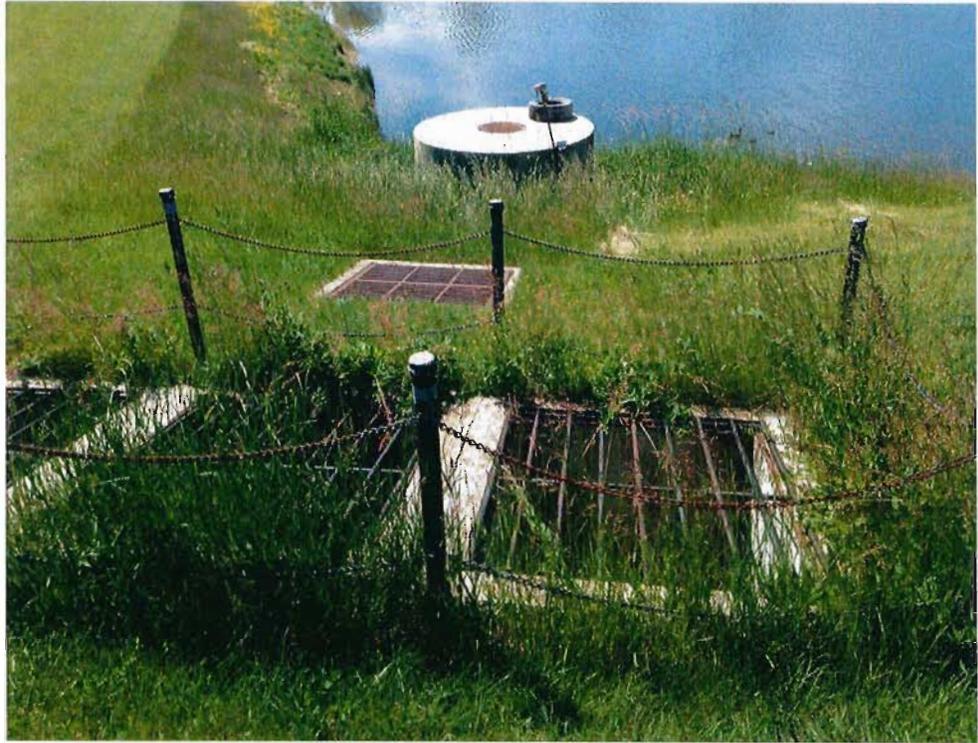
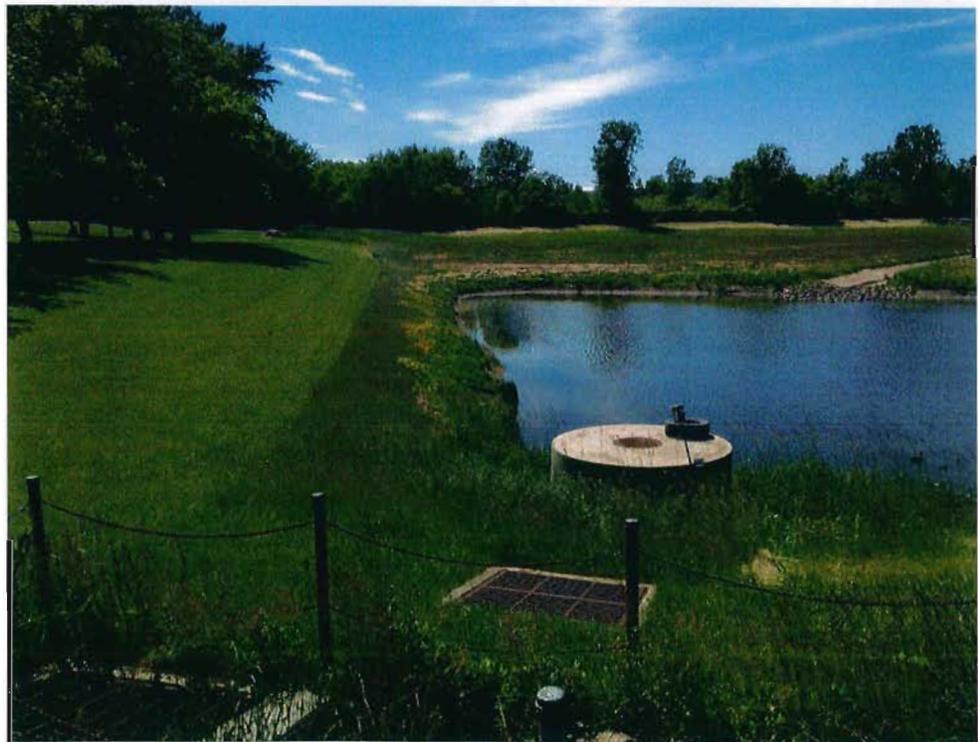
1. The designed water depth of the pond is 4.5 feet. The measured water depth in July of 2013 varied between 4.2 and 5.2 feet.
2. The inlet and outlet structures were inspected and were found to be in good condition. There was some vegetation growing around the outlet structure.
3. Sediment build-up varied between 0.4 and 0.8 feet.
4. Sections of the pond perimeter had been mowed, with the grass left longer near the pond. The rip-rap area was clear.
5. Some sediment has built up in the concrete gutters.

1. The water depth should be measured in 2018 to compare to the 2013 measurements. This will provide a comparable depth to determine the rate of sediment accumulation as well as an anticipated date for sediment removal.
2. The concrete gutters should be cleaned.
3. Vegetation should be cleared around the outlet structure.

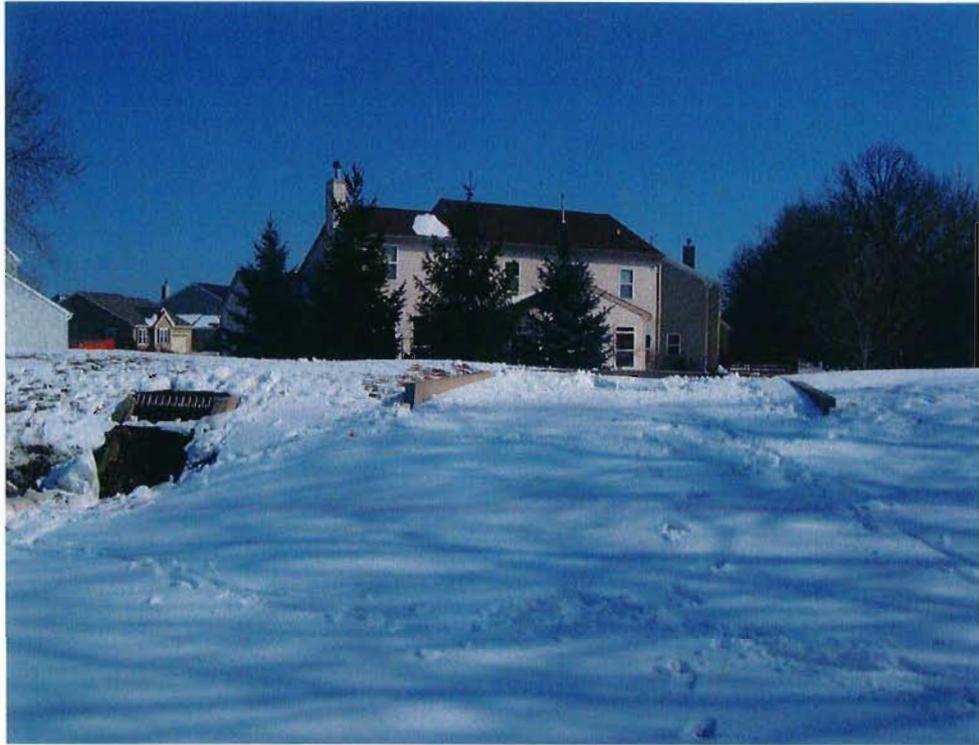
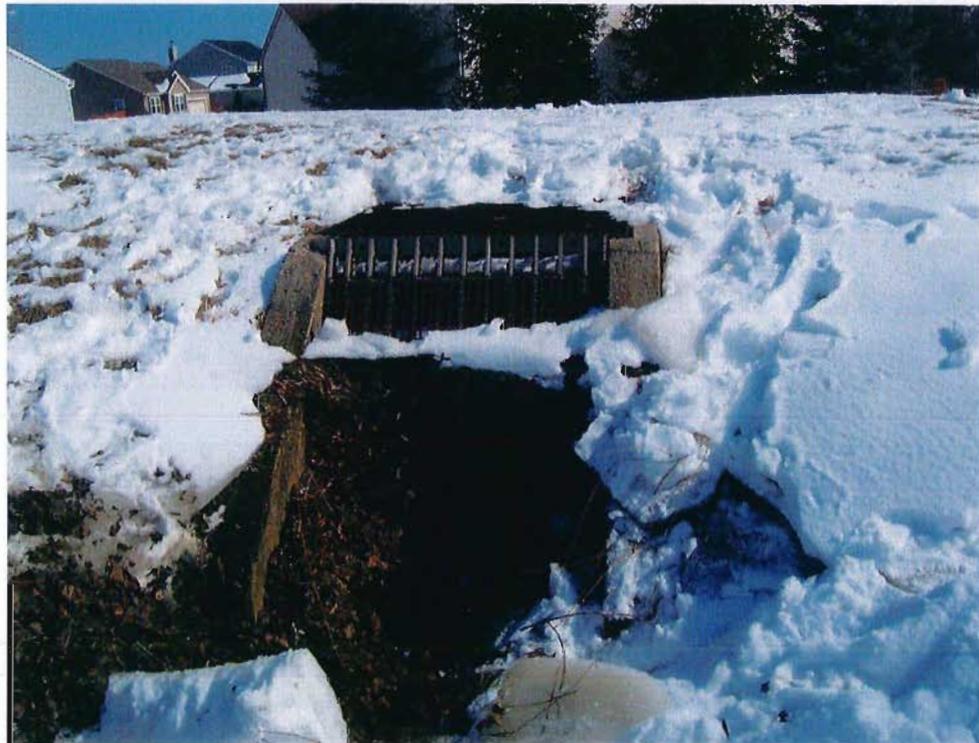
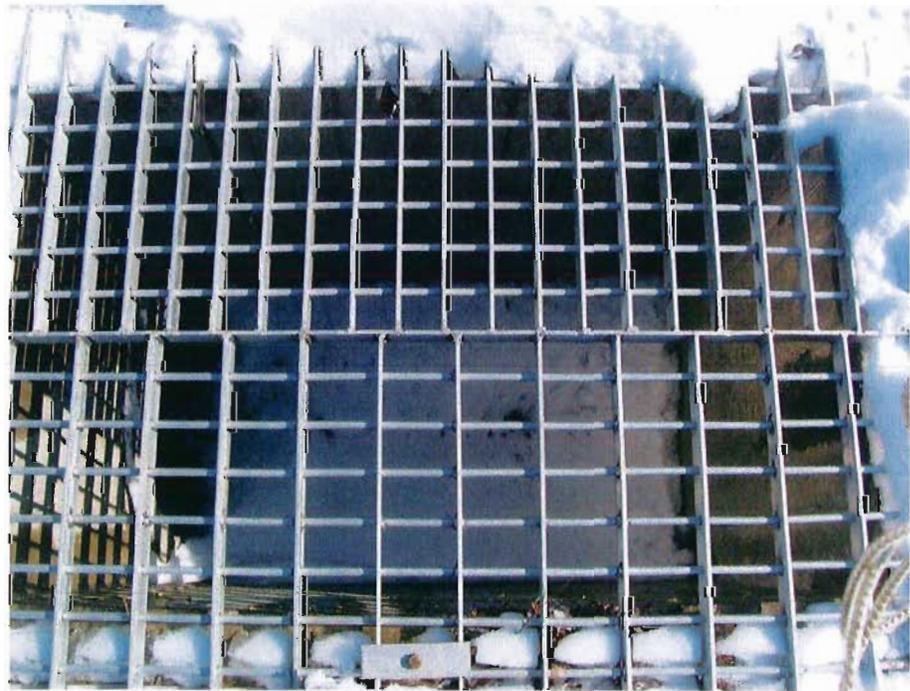
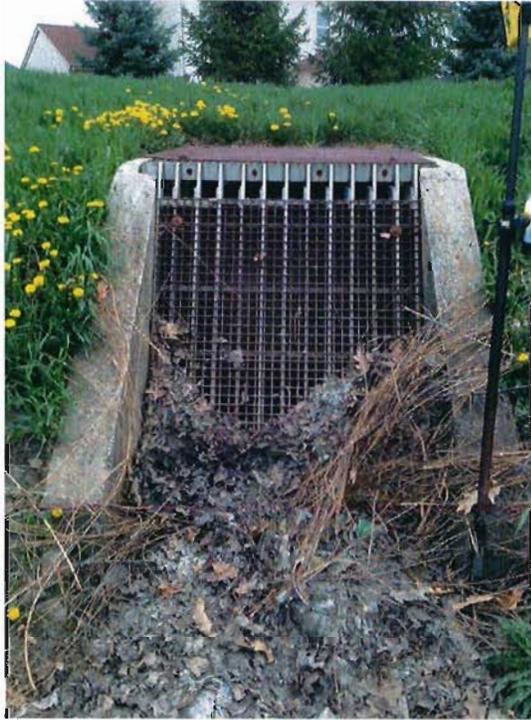
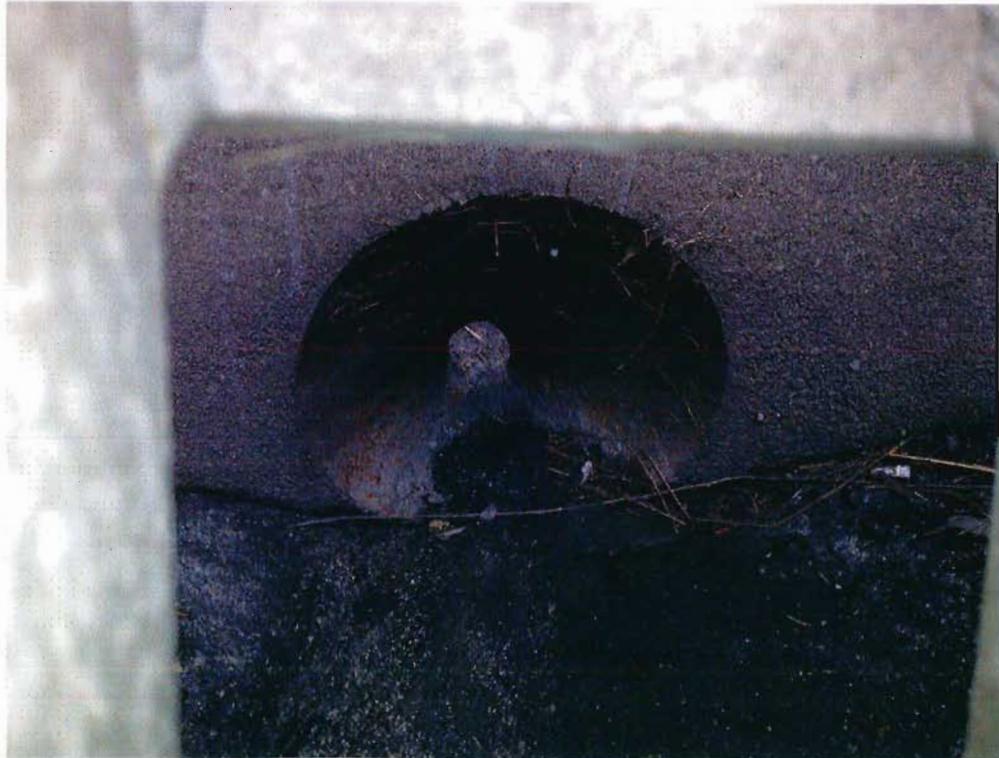
1. This dry pond was inspected in February of 2013.
2. The inlet and outlet pipes were inspected and were found to be in good structural condition.
3. Leaves and debris were built-up in front of the outlet grate to a height of about 3 feet.
4. The entire pond area is mowed.

1. Remove debris from the outlet grate periodically to prevent back-ups.

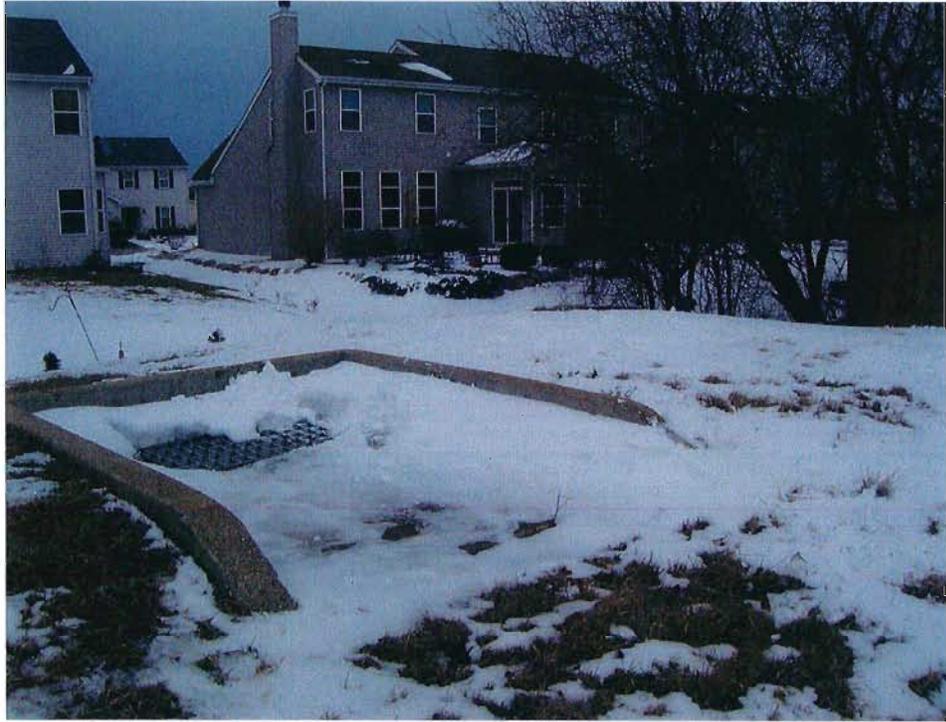
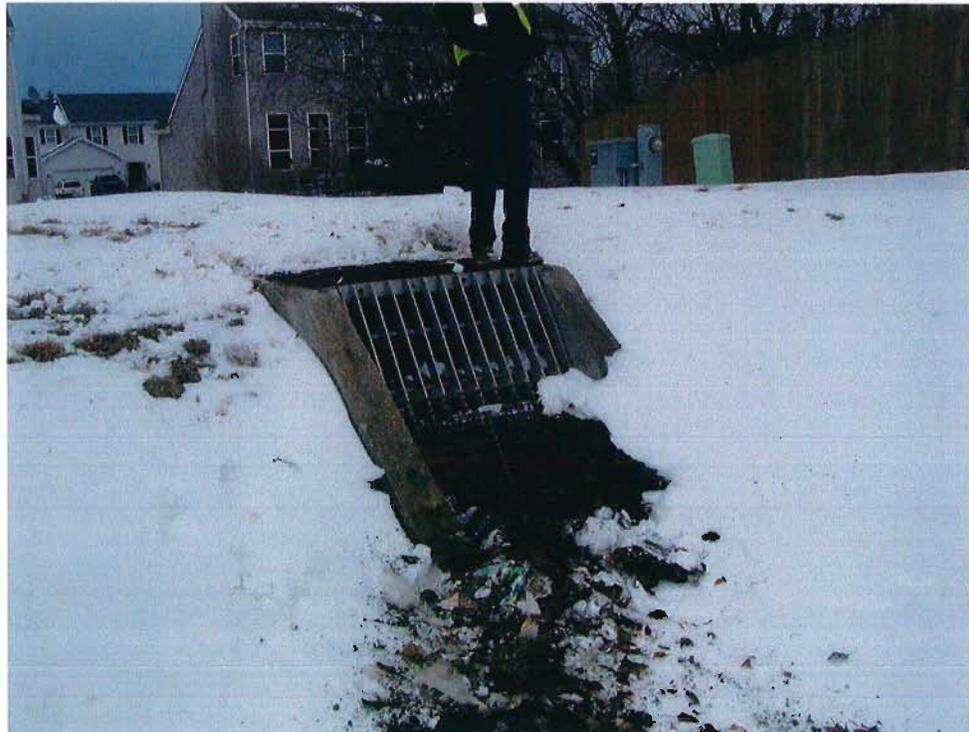
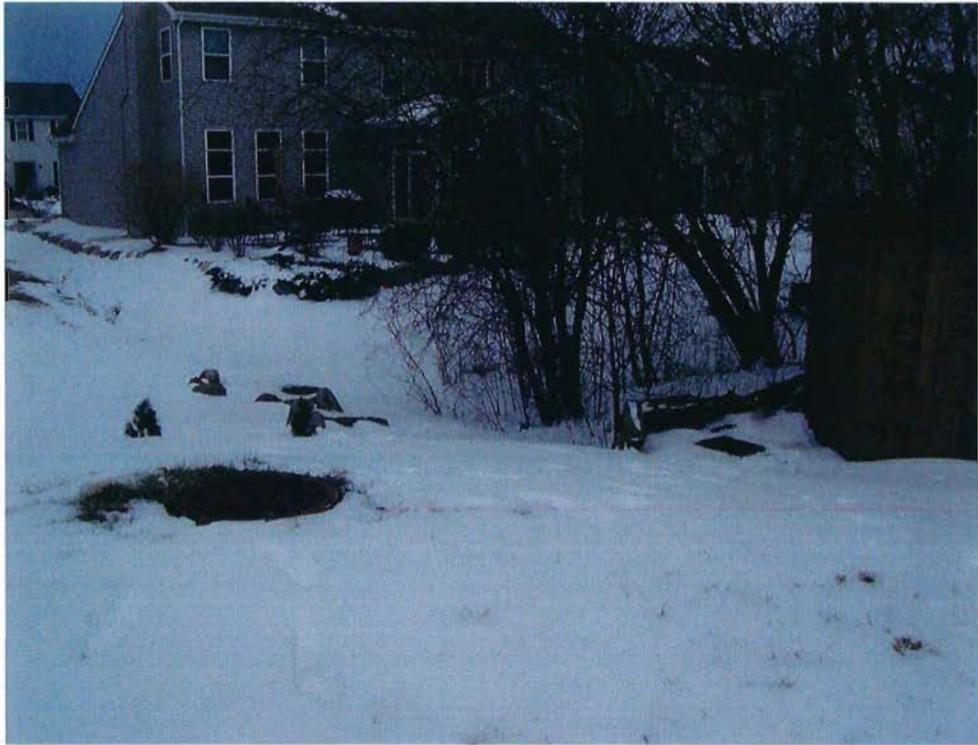
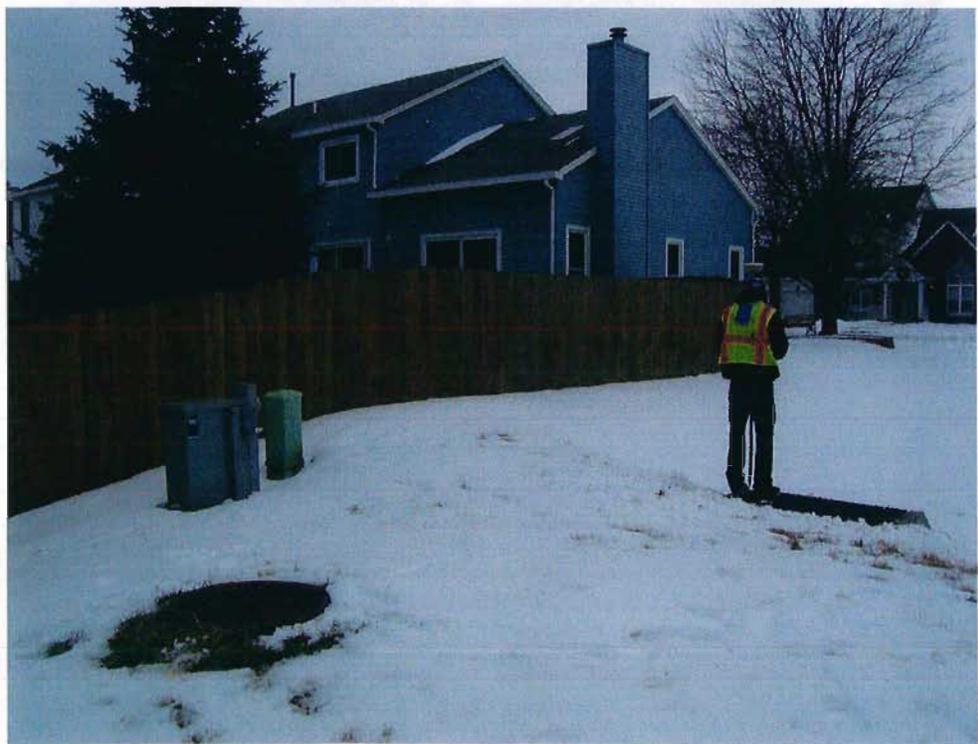
1. This dry pond only had scattered puddles when inspected in Spring of 2013.
2. The inlet and outlet pipes were inspected and were found to be in good structural condition.
3. Leaves and debris were clogging a portion of the outlet grate.
4. The entire pond is mowed.

1. The pond should be maintained to keep the outlet opening clear.
