# 2013 Ponds Certifications

City of Kenosha, Wisconsin

July 9, 2014

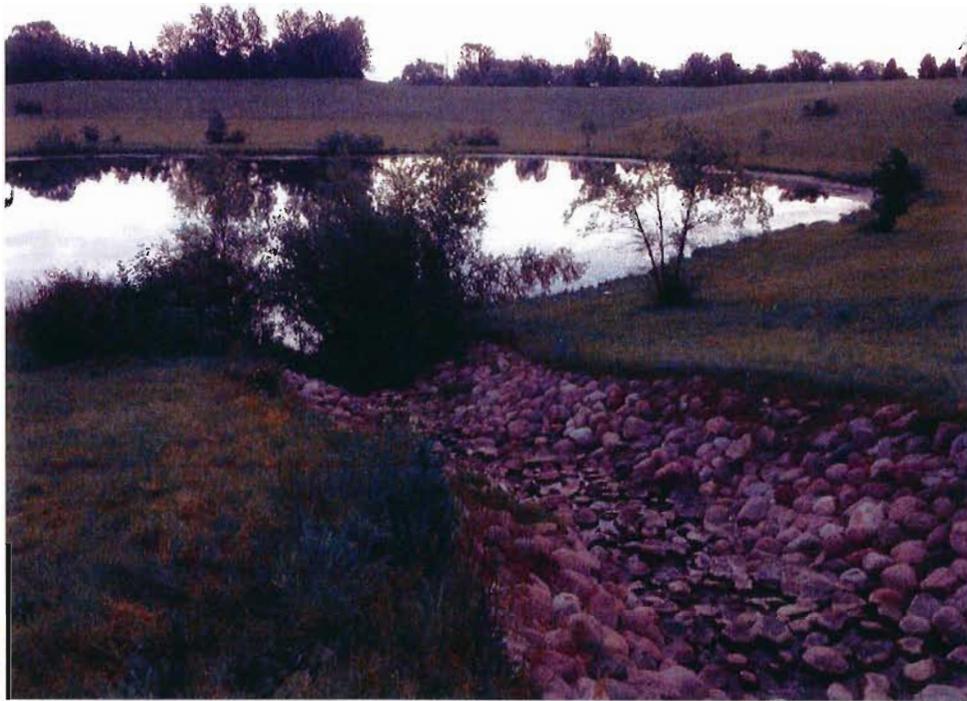
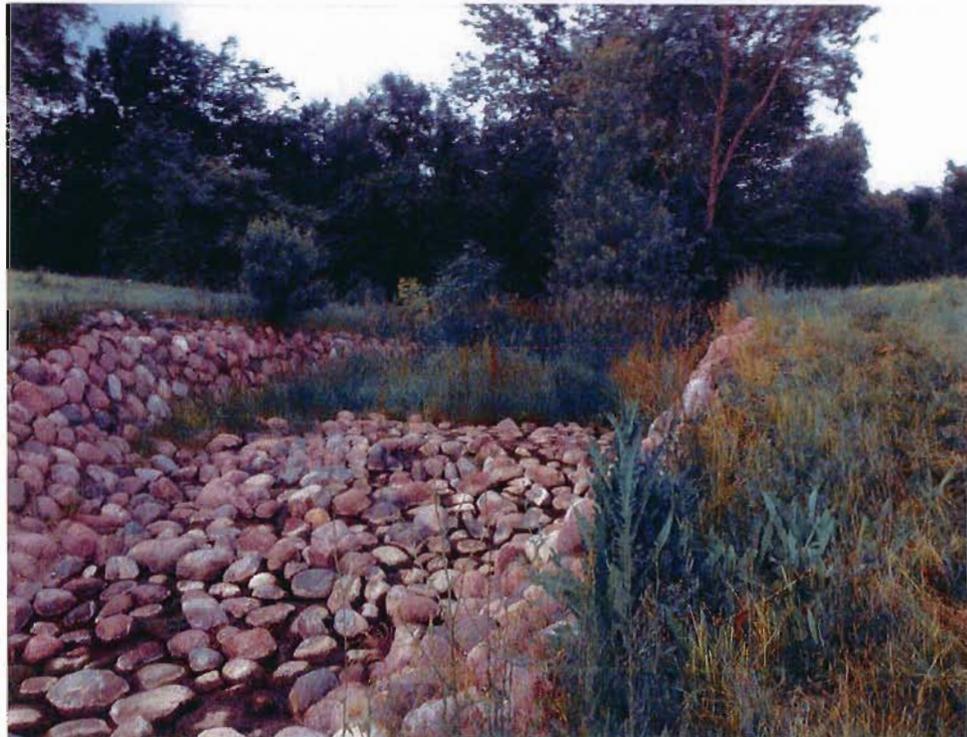
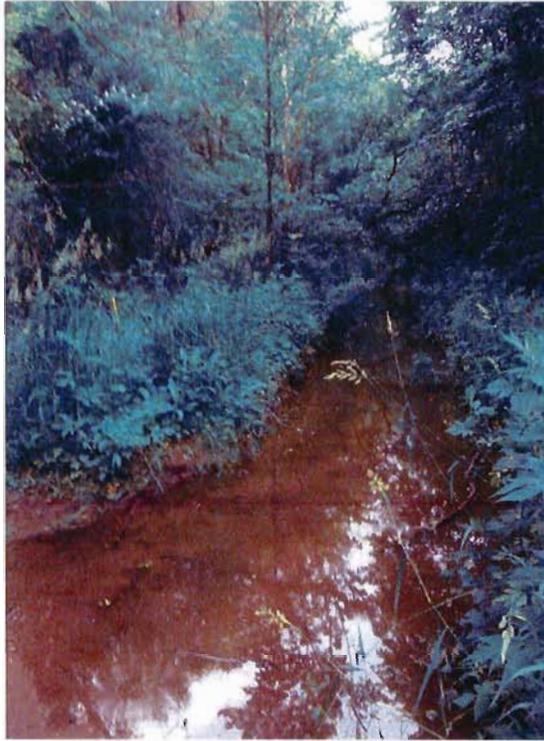
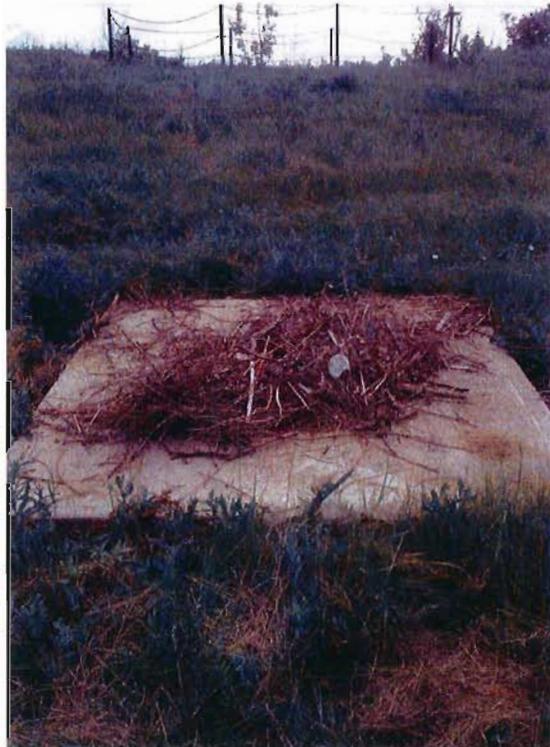
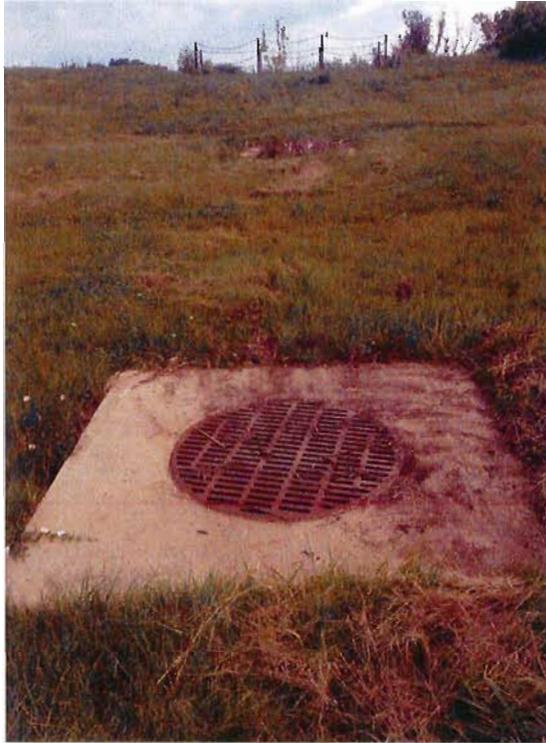
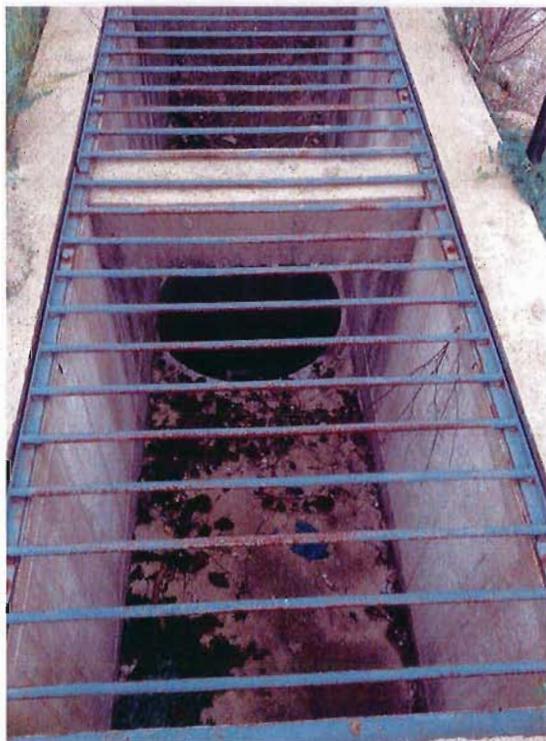
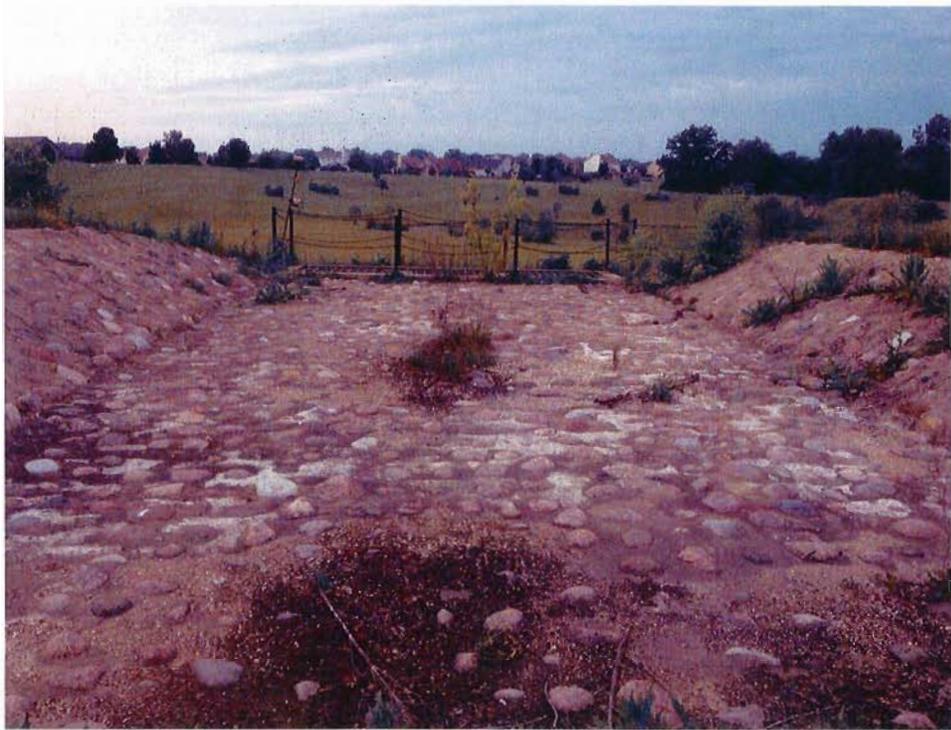
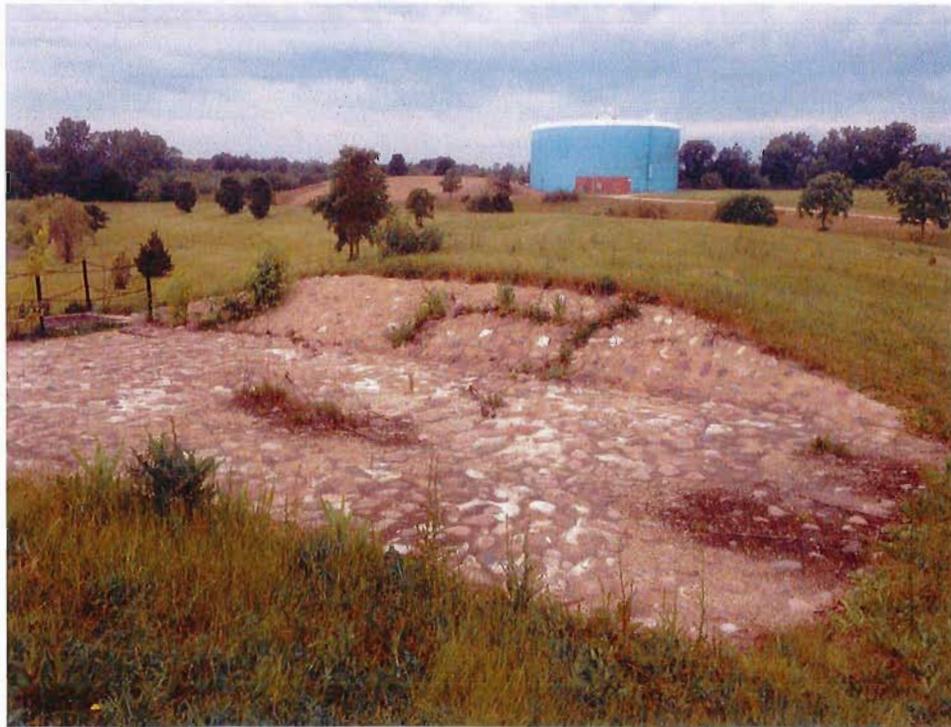
1. The designed water depth of the pond is 12 feet. The measured water depth in June of 2013 varied between 7.2 and 11.0 feet. We conclude that the pond is filling with sediment.
2. The inlet and outlet pipes were inspected and were found to be in good structural condition. Some debris was built up on the structures.
3. Sediment build-up averaged 1.1 feet.
4. Vegetation is growing in the spillway and structures. The pond perimeter had not been mowed recently.

- Clearing debris buildup on CB's
- Vegetation growth in concrete spillway

1. The water depth should be measured in 2018 to compare to the 2013 measurements. This will provide a comparable depth to determine the rate of sediment accumulation as well as an anticipated date for sediment removal.
2. Clear vegetation and debris from the inlet and outlet structures.

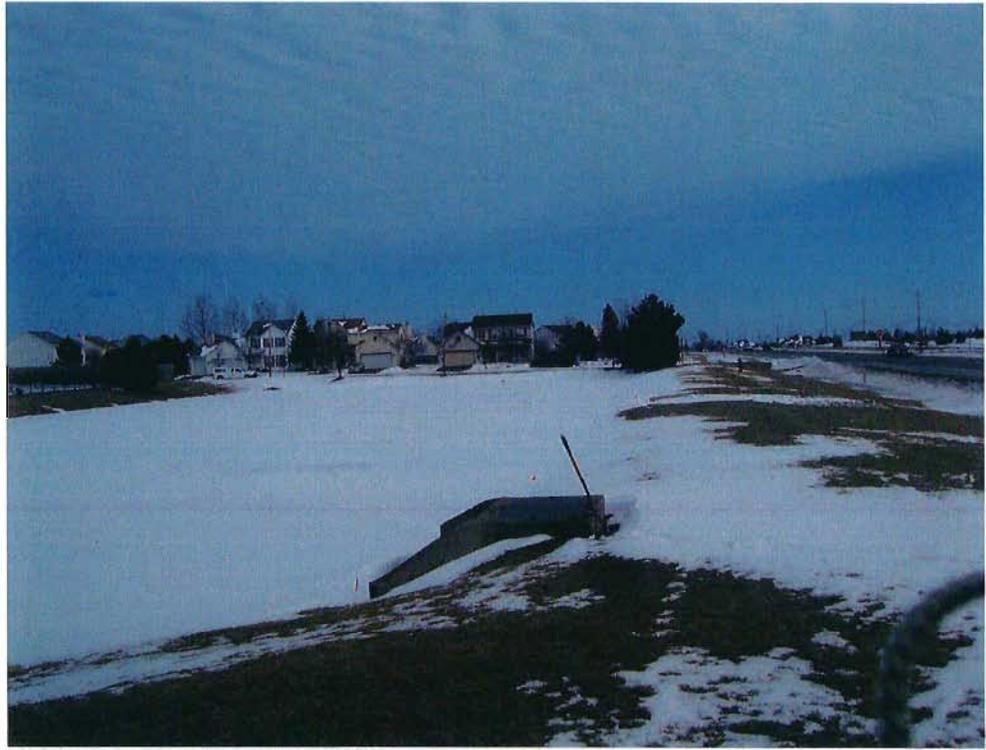
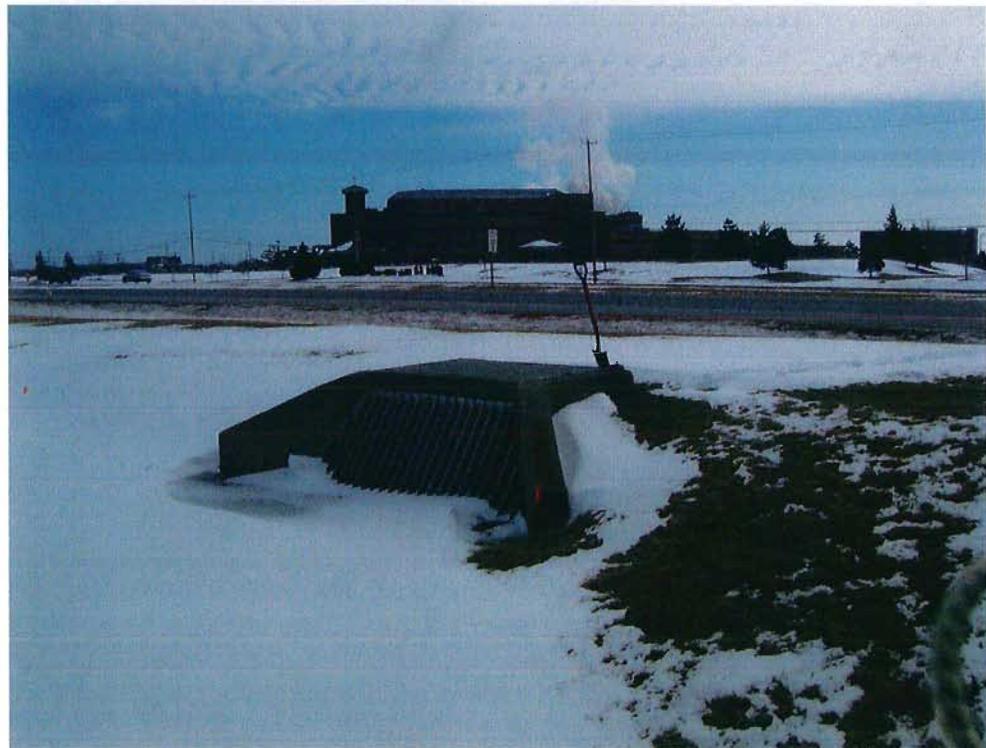
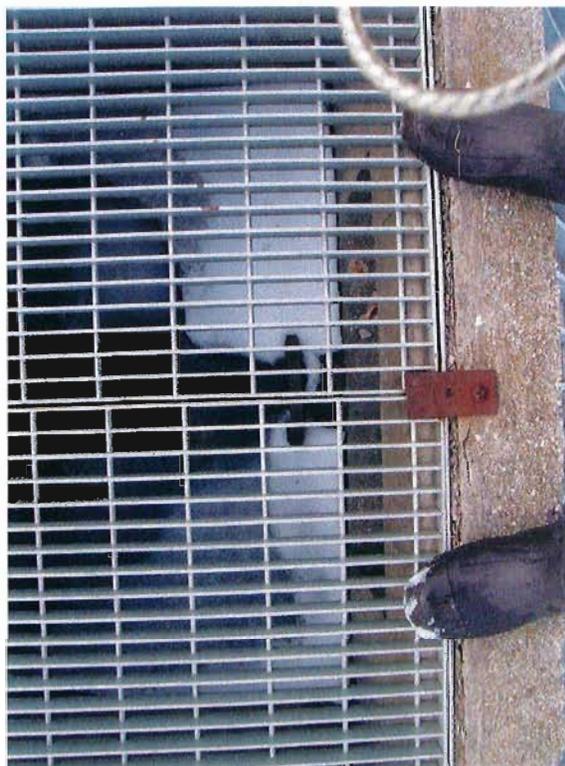
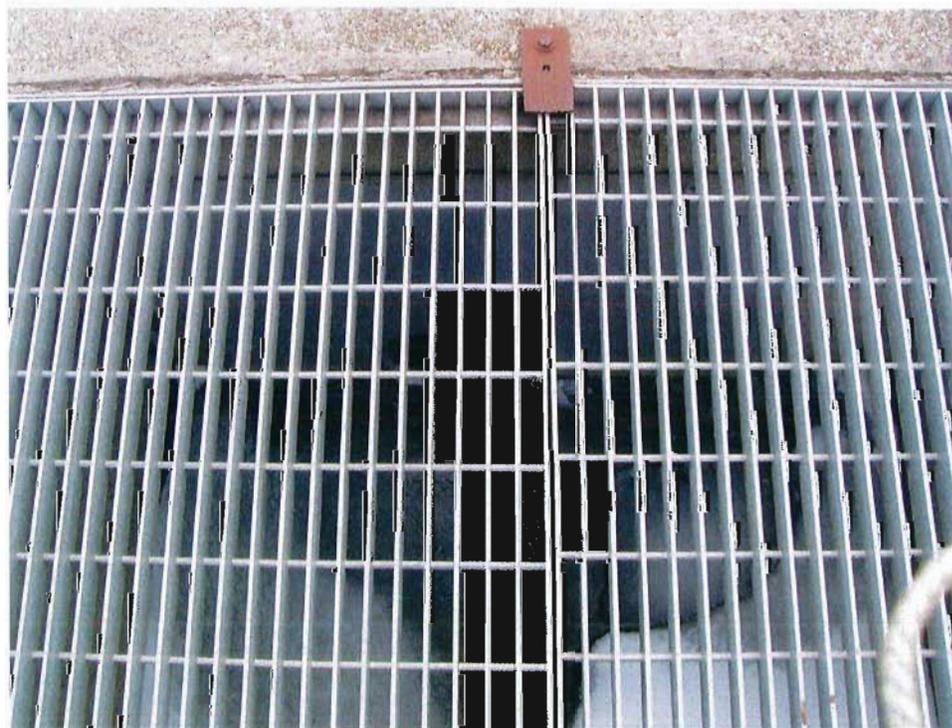
1. The designed water depth of the pond is 5.75 feet. The measured water depth in June of 2013 varied between 5.6 and 6.2 feet. We conclude that the pond was over-excavated at the time of construction.
2. The inlet and outlet pipes were inspected and were found to be in good structural condition.
3. Sediment build-up varied between 0 and 0.3 feet.
4. The whole pond perimeter is mowed.

1. The water depth should be measured in 2018 to compare to the 2013 measurements. This will provide a comparable depth to determine the rate of sediment accumulation as well as an anticipated date for sediment removal.
2. When mowing, leave a grassy strip around the pond perimeter to improve safety and deter geese.

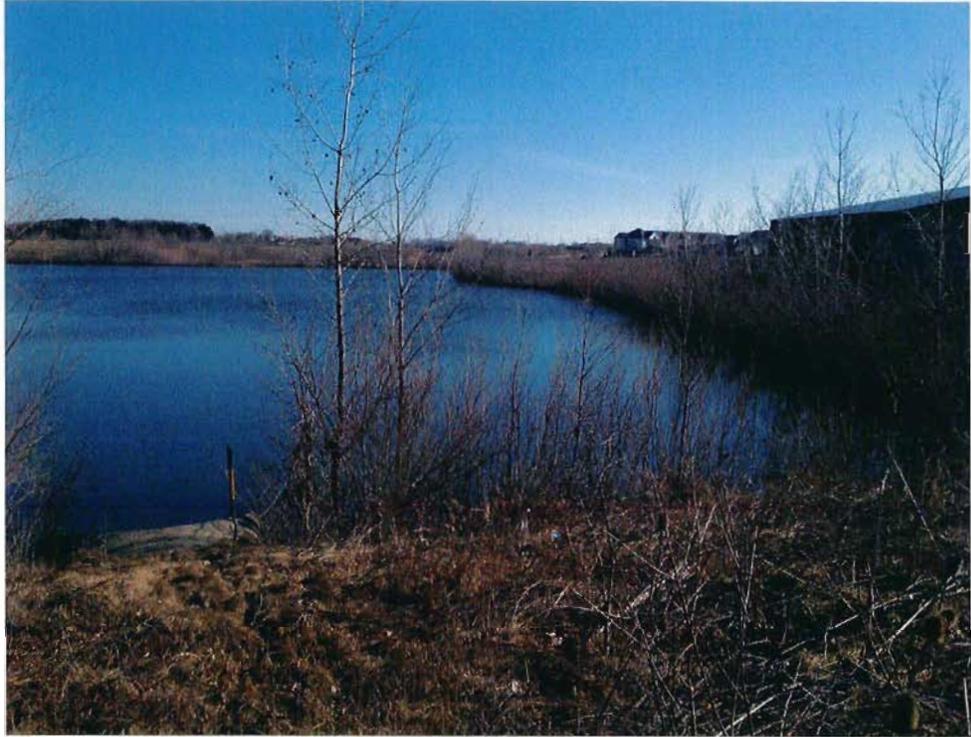
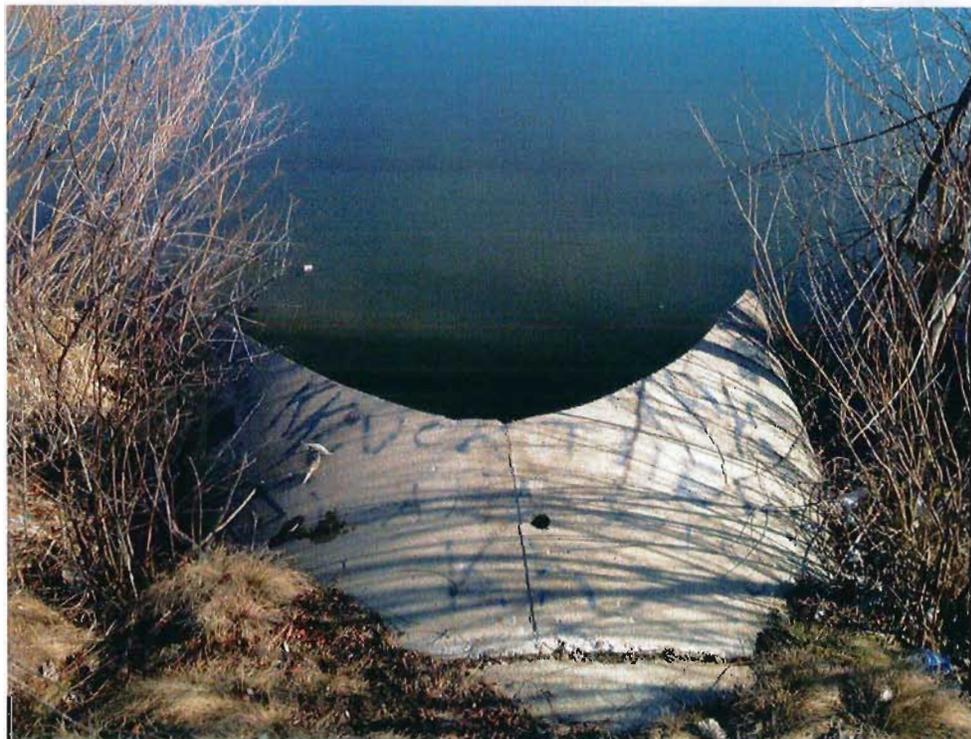
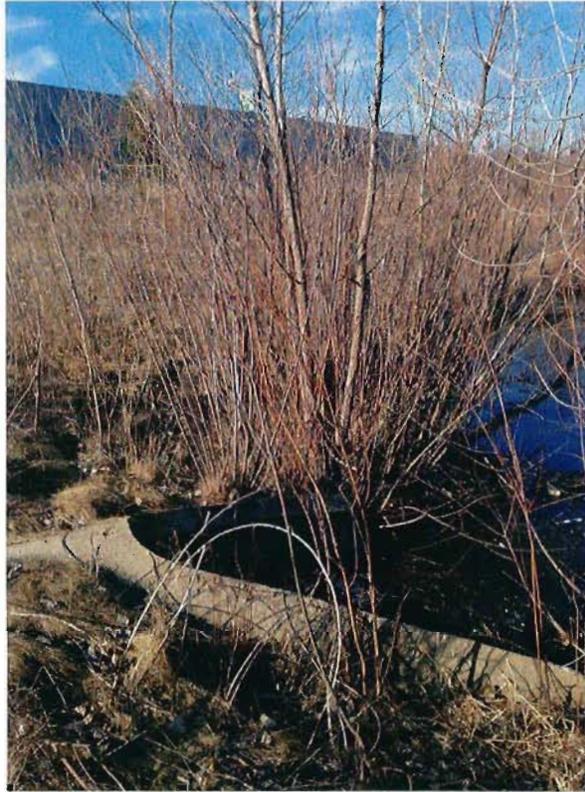
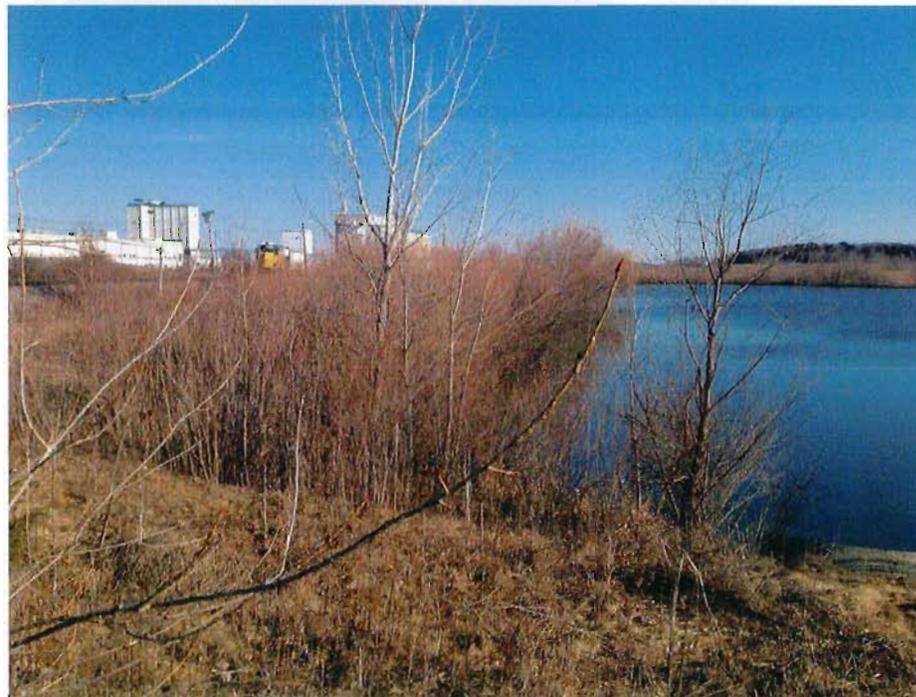
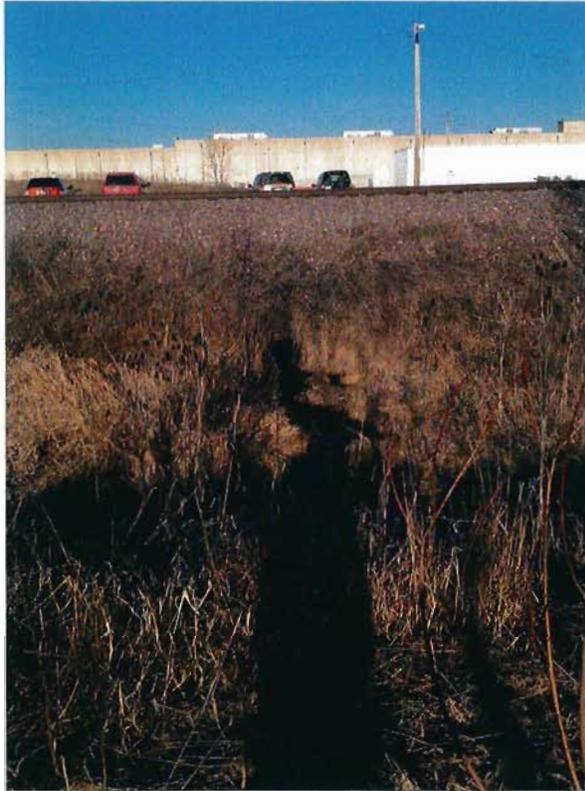
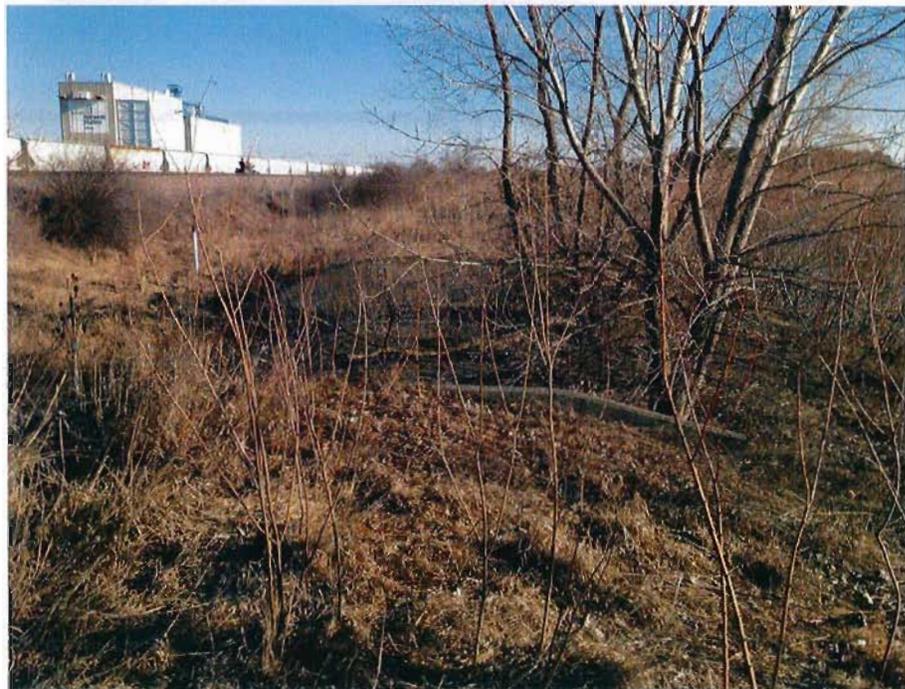
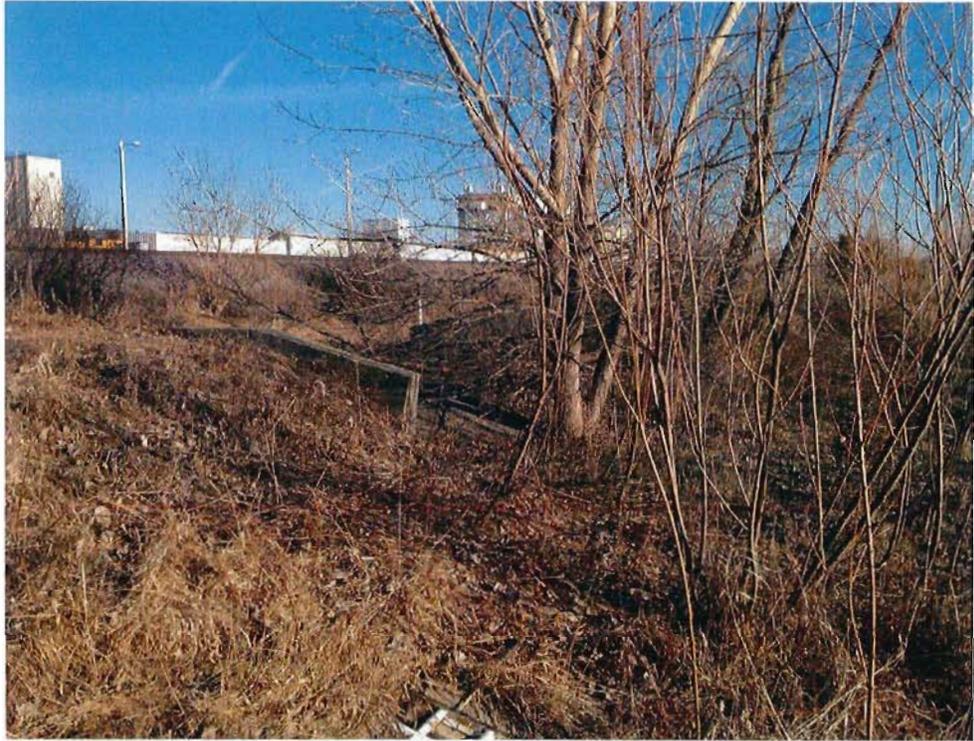
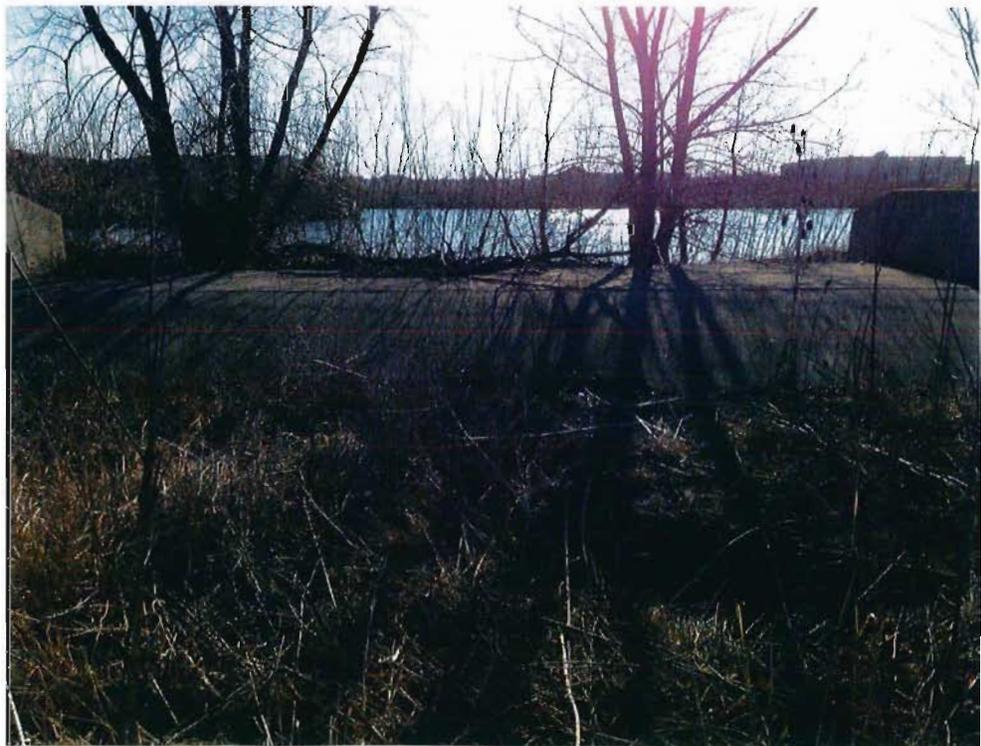
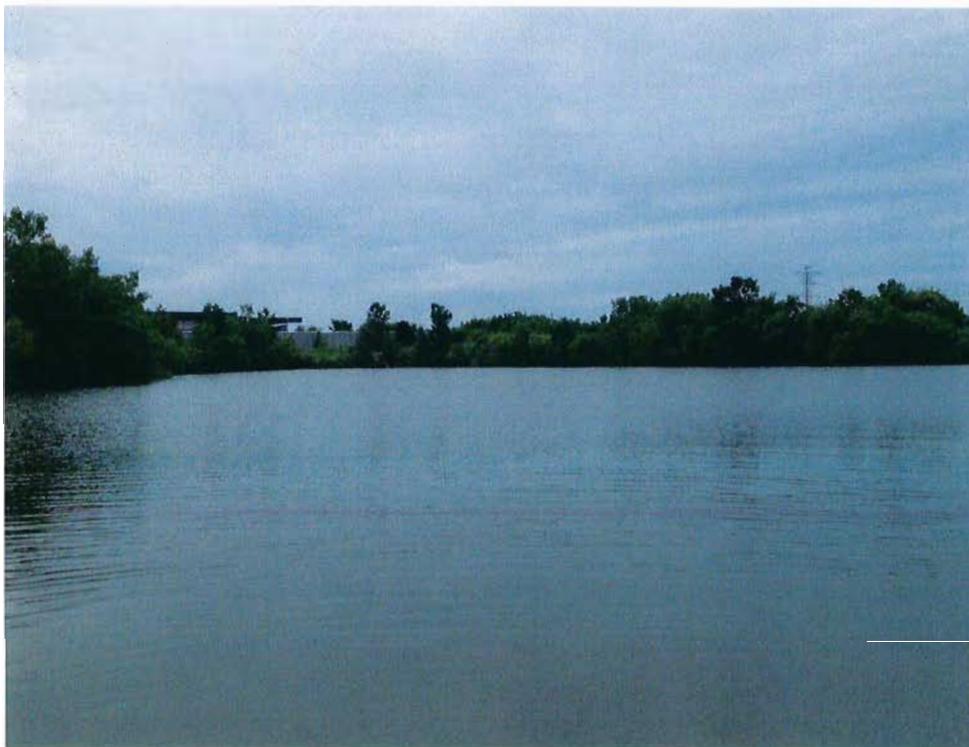
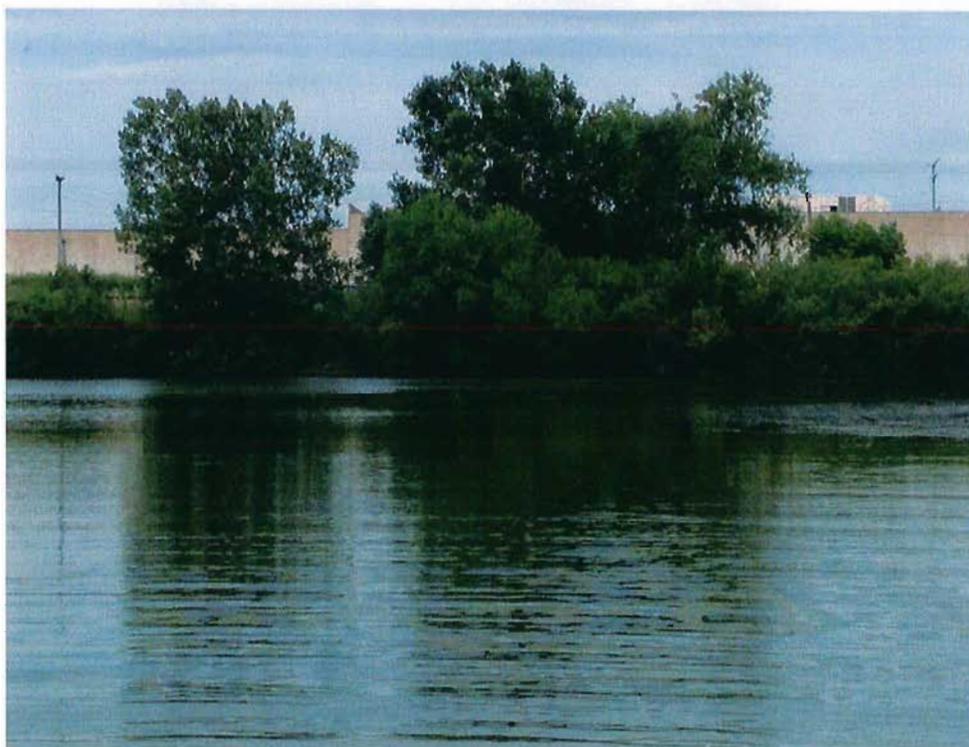
1. The designed water depth of the pond is 6 feet. The measured water depth in July of 2013 varied between 3.6 and 6.7 feet. We conclude that the pond was over-excavated at the time of construction but is now starting to fill up with sediment.
2. The inlet and outlet pipes were inspected and were found to be in good structural condition. Two of the inlets do not have grates.
3. Sediment build-up varied between 0 and 1.3 feet.
4. There is thick vegetation growth all around the pond perimeter.
5. Vegetation is also growing in the rip-rap near the pond inlets and outlets.

1. The water depth should be measured in 2018 to compare to the 2013 measurements. This will provide a comparable depth to determine the rate of sediment accumulation as well as an anticipated date for sediment removal.
2. The trees and vegetation growing around the pond should be cleared, especially near the rip-rap, inlets, and outlet.
3. The outlet structure requires a good cleaning, and the two inlets at the south end should be cleared.
4. Perform routine mowing.
5. Perform dredging operations at the pond to restore it to its design depth.

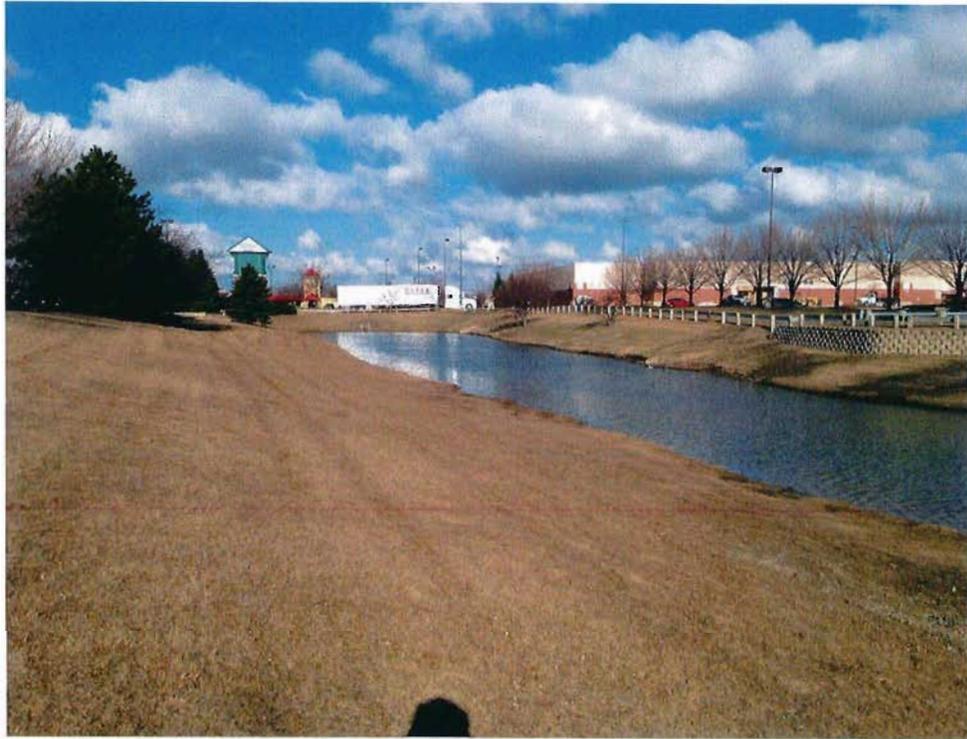
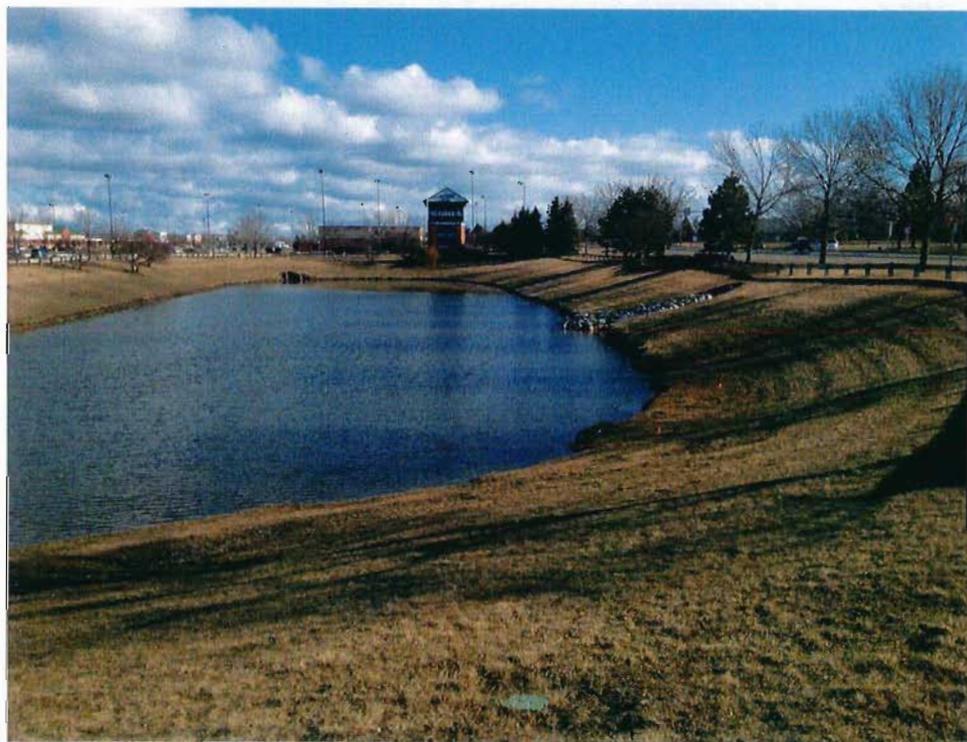
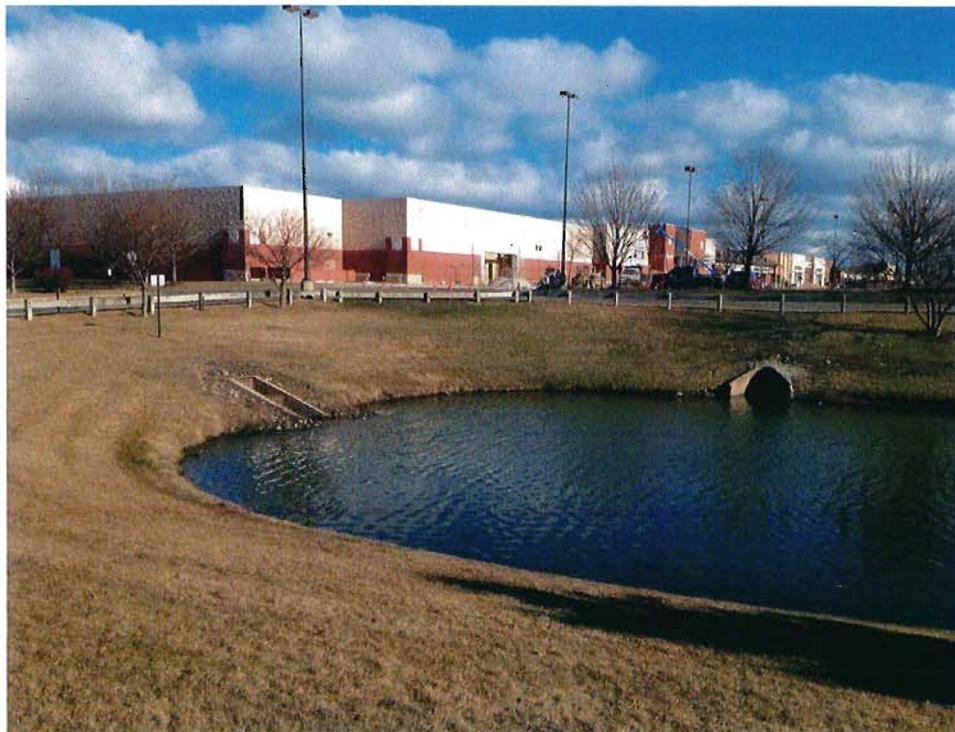
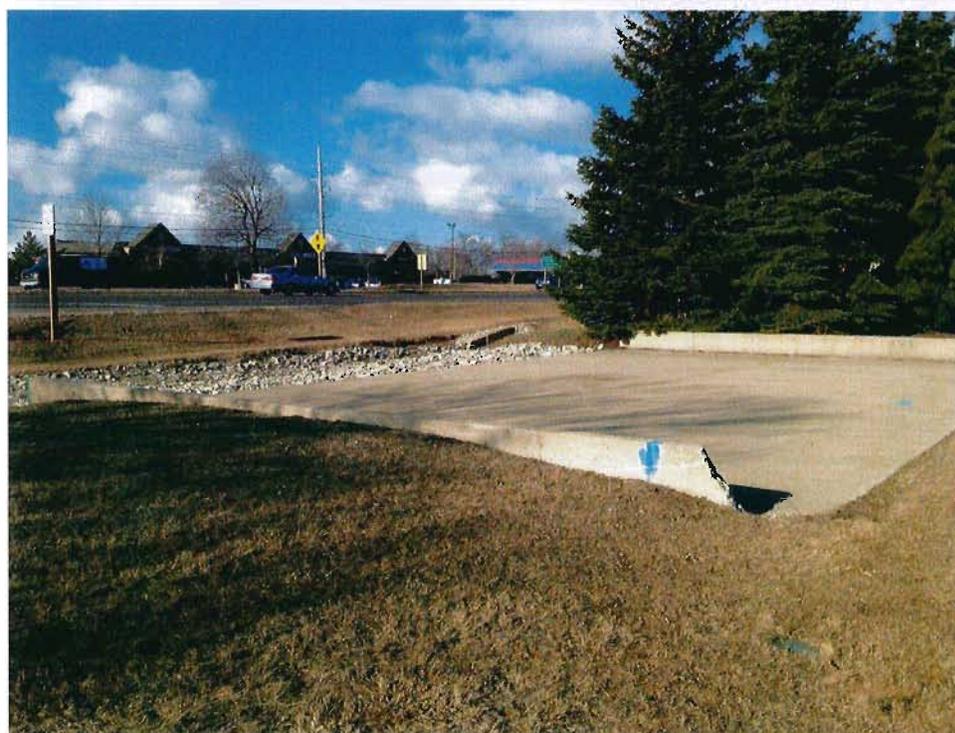
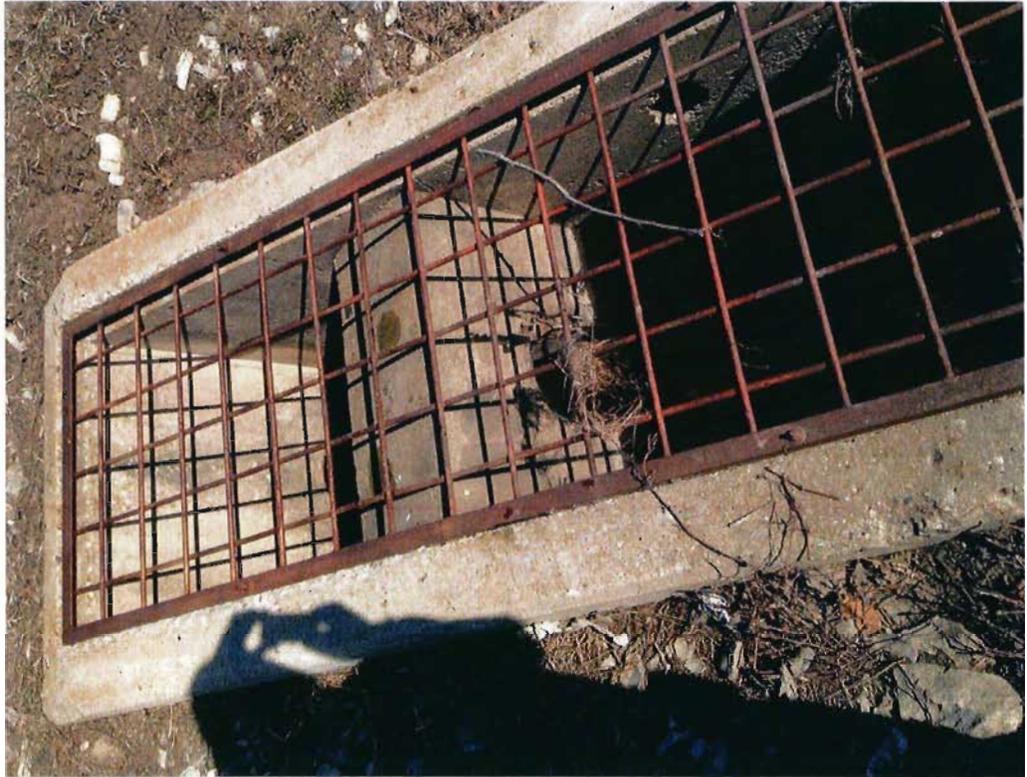
1. The designed water depth of the pond is 3.6 feet on the west side of the pond and 5.6 feet on the east side of the pond. The measured water depth in July of 2013 varied between 1.0 and 5.4 feet. We conclude that the pond has partially filled with sediment.
2. The inlet and outlet pipes were inspected and were found to be in good structural condition.
3. Sediment build-up varied between 0 and 1.8 feet.
4. The entire pond perimeter is mowed.
5. The water was murky and stagnant.

1. The water depth should be measured in 2018 to compare to the 2013 measurements. This will provide a comparable depth to determine the rate of sediment accumulation as well as an anticipated date for sediment removal.
2. When mowing, leave a grassy strip around the perimeter of the pond to deter geese.
3. Perform dredging operations at the pond to restore it to its design depth.

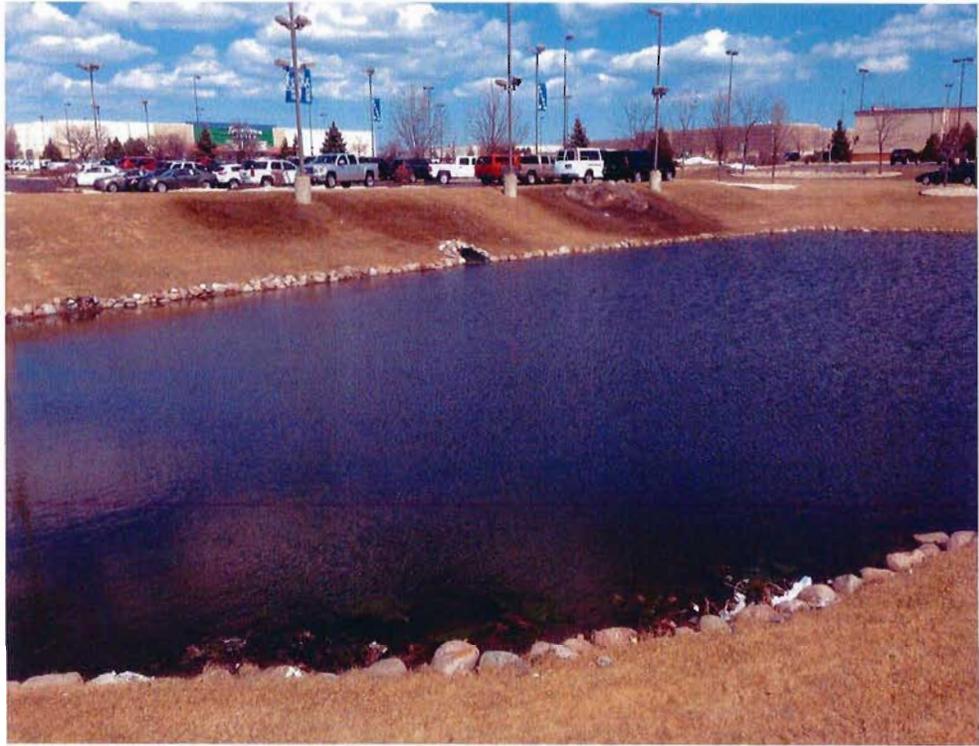
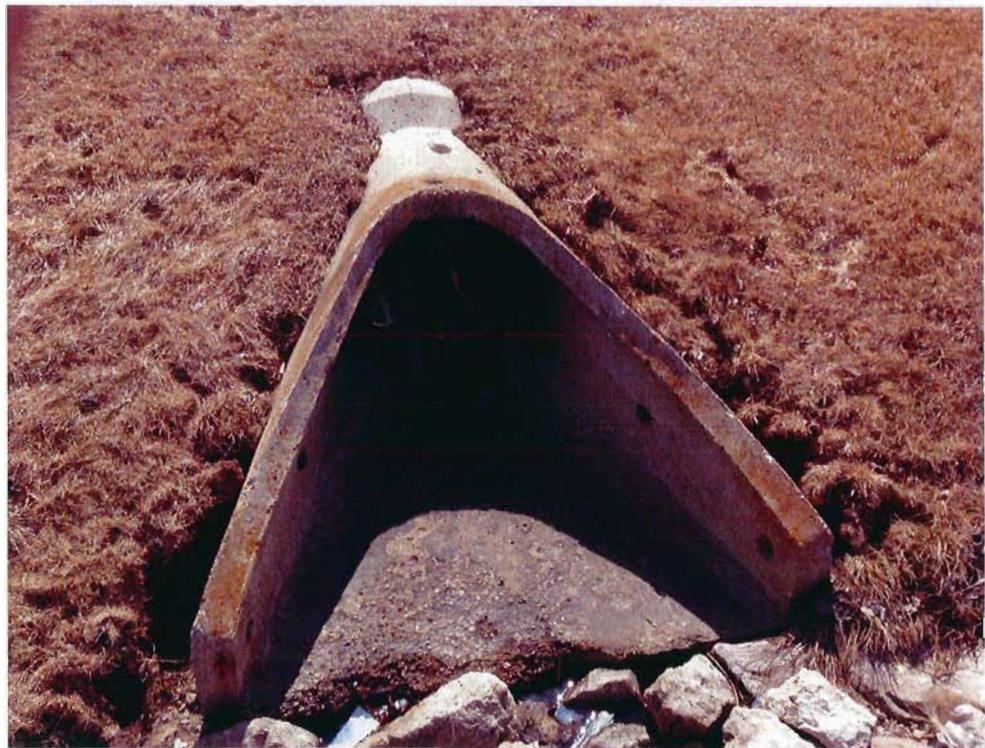
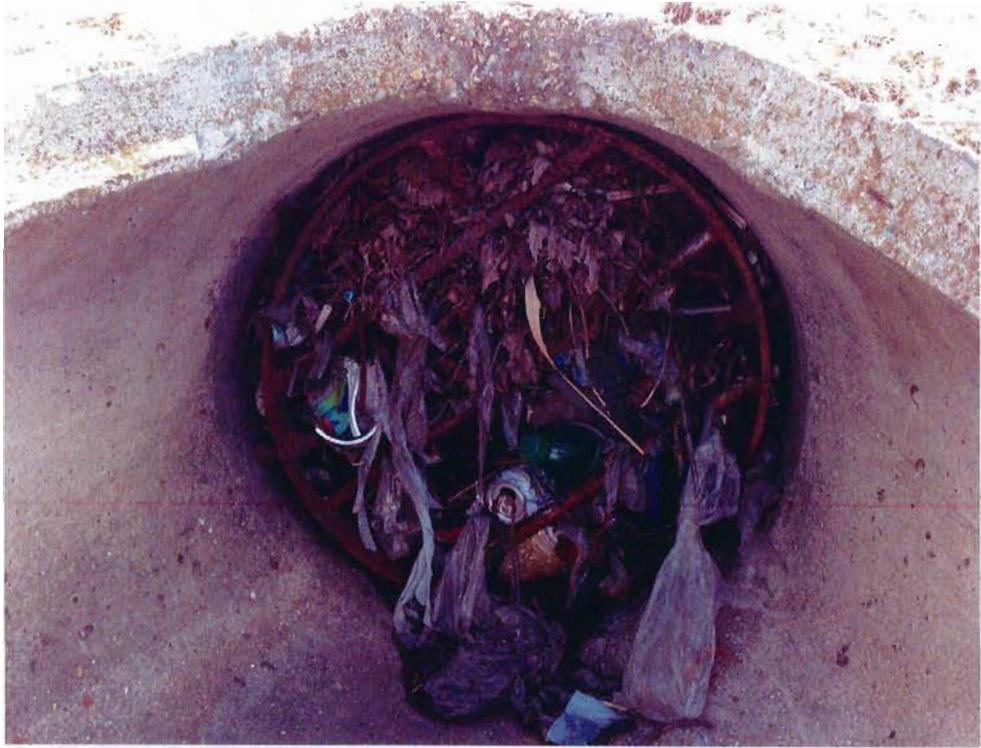
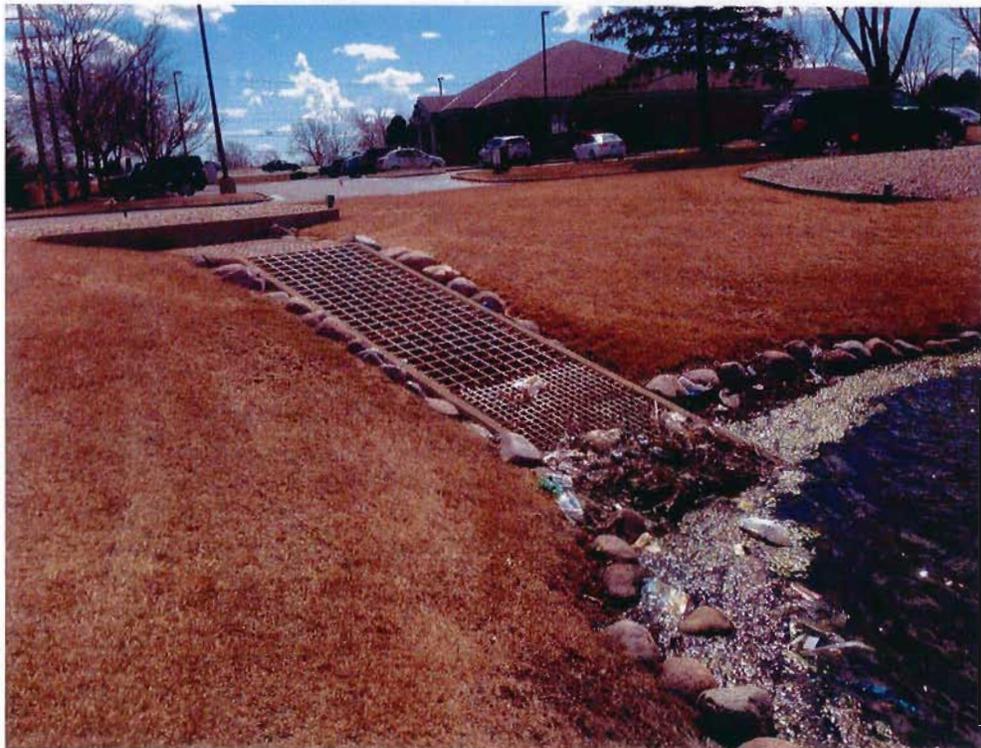
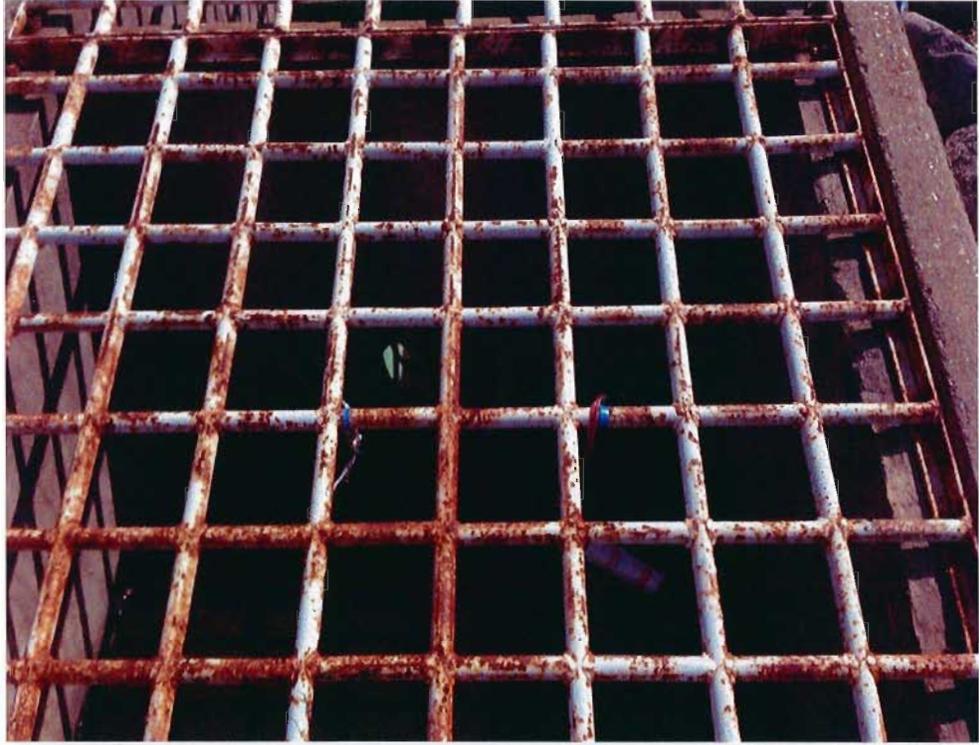
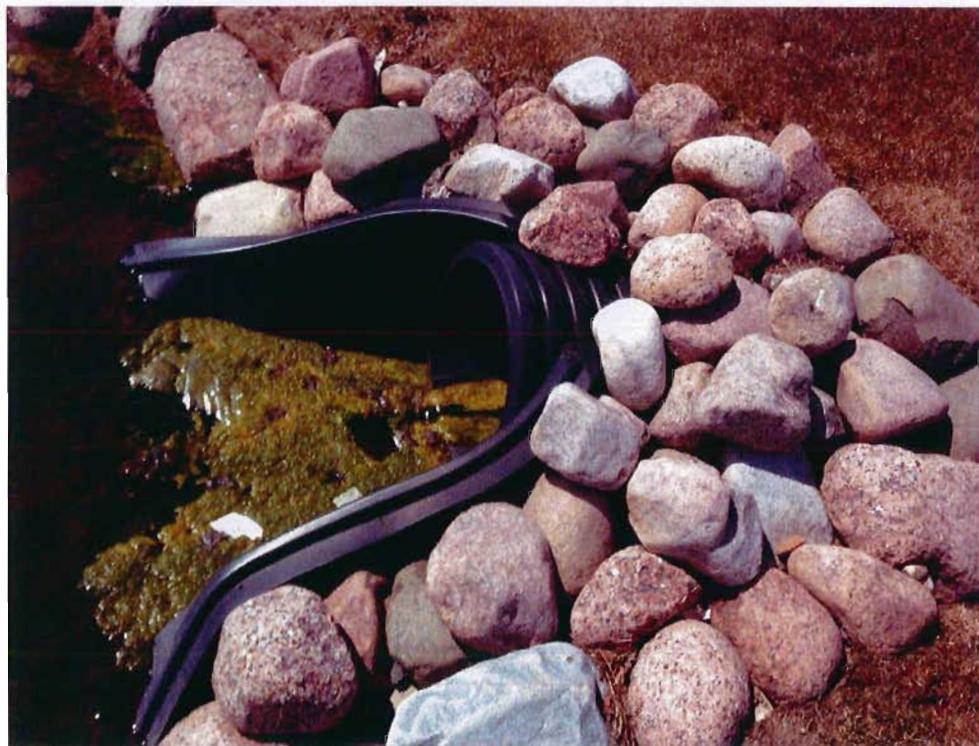
1. The original design plans for the pond were not available. The measured water depth in July of 2013 varied between 5.9 and 6.2 feet.
2. The inlet and outlet pipes were inspected and were found to be in good structural condition. A new inlet has been installed on the north side of the pond.
3. The 24" inlet was clogged with trash and there was also trash on the outlet structure.
4. Sediment build-up varied between 0.8 and 1.3 feet.
5. The pond area has been mowed.

1. The water depth should be measured in 2018 to compare to the 2013 measurements. This will provide a comparable depth to determine the rate of sediment accumulation as well as an anticipated date for sediment removal.
2. The trash should be cleaned from the inlet and outlet.
3. Routine clean-up should be performed around the pond.
