# 2013 Ponds Certifications

City of Kenosha, Wisconsin

July 9, 2014

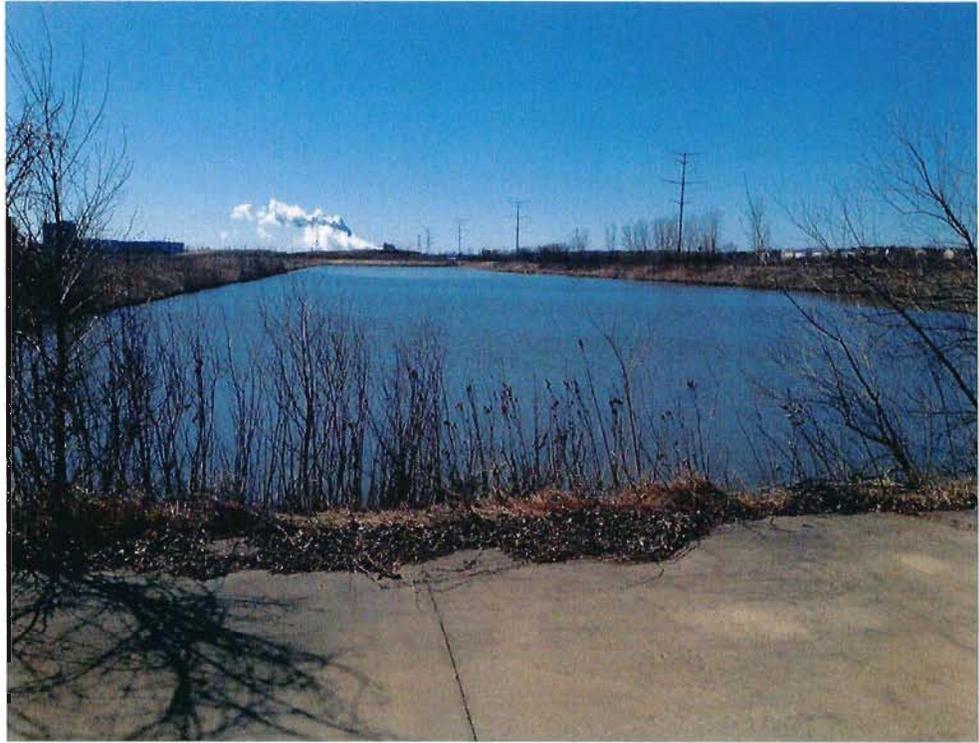
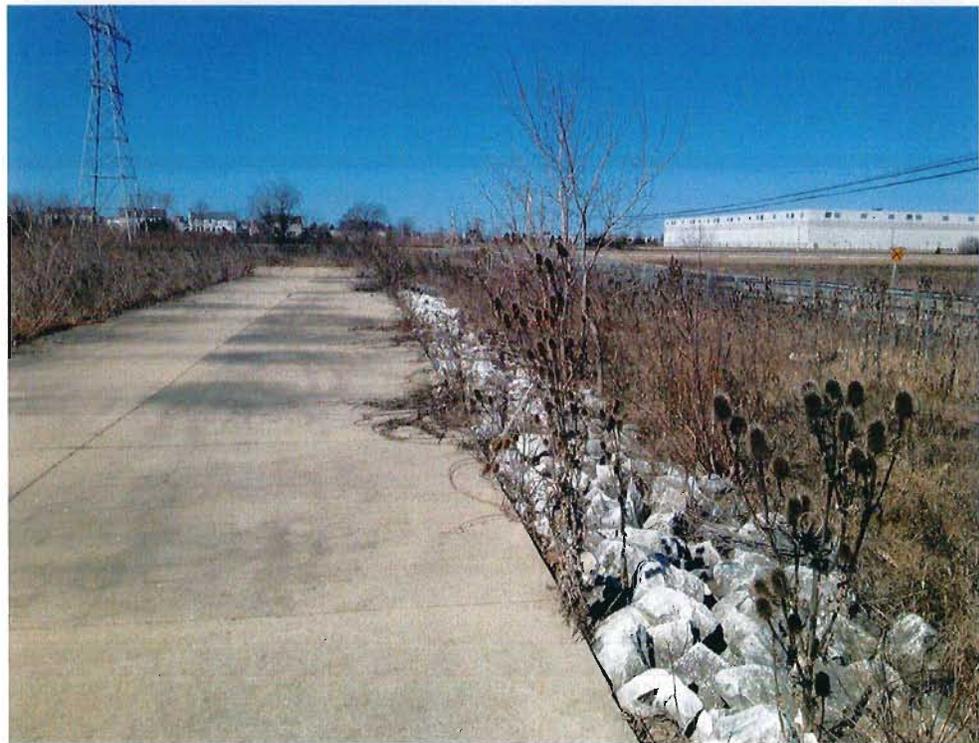
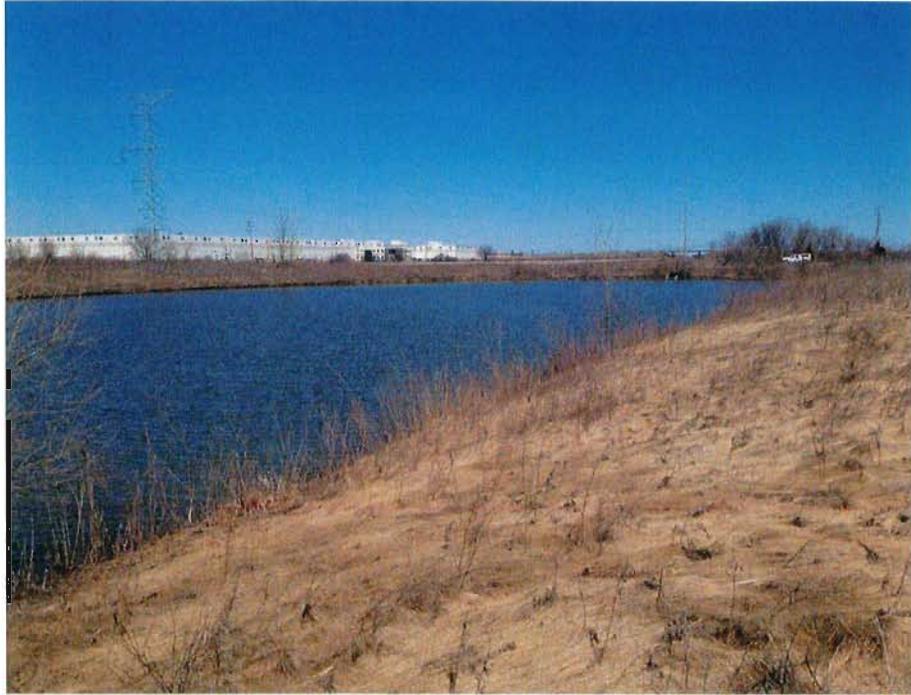
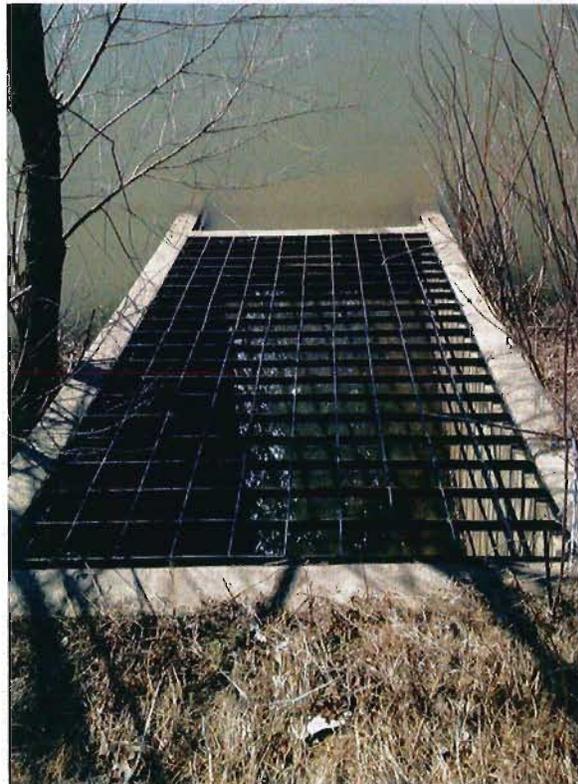
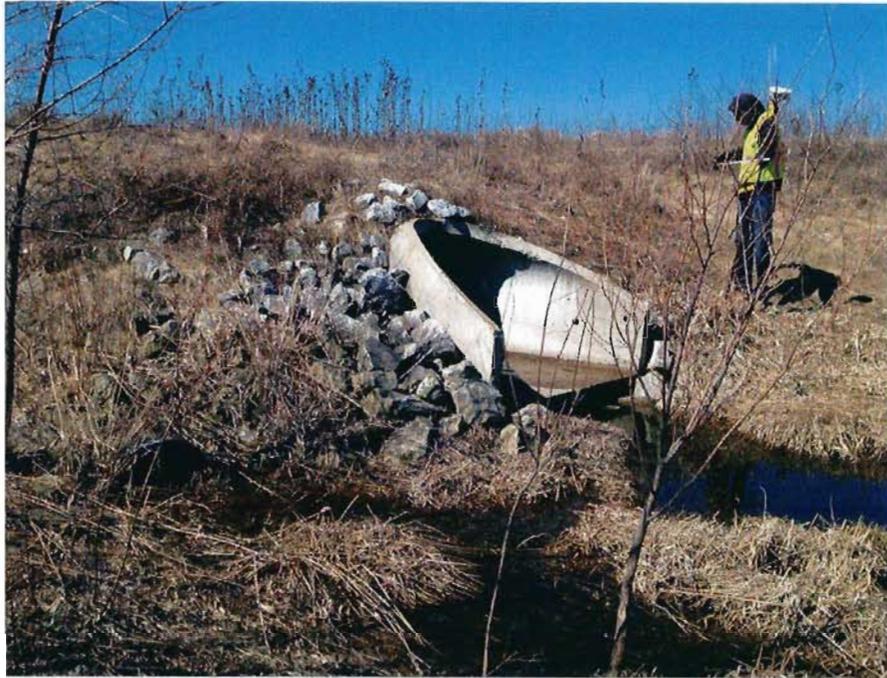
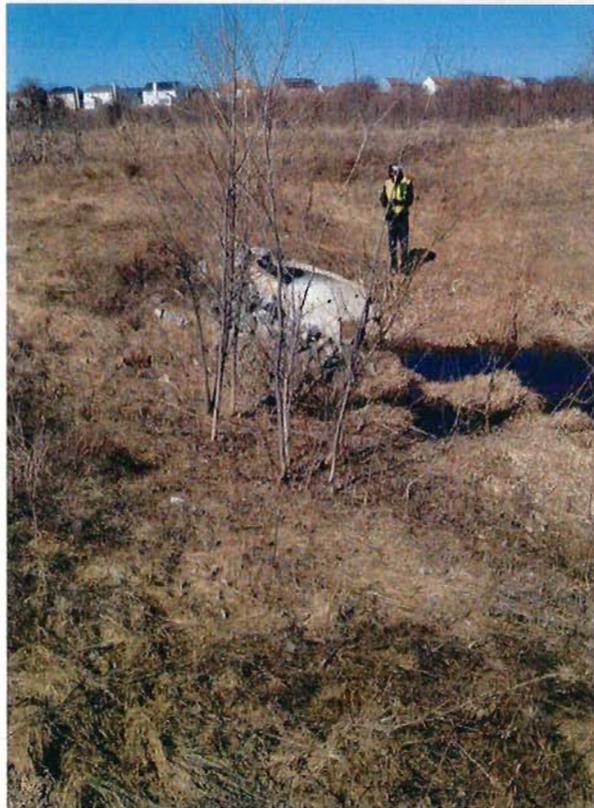
1. The designed water depth of the pond is 4 feet. The measured water depth in April of 2013 varied between 3 and 5.3 feet. We conclude that the pond was over-excavated at the time of construction and is starting to fill with sediment in one small area.
2. The inlet and outlet pipes were inspected. They are in good condition except that the bottom grate of the outlet structure is missing.
3. Sediment build-up varied between 0 and 0.4 feet.
4. The area around the pond perimeter is grassy. The only heavy vegetation growth is at the north end and near the 72" pipe.

1. The water depth should be measured in 2018 to compare to the 2013 measurements. This will provide a comparable depth to determine the rate of sediment accumulation as well as an anticipated date for sediment removal.
2. Clear the willow brush at the north end and surrounding the 72" pipe.
3. Replace the bottom grate on the outlet structure.

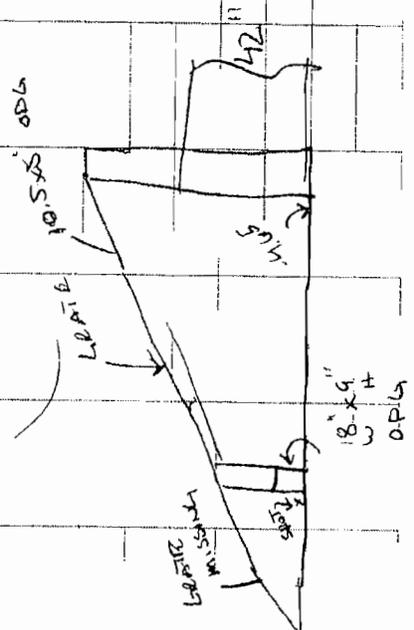
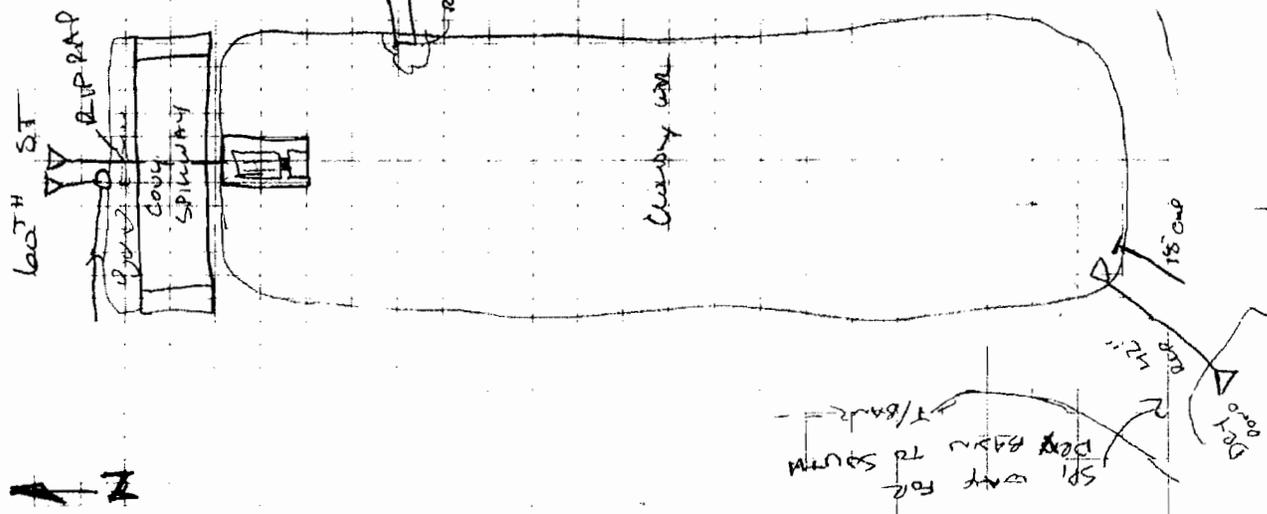
MAINTENANCE - CUT SCATTERED WILLOW BRUSH  
MAINLY N. END & AT 72" PIPE

- NEED LOW WALL BENCH
- NEED B/W DEPTS

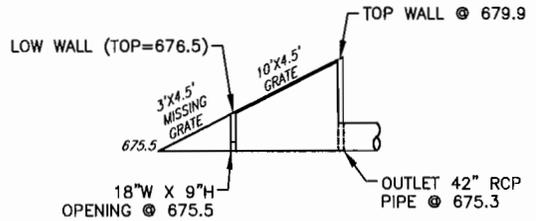
OUTLET STRUCTURE  
2-BAYS. UPPER GRATED, LOW GRATE MISSING  
TOP 4.5'X10', LOWER 4.5'X3'  
LOWER BAY WALL (TOP=676.5)  
18"W X 9"H OPENING @ 675.5  
TOP WALL @ 679.9  
OUTLET 42" RCP PIPE @ 675.3

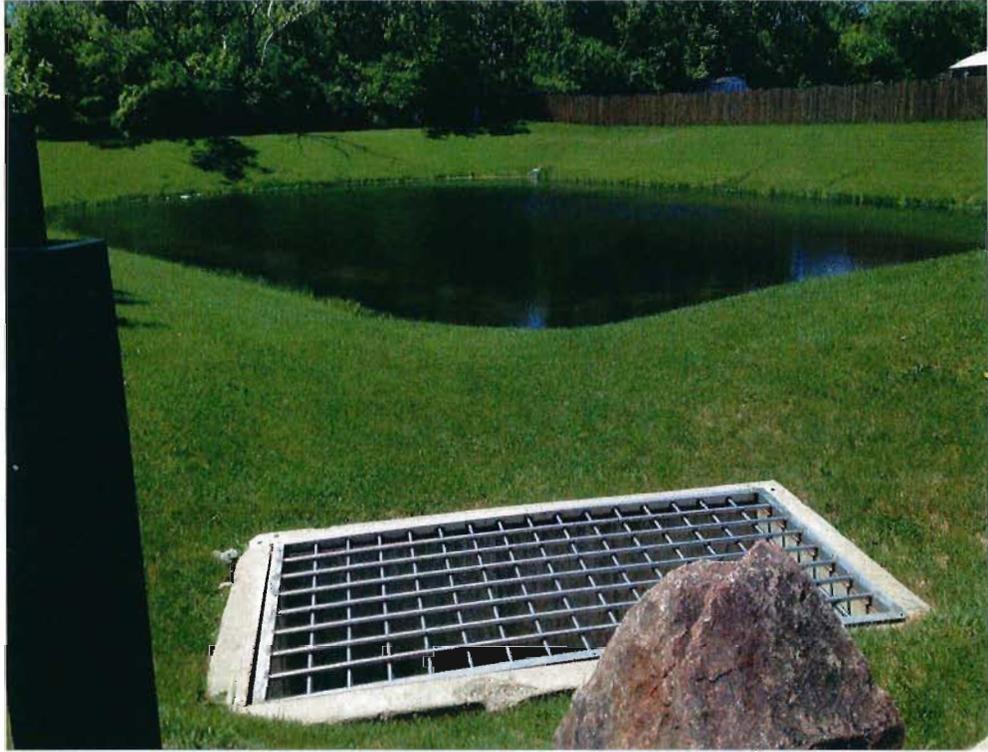
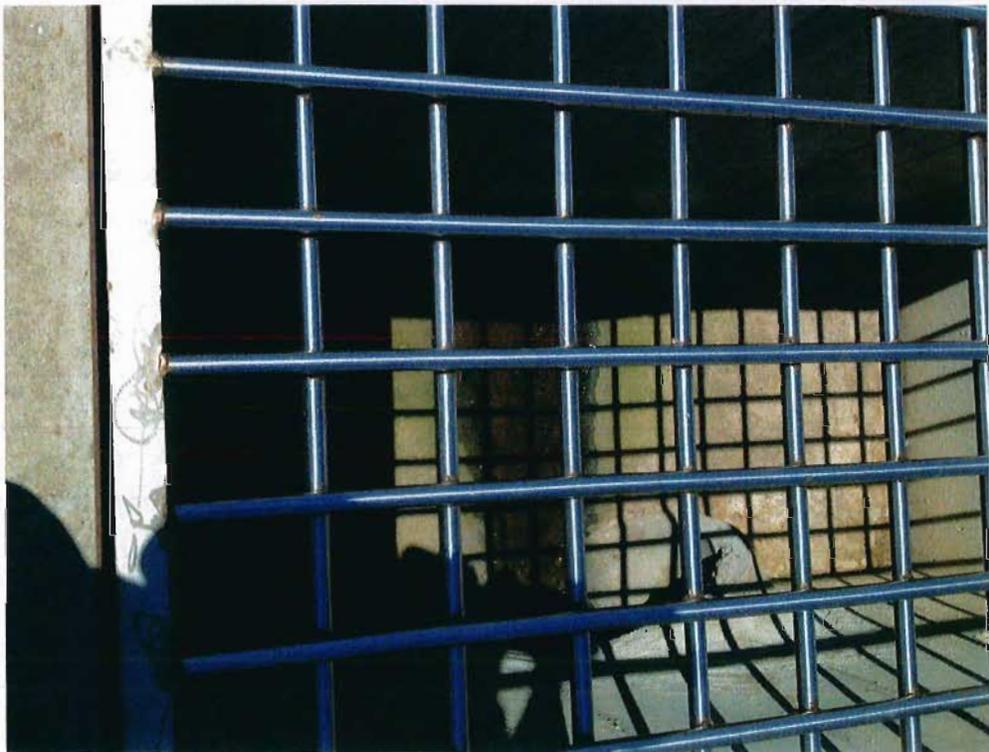
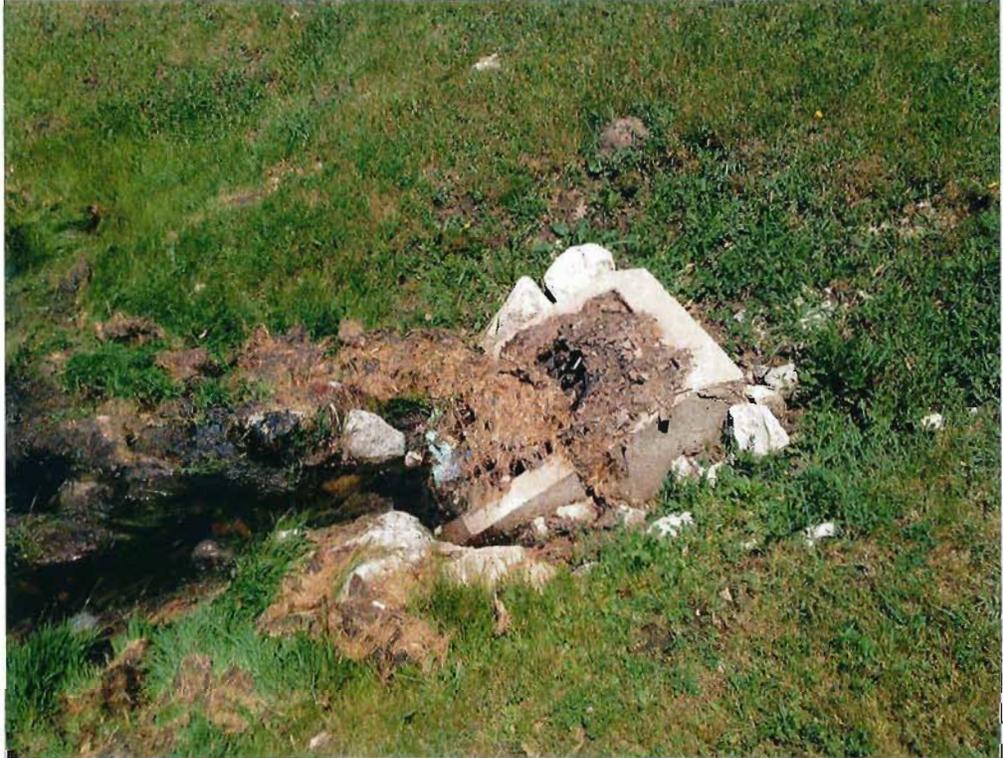
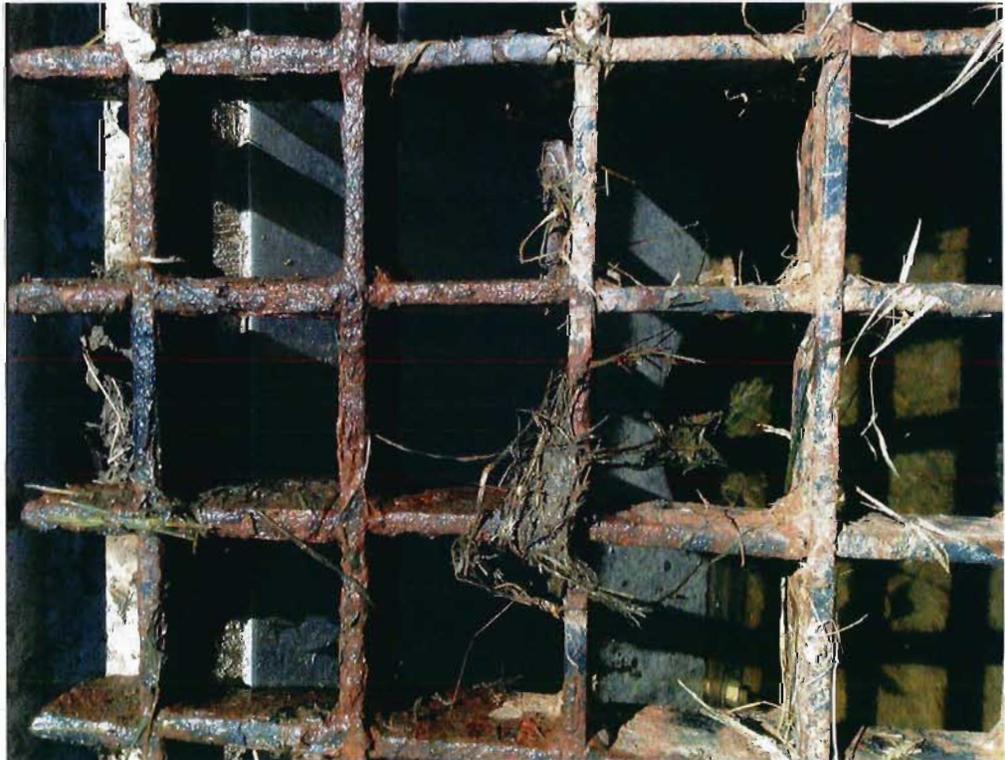
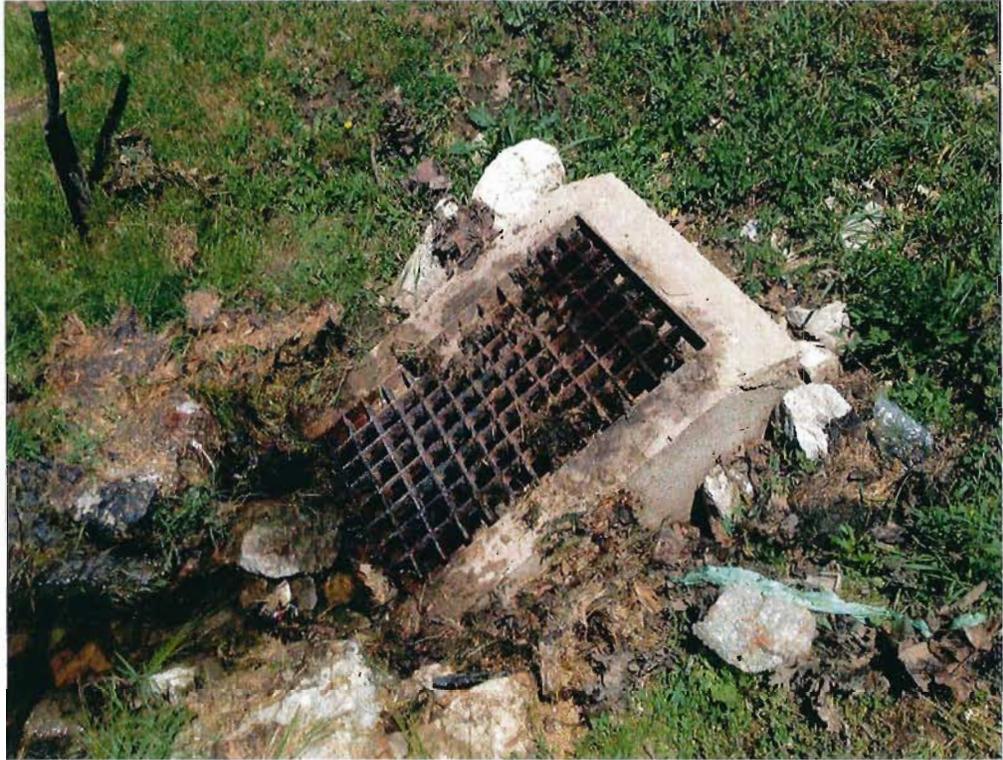
BRADFORD ESTATES

1. The designed water depth of the pond is 4 feet. The measured water depth in June of 2013 was approximately 3.5 feet. We conclude that the pond is starting to fill up with sediment.
2. The inlet and outlet pipes were inspected. There were loose grates on the outlet structure. There were also heavy grass clippings and plastic debris built up on the structures.
3. Sediment build-up averaged approximately 0.8 feet.
4. The whole pond perimeter had been mowed to the water's edge.

- \* BOWL DOWN SS GRATE ON OUPFL FLOW
- \* " " METAL WATER OUTLET (LOWE)
- \* LUMBS CLIPPINGS? PLASTIC DEBRIS

1. The water depth should be measured in 2018 to compare to the 2013 measurements. This will provide a comparable depth to determine the rate of sediment accumulation as well as an anticipated date for sediment removal.
2. The loose grates should be bolted down.
3. The structure grates should be cleaned regularly.
4. The City should consider dredging this small pond within the next five years.
5. Do not mow a narrow strip around the pond to improve safety.

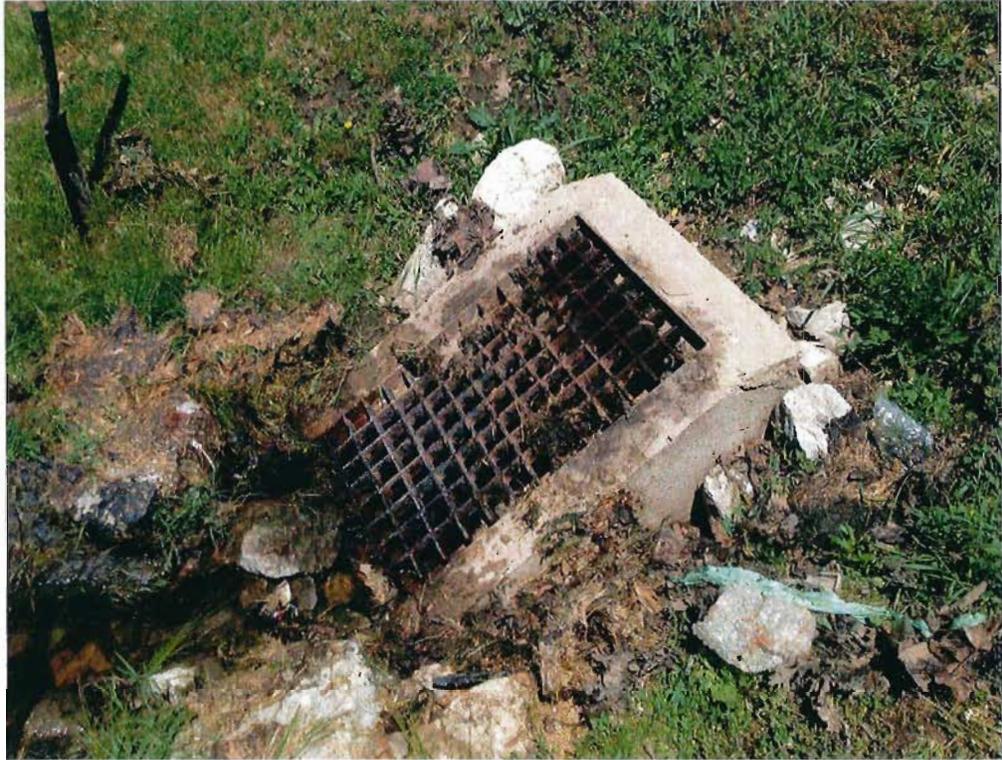
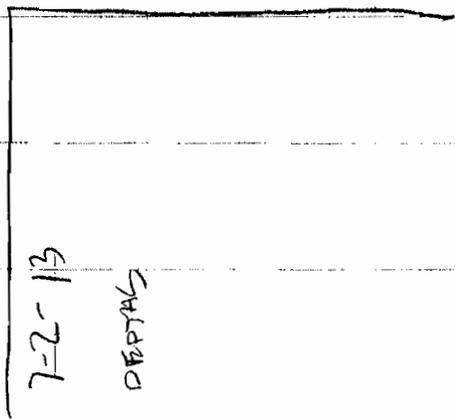
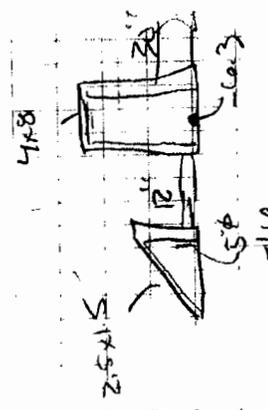
BRADFORD ESTATES

1. The designed water depth of the pond is 4 feet. The measured water depth in June of 2013 was approximately 3.5 feet. We conclude that the pond is starting to fill up with sediment.
2. The inlet and outlet pipes were inspected. There were loose grates on the outlet structure. There were also heavy grass clippings and plastic debris built up on the structures.
3. Sediment build-up averaged approximately 0.8 feet.
4. The whole pond perimeter had been mowed to the water's edge.

- \* BOWL DOWN SS GRATE ON OUPFL FLOW
- \* " " METAL WATER OUTLET (LOWE)
- \* LUMBS CLIPPINGS? PLASTIC DEBRIS

1. The water depth should be measured in 2018 to compare to the 2013 measurements. This will provide a comparable depth to determine the rate of sediment accumulation as well as an anticipated date for sediment removal.
2. The loose grates should be bolted down.
3. The structure grates should be cleaned regularly.
4. The City should consider dredging this small pond within the next five years.
5. Do not mow a narrow strip around the pond to improve safety.

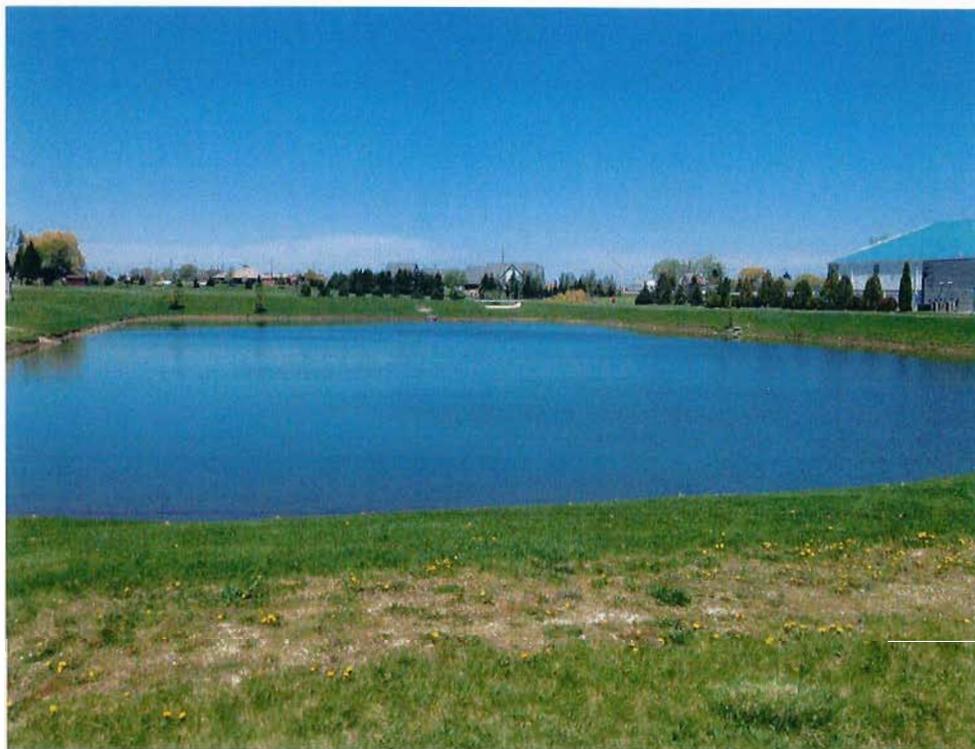
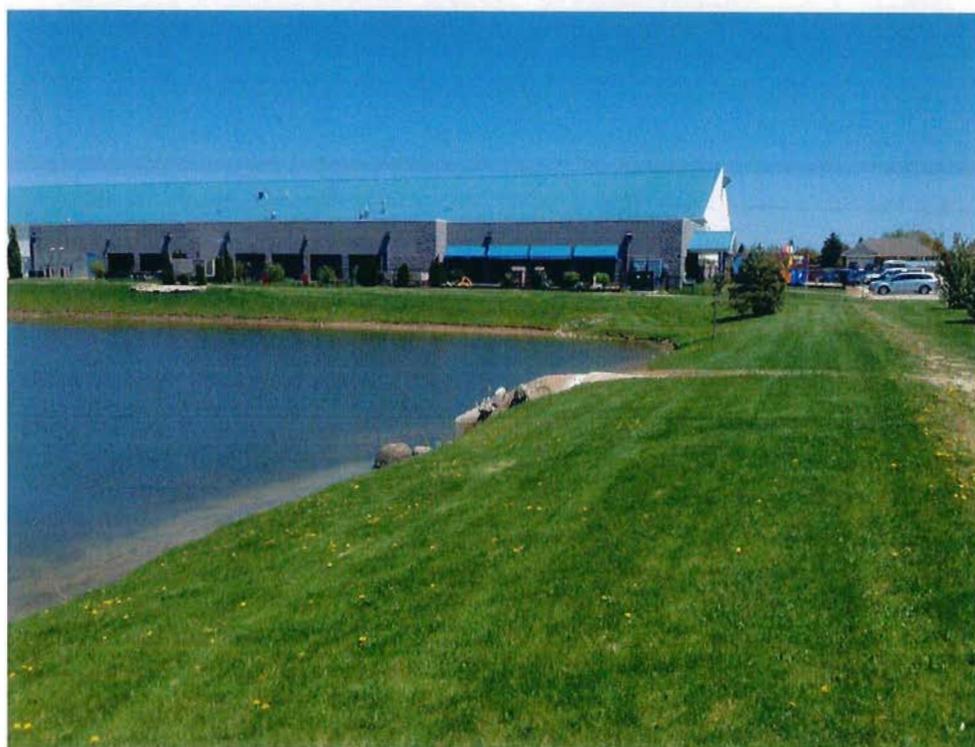
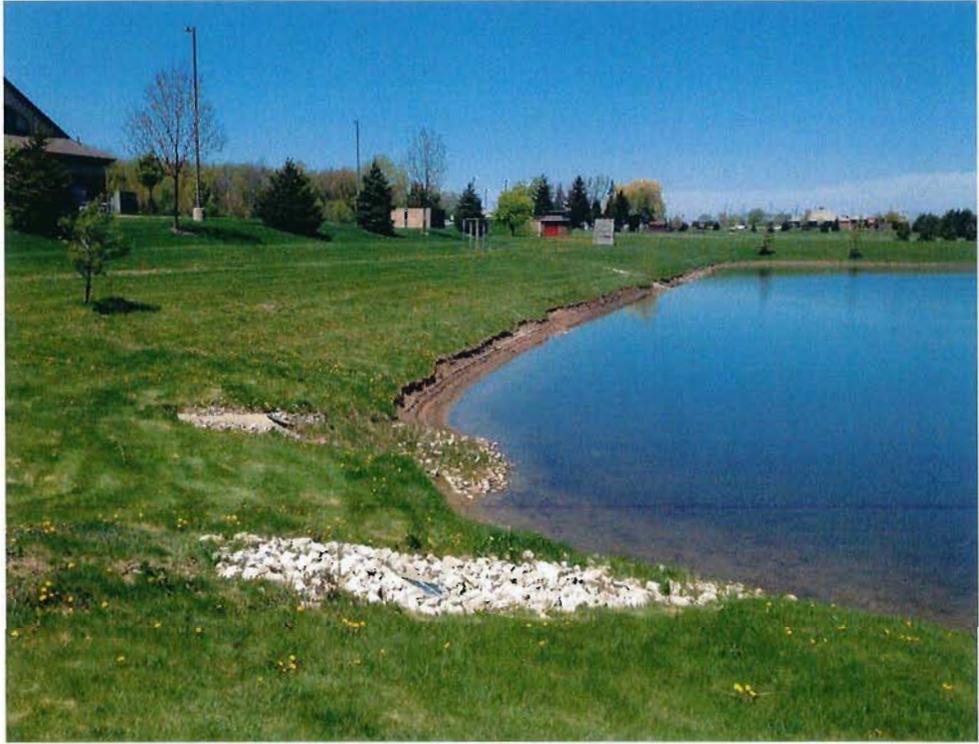
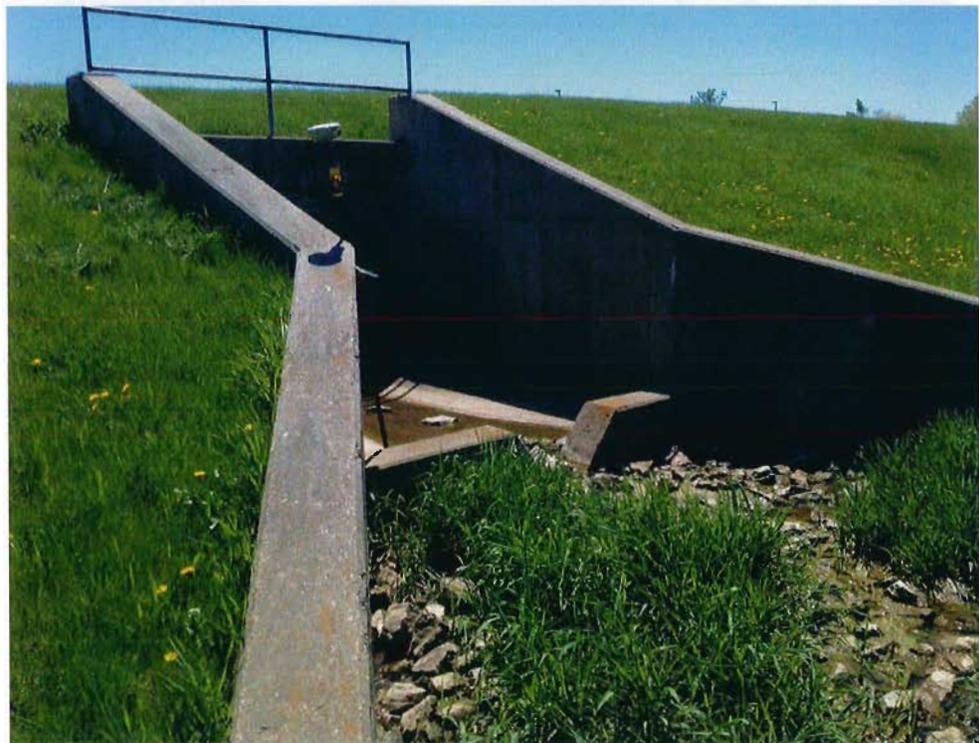
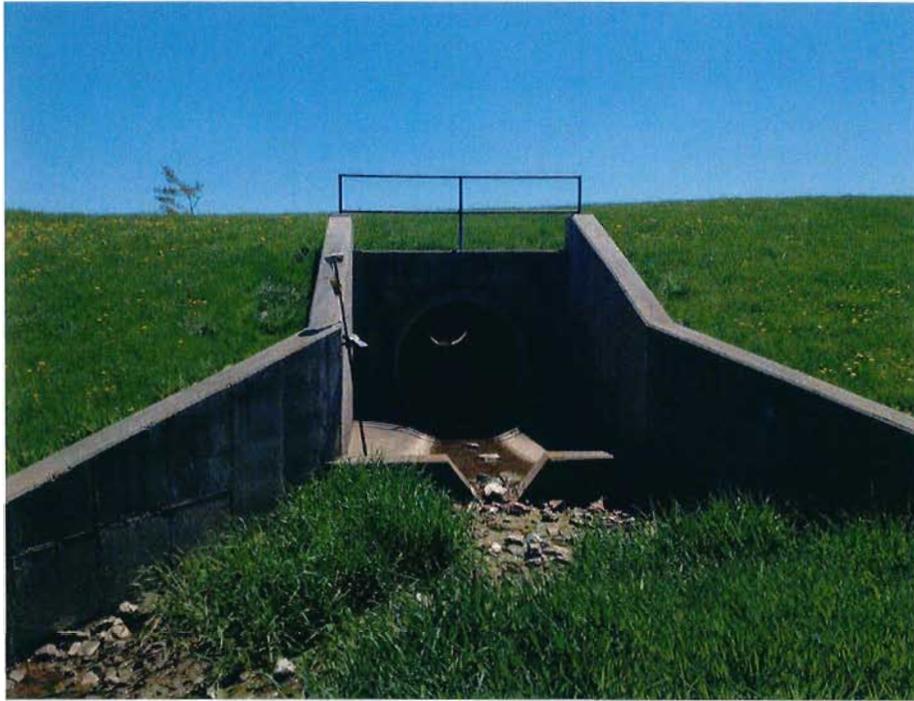
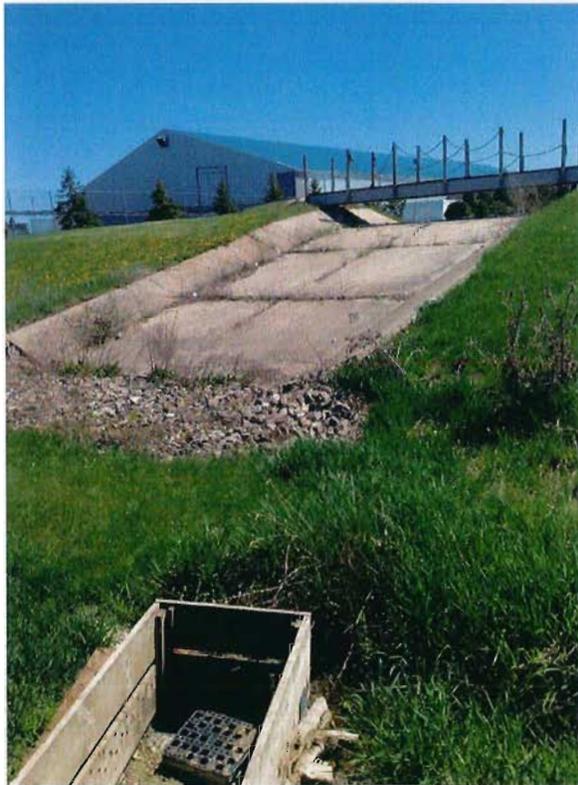
ANSSARI

1. The designed water depth of the pond is 5.7 feet. The measured water depth in July of 2013 varied between 4.7 and 7.7 feet. We conclude that the pond was over-excavated at the time of construction.
2. The inlet and outlet pipes were inspected and were found to be in fair structural condition. The bottom grate of the outlet structure is rusty. The end section on the 60" inlet is separated from the pipe.
3. Sediment build-up ranged between 0.2 and 0.5 feet.
4. The whole pond area is mowed. Some weeds and saplings are growing in the rip-rap areas near the structures.

- \* CURVE SEPARATE E TWO SECTIONS
- \* NEW LOWER LEAVE E CURVE STRUCT.
- \* RE-ATTACH LD" FRS

1. The water depth should be measured in 2018 to compare to the 2013 measurements. This will provide a comparable depth to determine the rate of sediment accumulation as well as an anticipated date for sediment removal.
2. The bottom grate of the outlet structure should be replaced.
3. Reattach the end section of the 60" inlet to the pipe.
4. When mowing, leave a grassy strip around the pond to deter geese and improve safety.

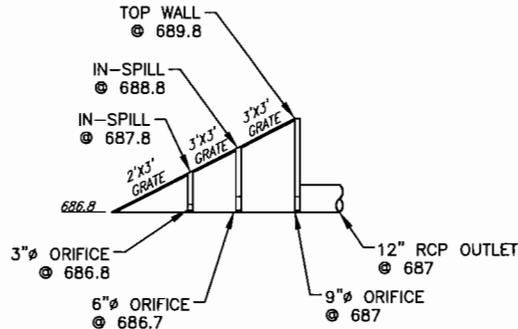
- OUTLET STRUCTURE (3 BAY)
- 2'x3' LOWER GRATED OPENING I.E. @ 686.8
  - 3"Ø ORIFICE @ 686.8
  - 3'x3' GRATED OPENING IN-SPILL @ 687.8
  - 6"Ø ORIFICE @ 686.7
  - 3'x3' GRATED OPENING IN-SPILL @ 688.8
  - 9"Ø ORIFICE @ 687
  - TOP WALL @ 689.8
  - 12" RCP OUTLET @ 687

1. The water depth should be measured in 2018 to compare to the 2013 measurements. This will provide a comparable depth to determine the rate of sediment accumulation as well as an anticipated date for sediment removal.
2. The trees around the outlet structure and spillway should be removed.
3. The drainage problem could be alleviated by dredging the swale to the railroad culvert approximately 50 feet away.

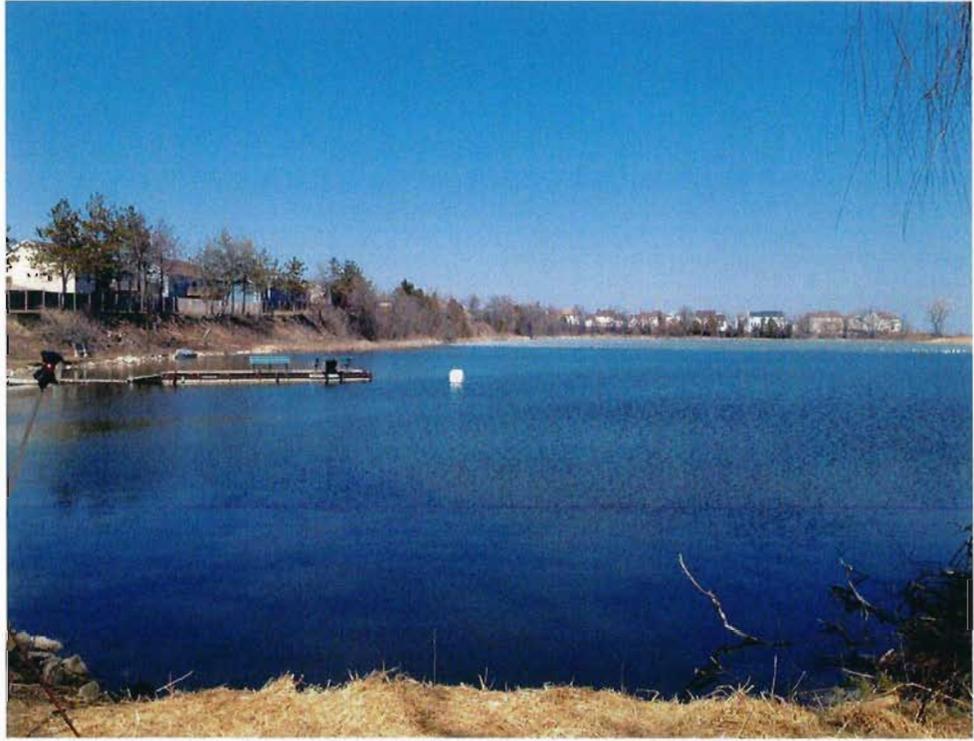
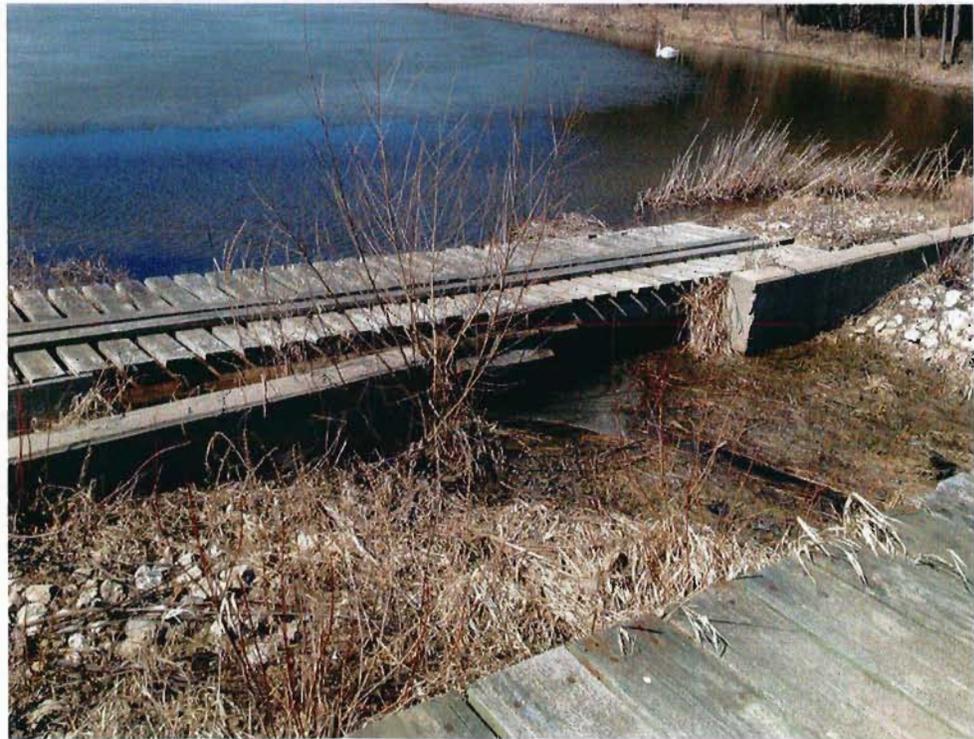
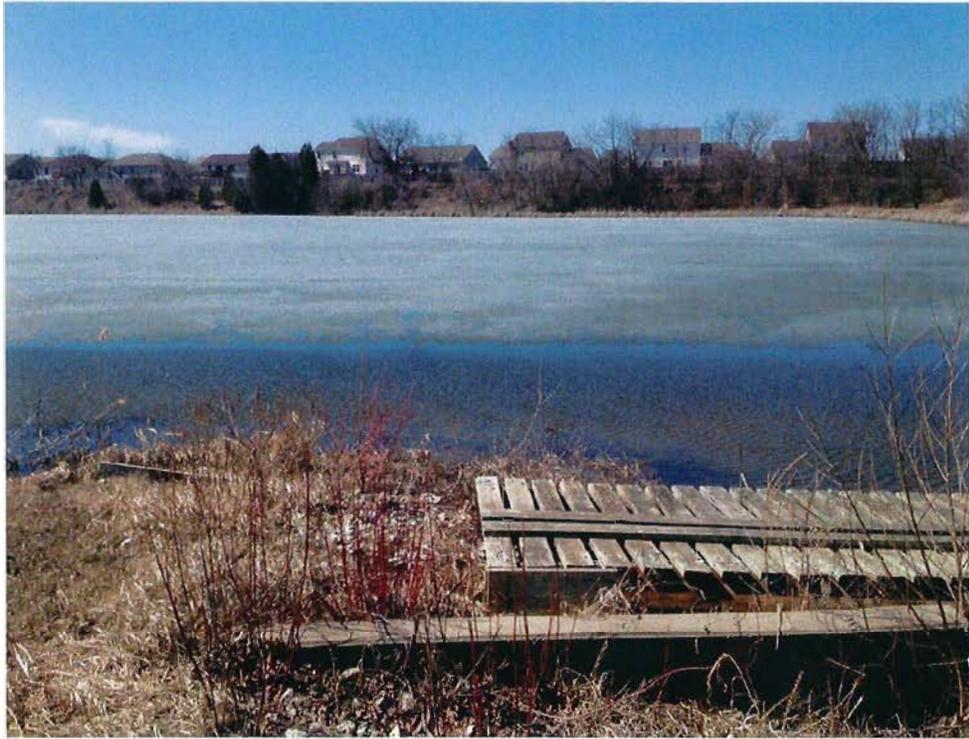
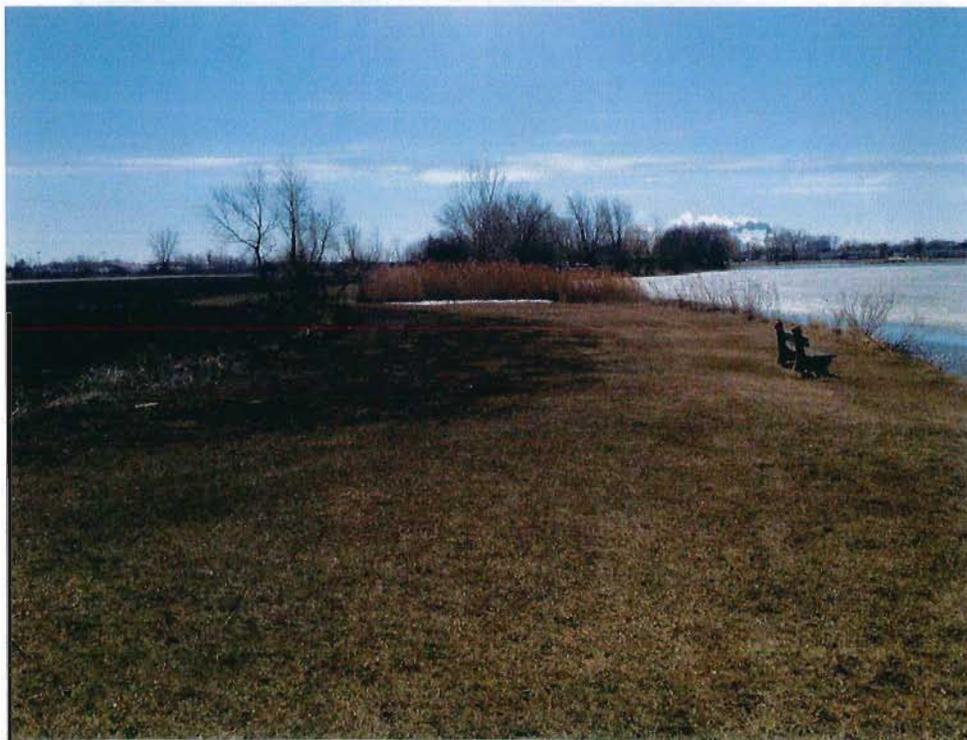
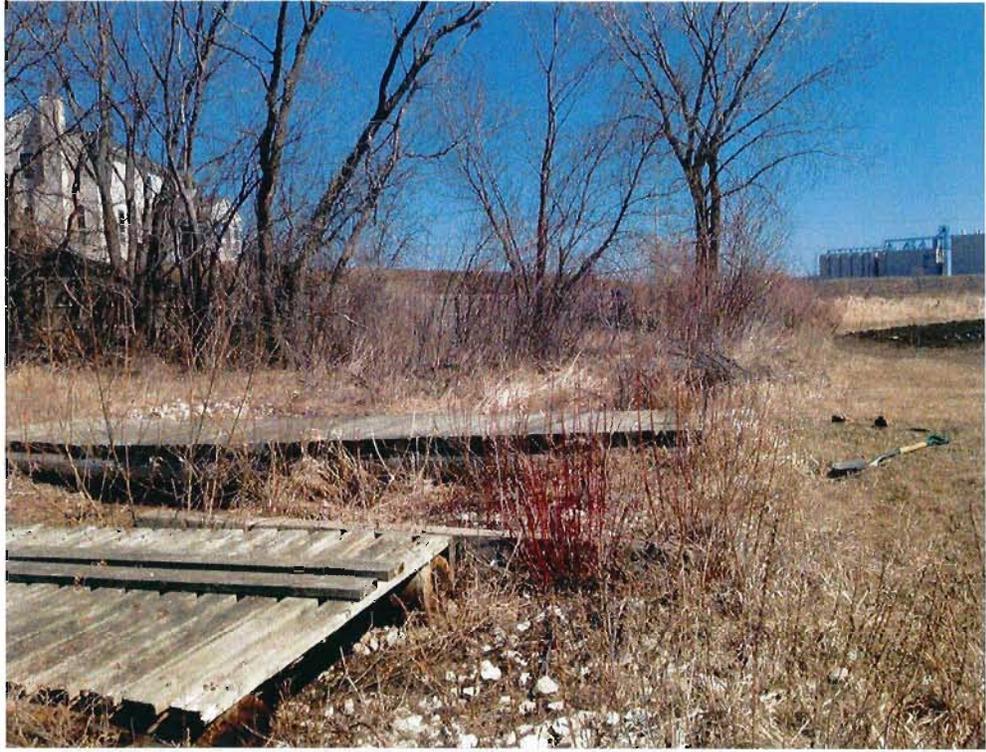
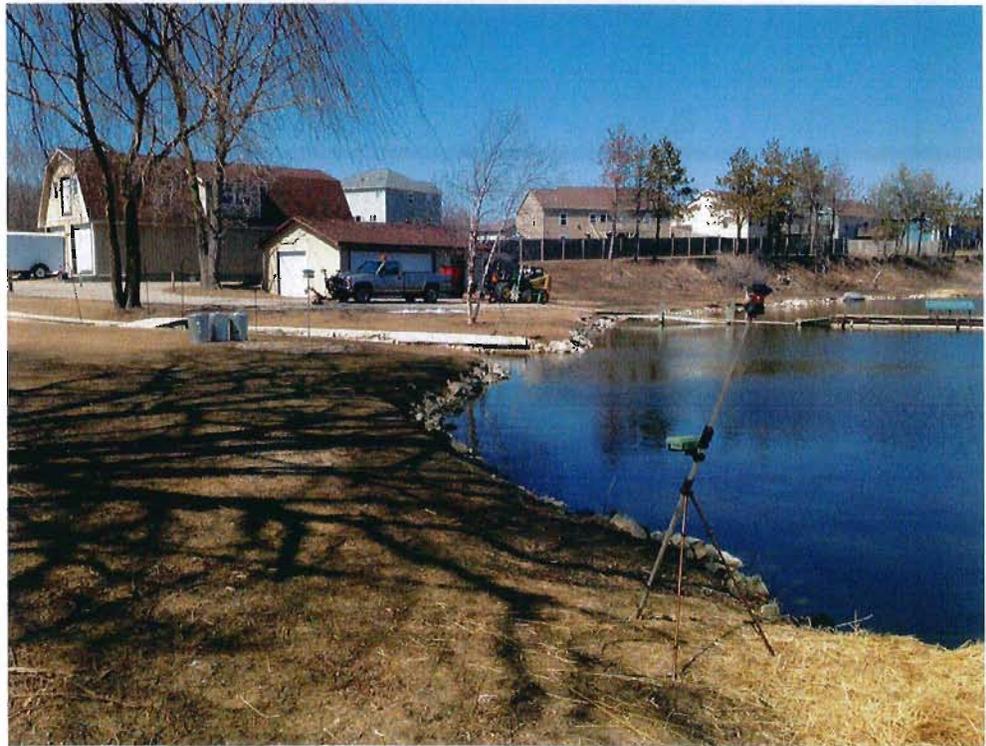
**PRAIRIE LAKE ESTATES (HEIBERG)**

1. The designed water depth of the pond is unknown. The plans do not show the elevation of the outlet or the bottom of the pond. The measured water depth in July of 2013 varied widely between 4.7 and 16.0 feet.
2. The inlet and outlet structures were inspected and were found to be in fair condition.
3. Sediment build-up varied between 0 and 2.0 feet.
4. Portions of the pond perimeter are mowed to the water's edge. Cattails and brush have grown up around the edge in other areas. The rip-rap area near the outlet is heavily vegetated.
5. 0.9 feet of water was above the weir, indicating that the downstream channel might be clogged.

1. The water depth should be measured in 2018 to compare to the 2013 measurements. This will provide a comparable depth to determine the rate of sediment accumulation as well as an anticipated date for sediment removal.
2. The vegetation within the rip-rap and around the outlet should be cleared out and the structures cleaned of debris. The downstream channel should be checked for clogging or a possible obstruction.
3. When mowing, leave a grassy strip around the pond to deter geese and improve safety.
4. Light maintenance is required at the weir.
