# 2013 Ponds Certifications

City of Kenosha, Wisconsin

July 9, 2014

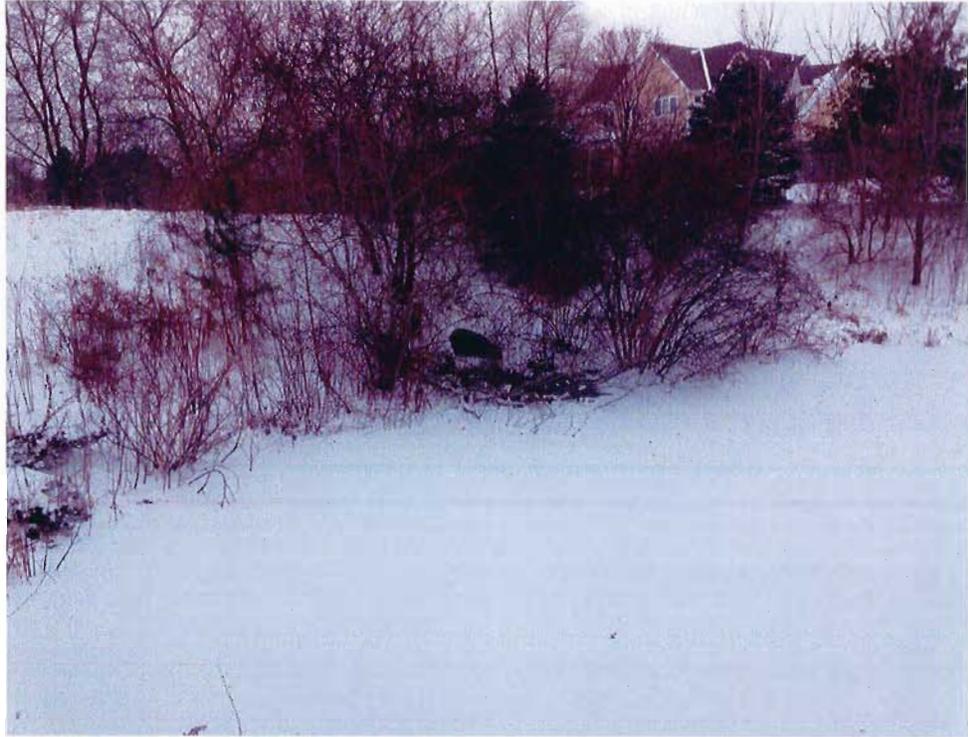
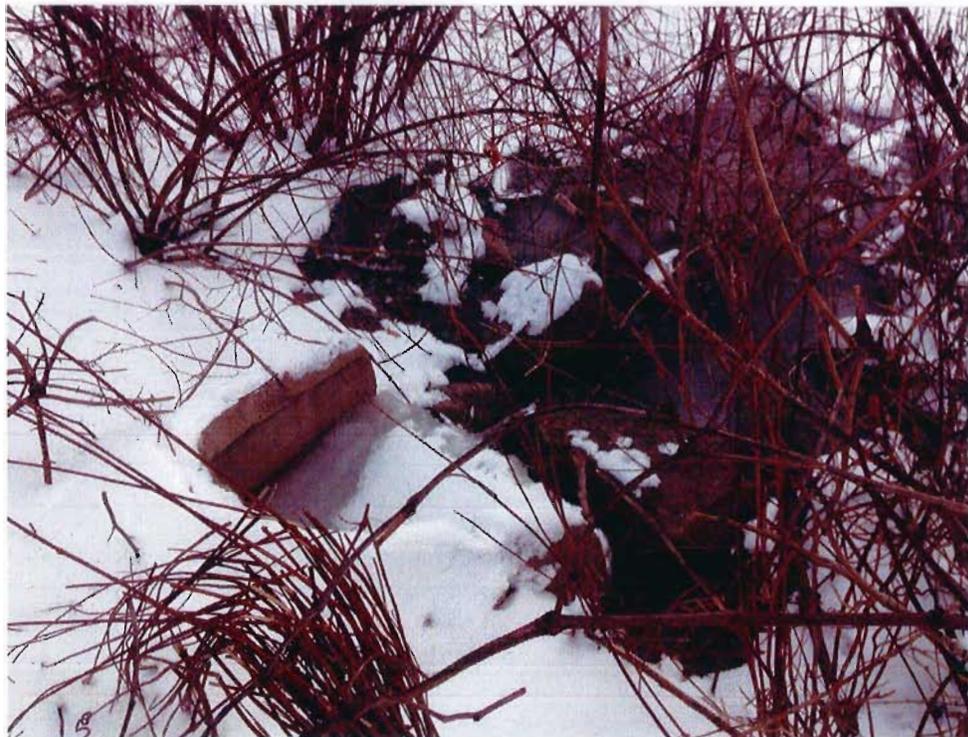
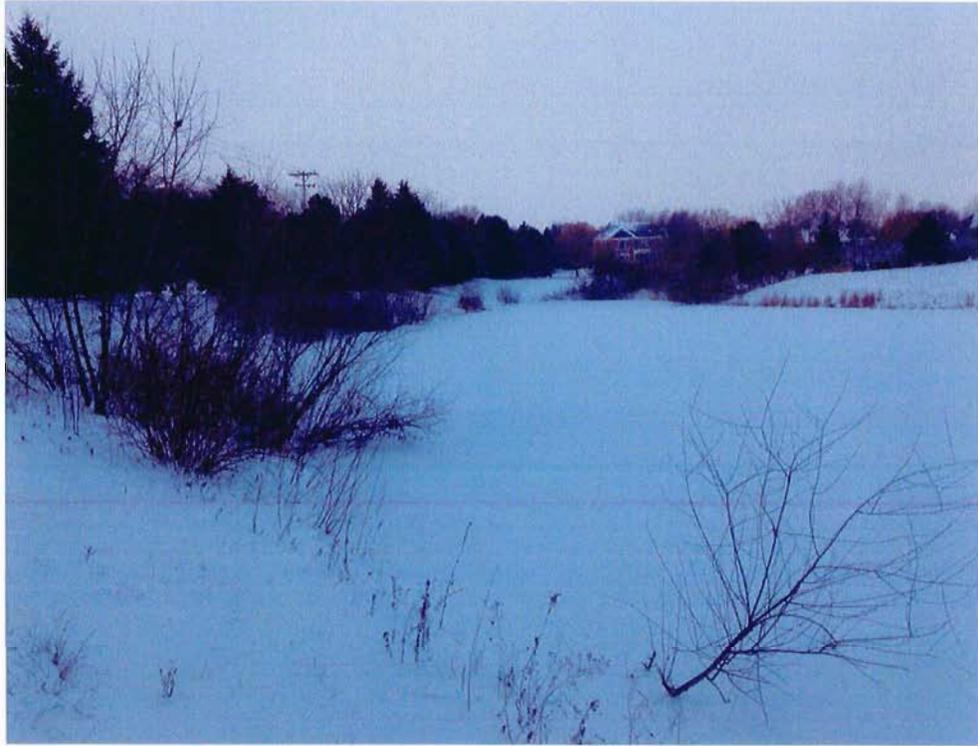
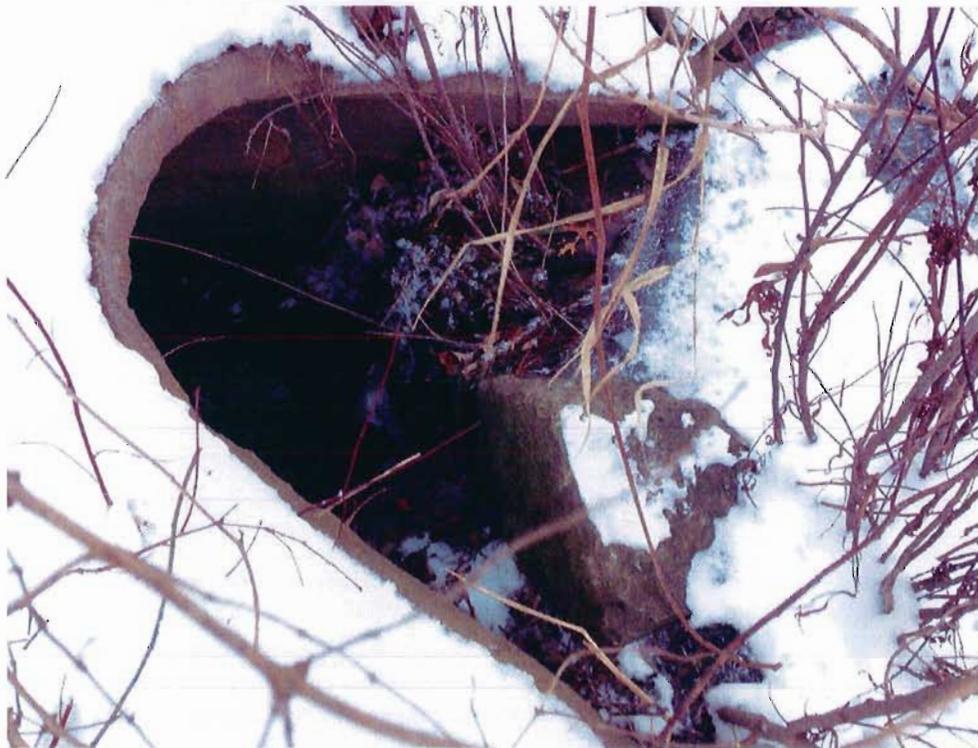
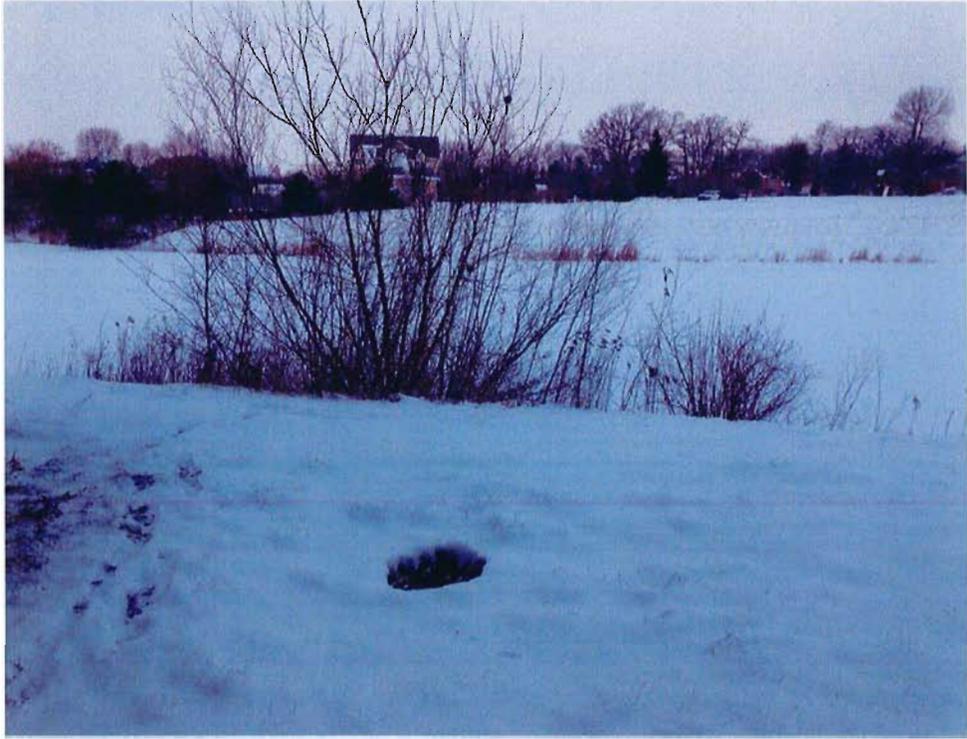
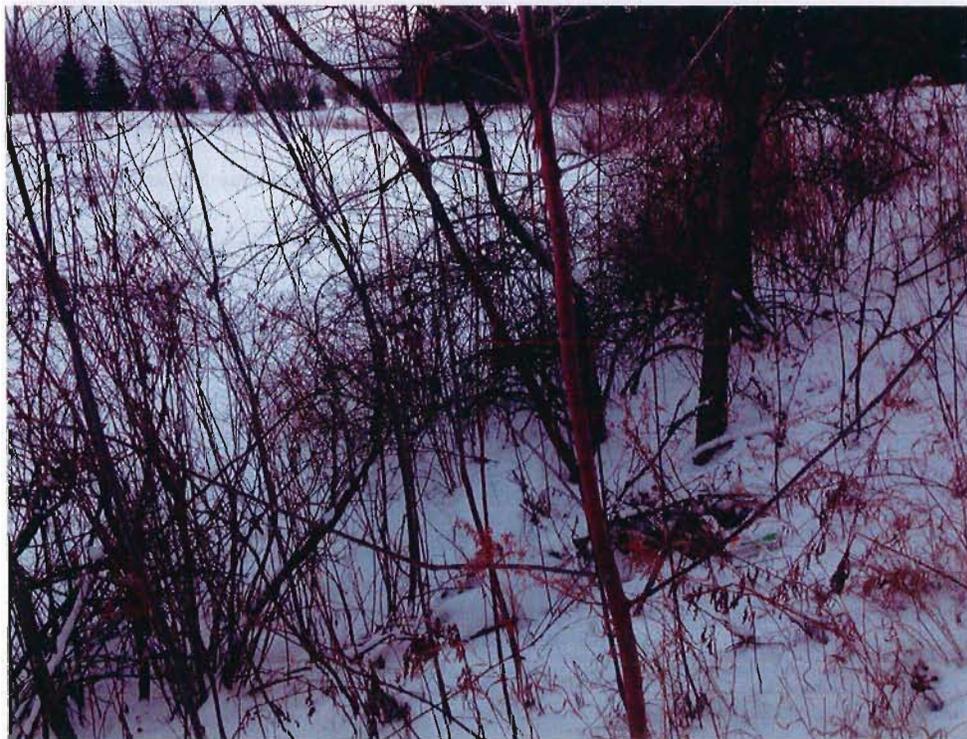
Year Constructed	Design Water Depth	Measured Water Depth	Next Recommended Water Depth Measurement
1991	12	9.1 – 13.6	2018

1. The water depth should be measured in 2018 to compare to the 2013 measurements. This will provide a comparable depth to determine the rate of sediment accumulation as well as an anticipated date for sediment removal.
2. The inlet structure should be repaired and reattached to the adjacent pipe.
3. The eroded channels should be repaired.
4. The cattails and willows should be cleared, especially from the structures.

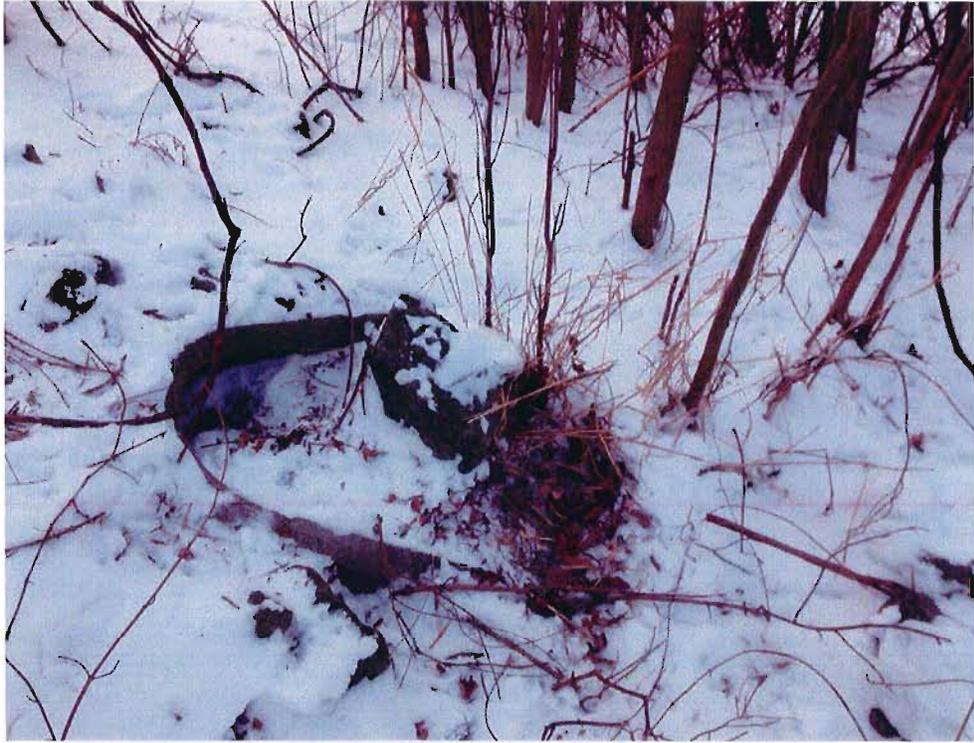
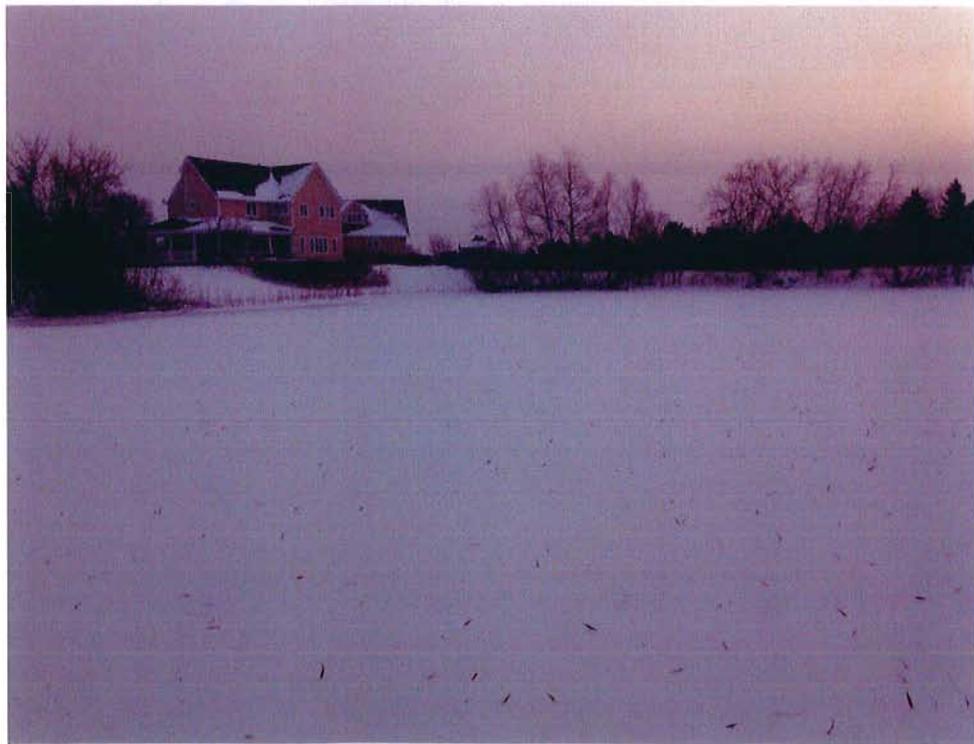
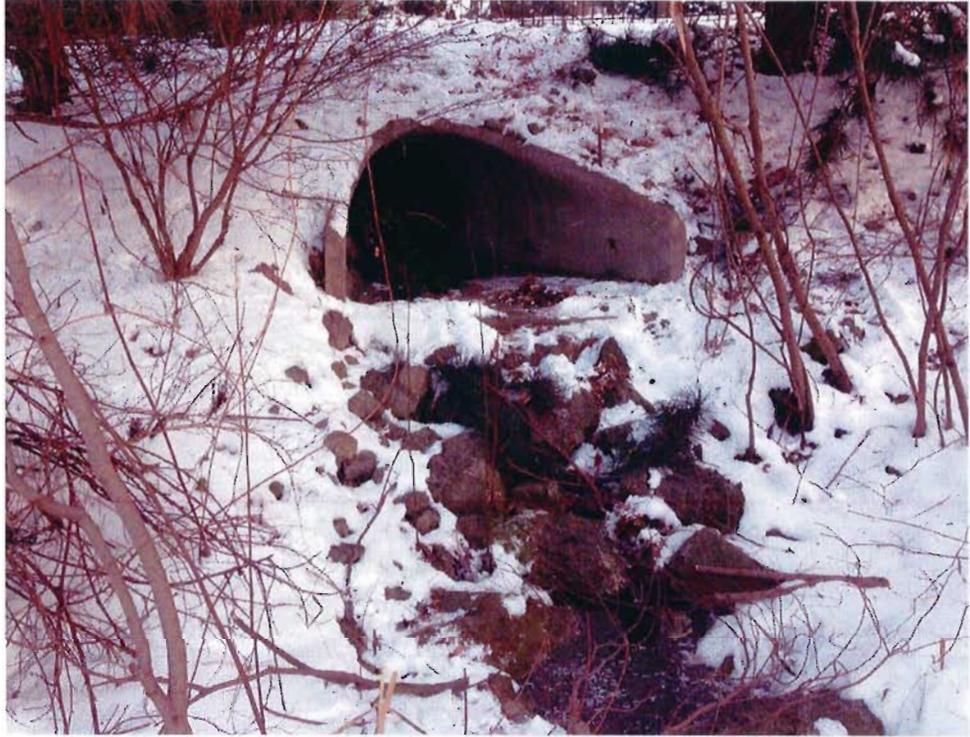
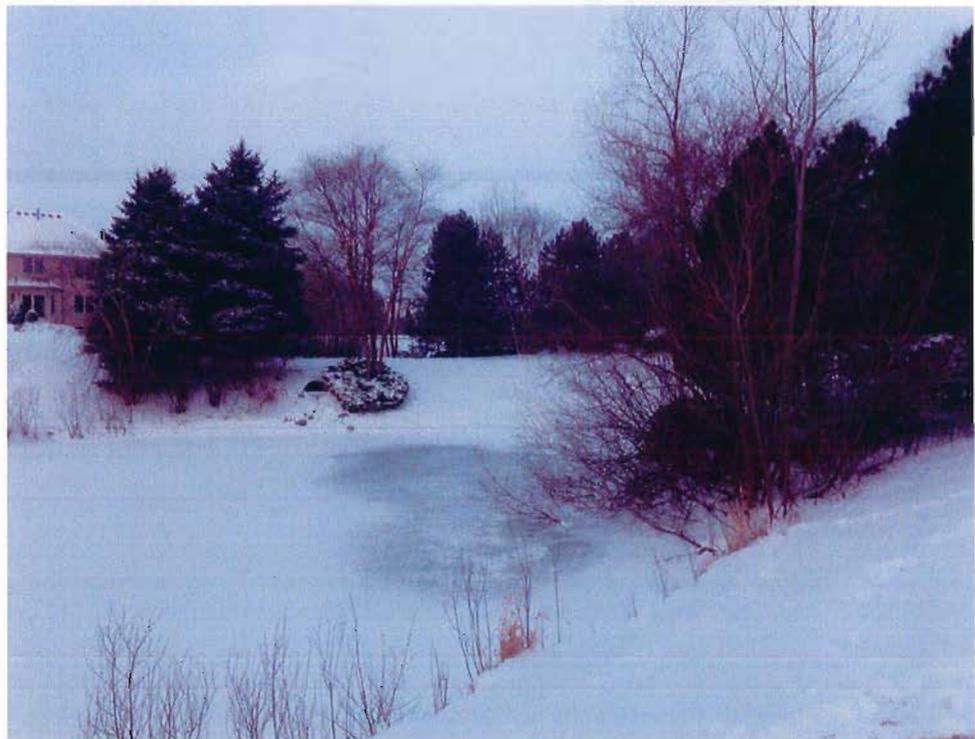
Year Constructed	Design Water Depth	Measured Water Depth	Next Recommended Water Depth Measurement
1991	12	10.4	2018

1. The water depth should be measured in 2018 to compare to the 2013 measurements. This will provide a comparable depth to determine the rate of sediment accumulation as well as an anticipated date for sediment removal.
2. All the separating end sections should be repaired and reattached to the adjacent pipes.
3. The willows and trees should be cleared, especially from the structures.
4. The function of the inlets and outlet should be checked to determine the cause of the low water level.

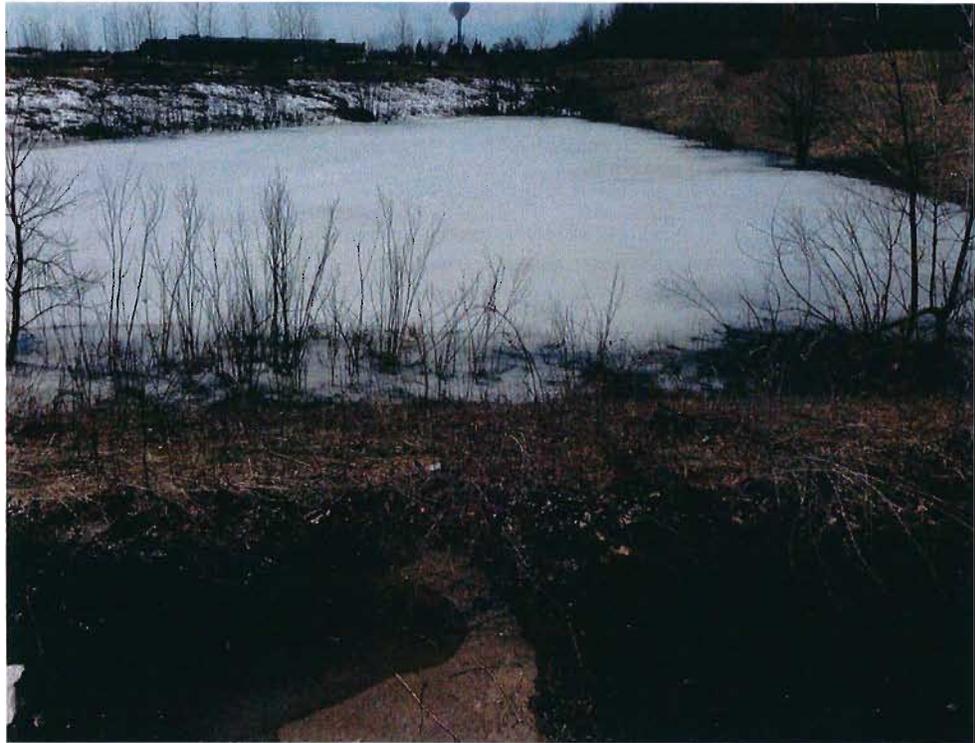
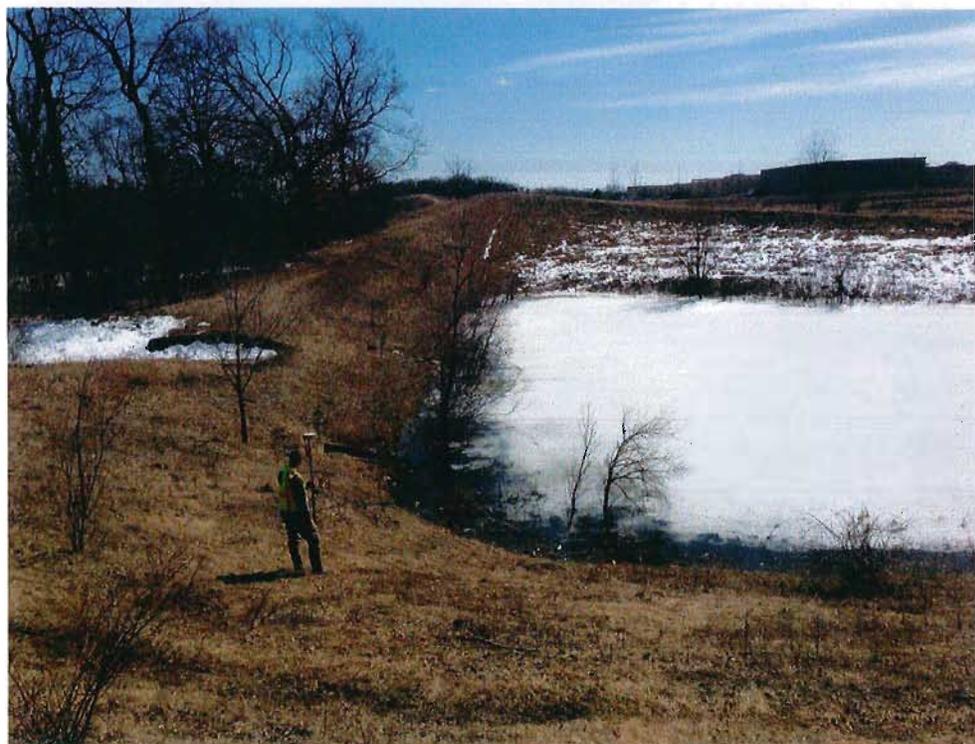
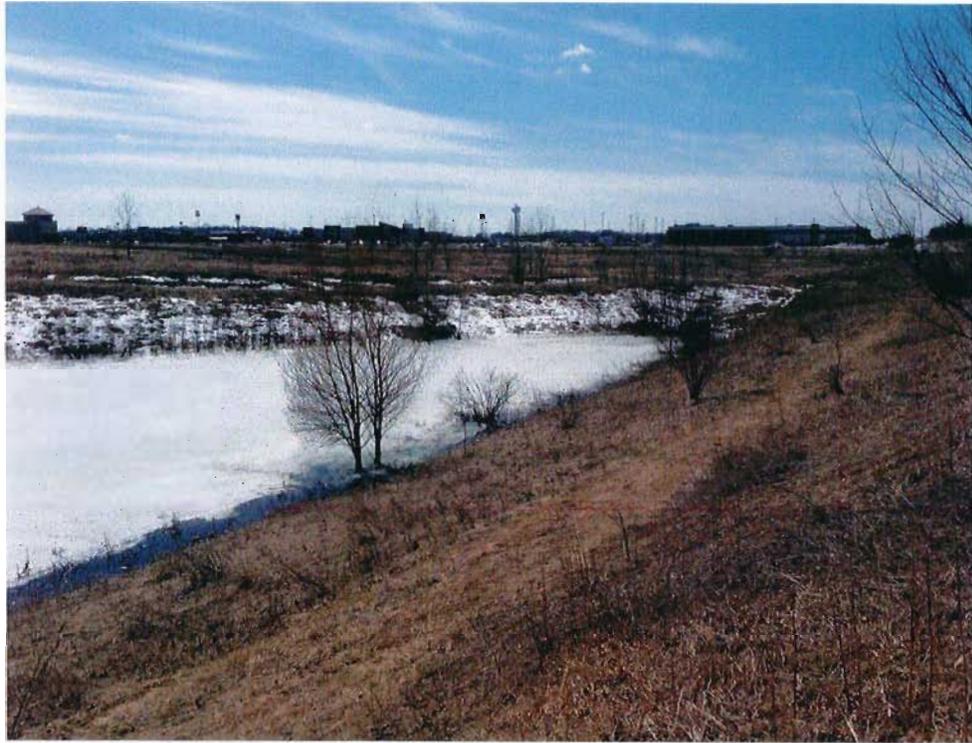
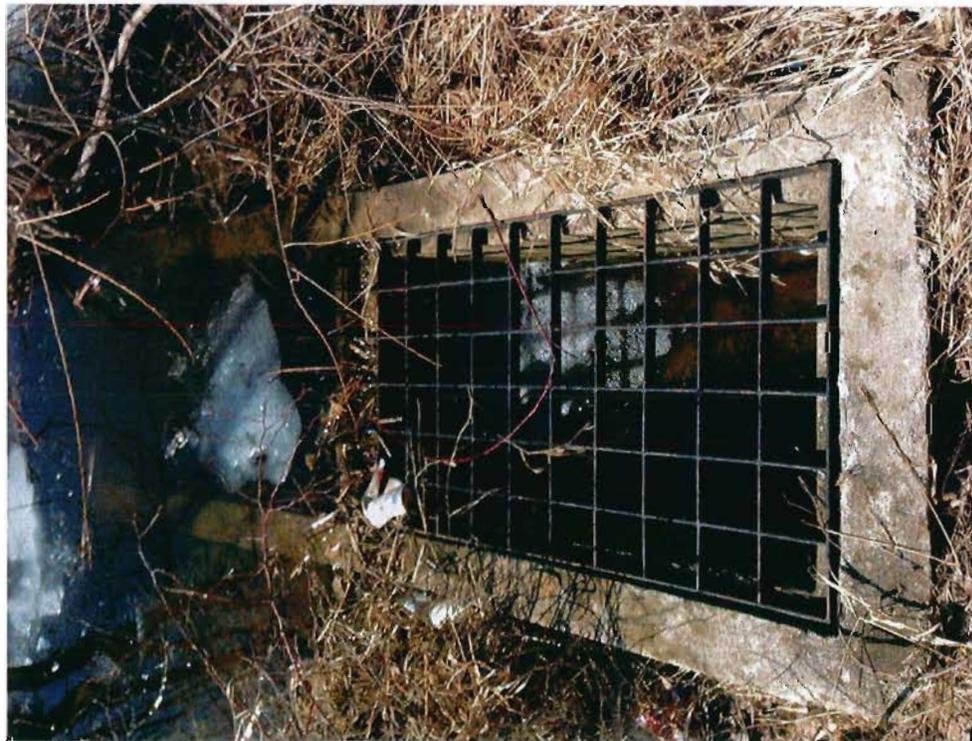
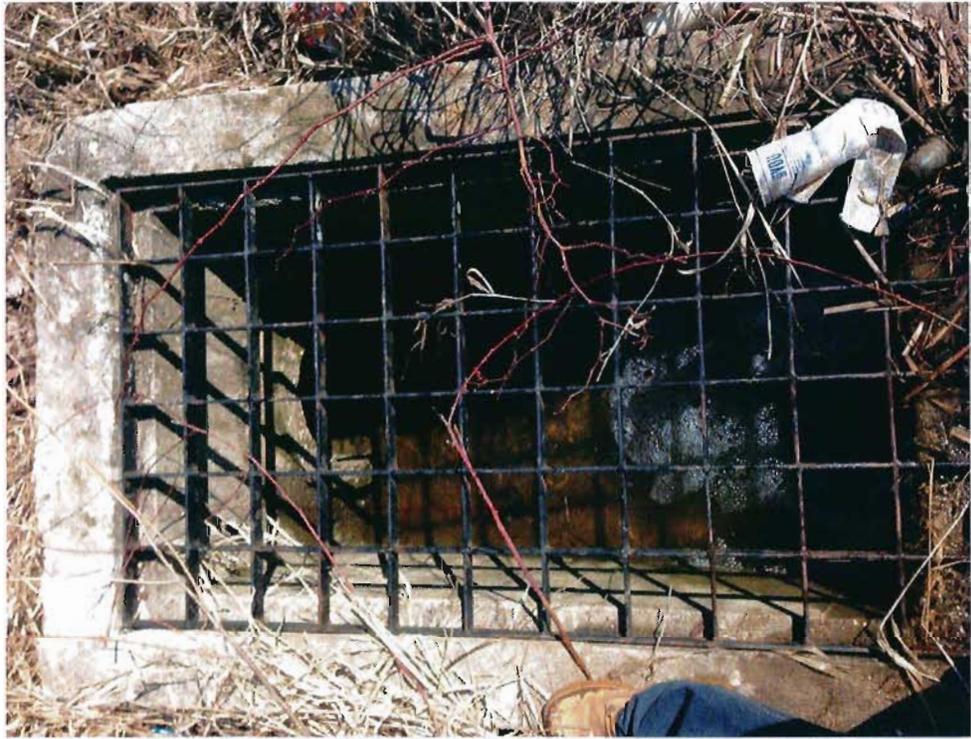
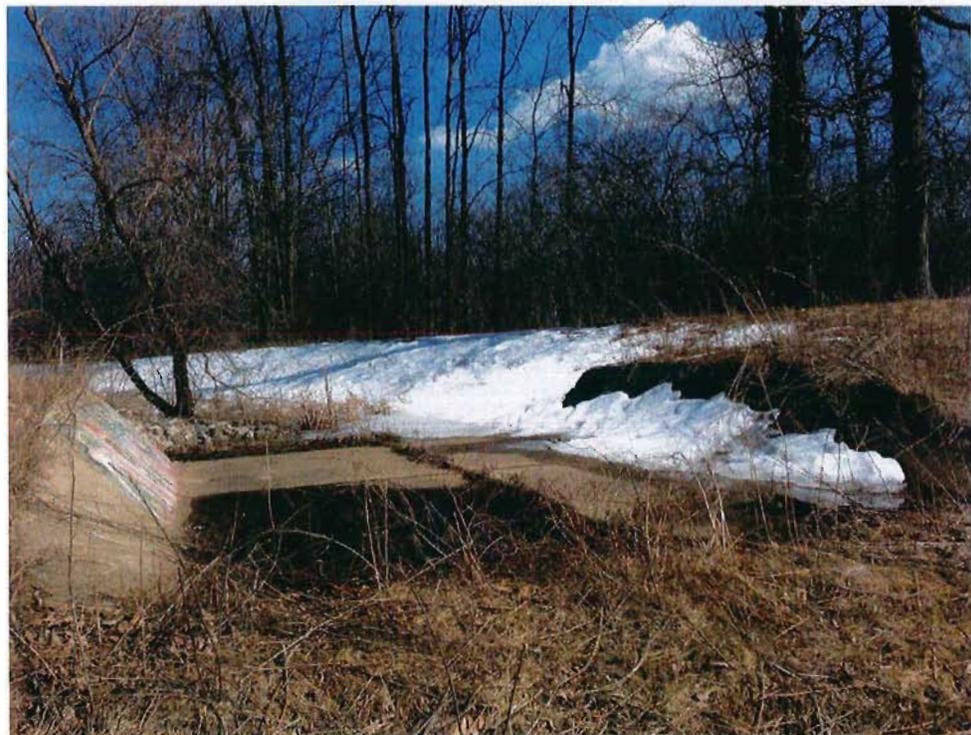
1. The designed water depth of the pond is 4 feet; the design plans are not clear. The measured water depth in June of 2013 varied between 4.8 and 5.4 feet.
2. The inlet and outlet pipes were inspected and were found to be in good structural condition.
3. Sediment build-up varied between 0.4 and 1.1 feet.
4. Vegetation has grown up around the outlets and certain other areas of the pond.
5. The water level was high, indicating that the outlet might be plugged.
6. The water was cloudy, likely due to the nearby construction.

1. The water depth should be measured in 2018 to compare to the 2013 measurements. This will provide a comparable depth to determine the rate of sediment accumulation as well as an anticipated date for sediment removal.
2. The vegetation should be cleared, especially around the outlets.
3. The outlet structure should be cleaned to remove a possible blockage.
4. Perform routine mowing, maintenance, and clean-up at the pond.

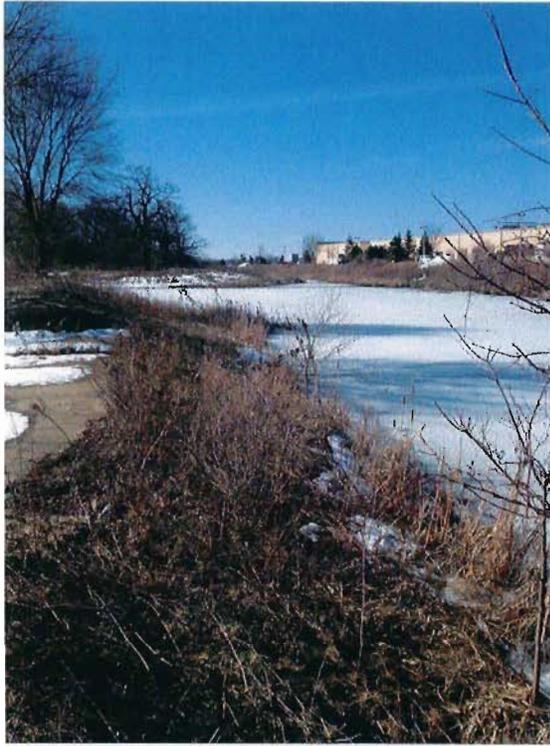
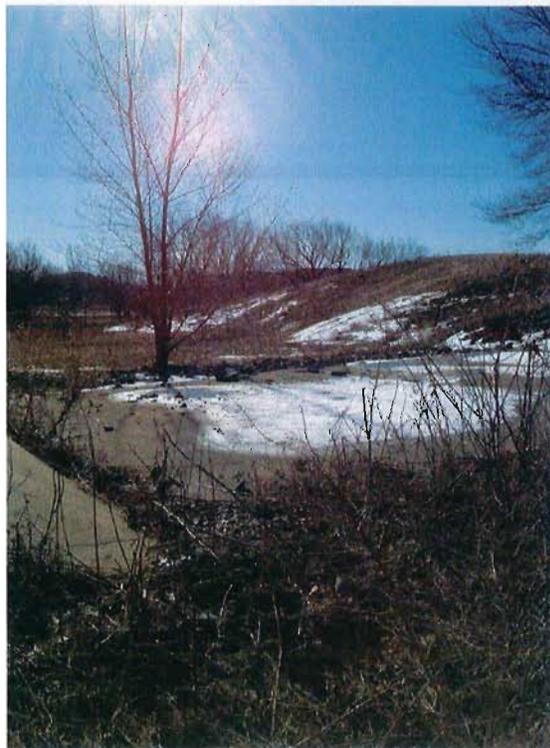
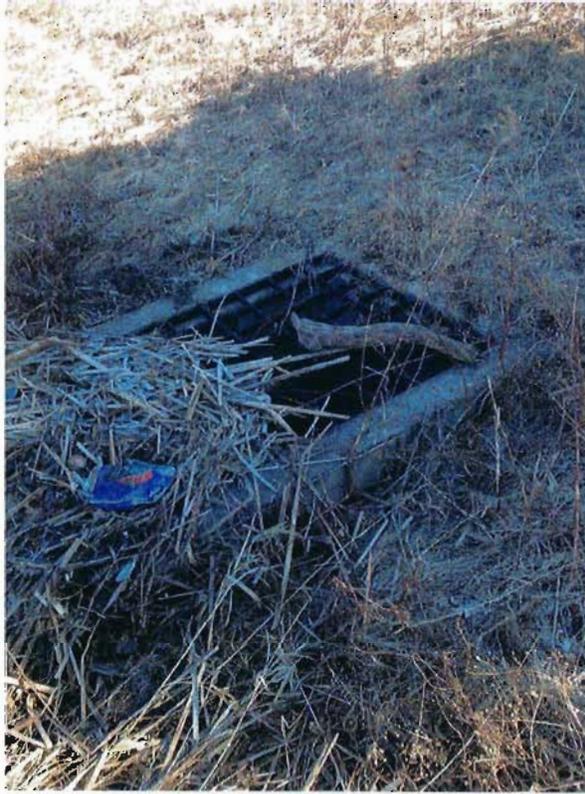
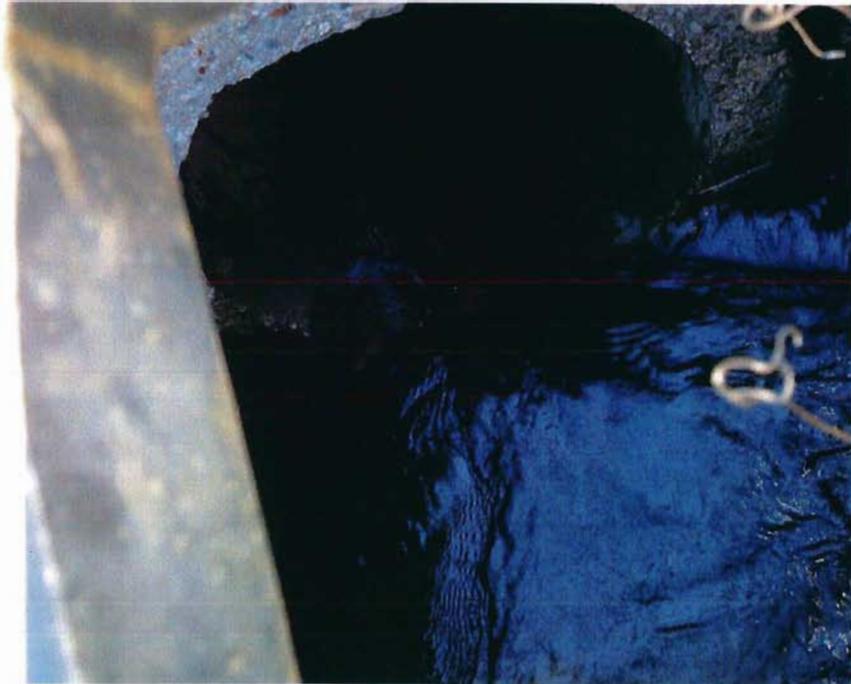
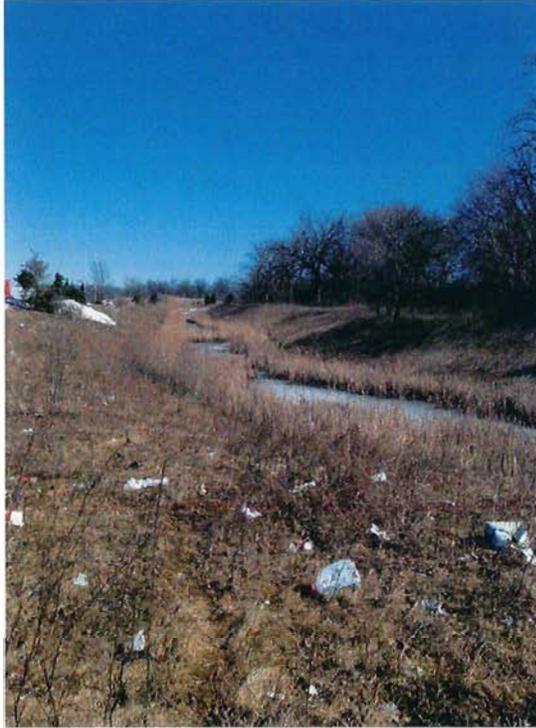
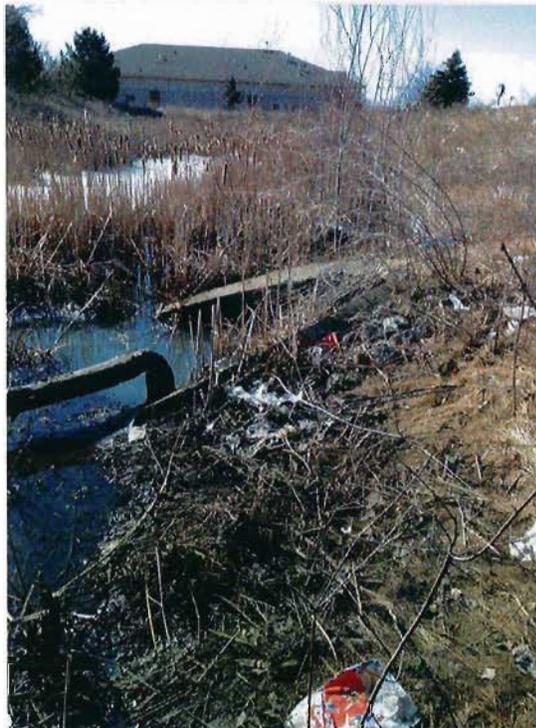
1. The designed water depth of the pond is approximately 4 feet; the design plans are not clear. The measured water depth in Spring of 2013 varied between 4.8 and 5.9 feet.
2. The inlet and outlet pipes were inspected and were found to be in good structural condition.
3. Sediment build-up varied between 0 and 0.8 feet.
4. The outlet was plugged with dirt and vegetation.
5. There is moderate willow and cattails growth around the majority of the pond, including the inlet and outlet structures.
6. The pond contains muskrats and showed signs of past beaver activity.
7. Trash is scattered all around the pond area.

1. The water depth should be measured in 2018 to compare to the 2013 measurements. This will provide a comparable depth to determine the rate of sediment accumulation as well as an anticipated date for sediment removal.
2. The pond should be dredged at the south end and near the outlet structures.
3. The vegetation should be cleared, especially around the structures.
4. Routine mowing and clean-up should be performed.

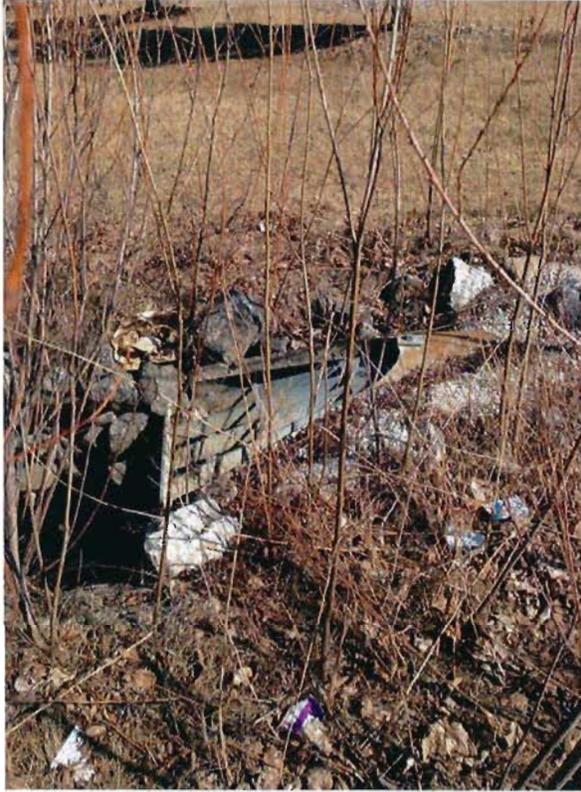
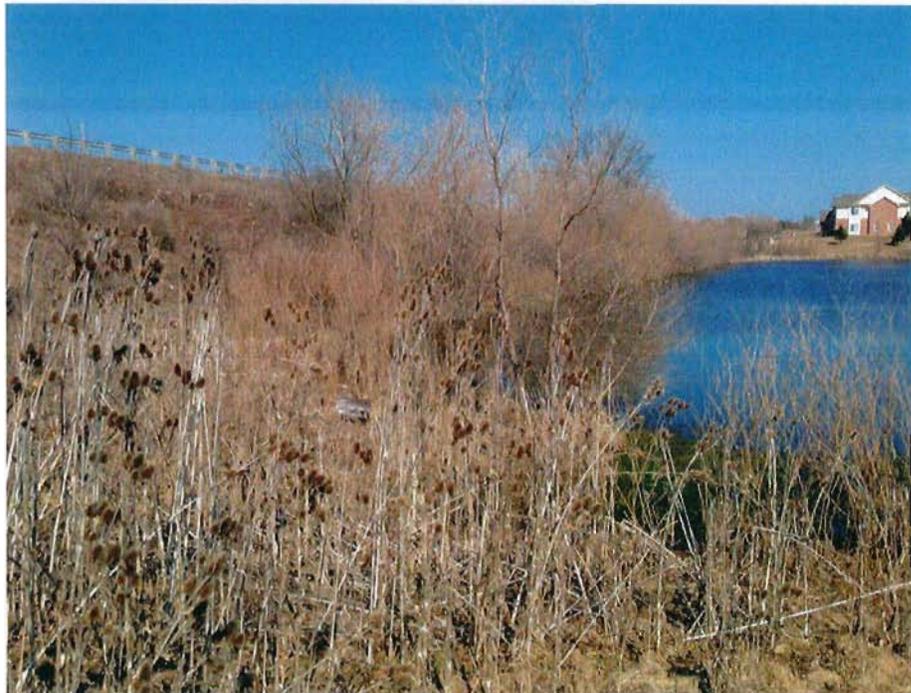
1. The designed water depth of the pond is 4 feet at the east end and 8 feet at the west end. The measured water depth in July of 2013 varied between 4.2 and 6.7 feet. We conclude that sediment is starting to build up in this pond.
2. The inlet and outlet pipes were inspected and were found to be in good structural condition. Some rip-rap areas have been washed out.
3. Sediment build-up varied between 0.6 and 1.2 feet.
4. There is thick vegetation growing around the perimeter of the pond, including in the rip-rap areas near the inlet and outlet structures.
5. Pond scum covered the entire pond during the July inspection.

1. The water depth should be measured in 2018 to compare to the 2013 measurements. This will provide a comparable depth to determine the rate of sediment accumulation as well as an anticipated date for sediment removal.
2. The vegetation within and surrounding the inlet and outlet structures should be cleared.
3. When mowing, leave a grassy strip around the perimeter of the pond to deter geese and improve safety.
4. The washed-out rip-rap areas should be repaired.
