# 2013 Ponds Certifications

City of Kenosha, Wisconsin

July 9, 2014

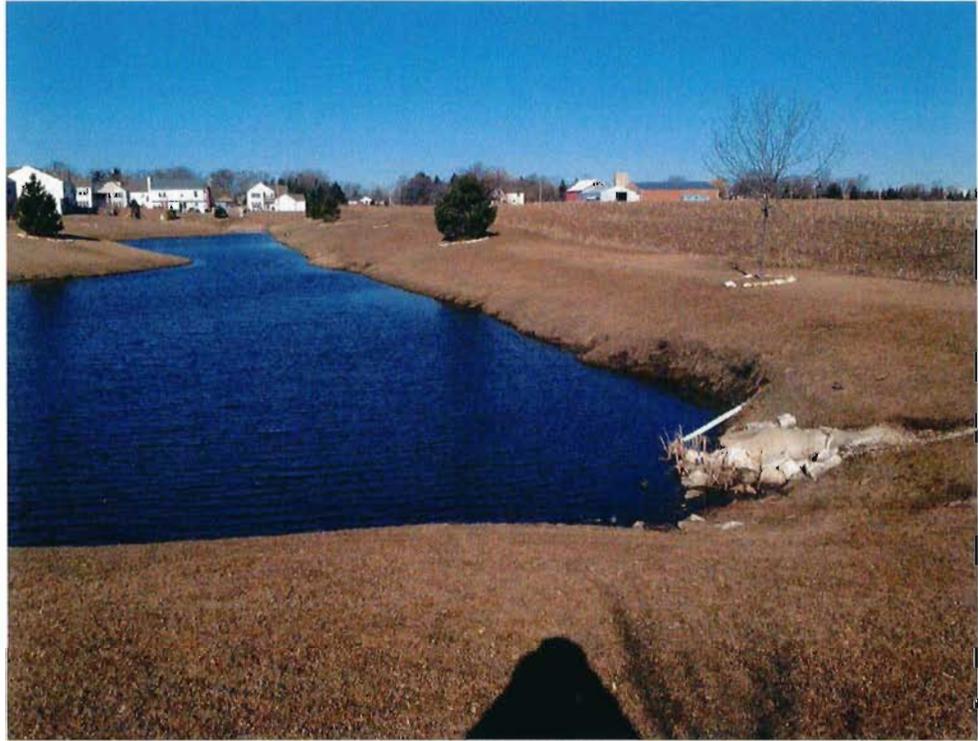
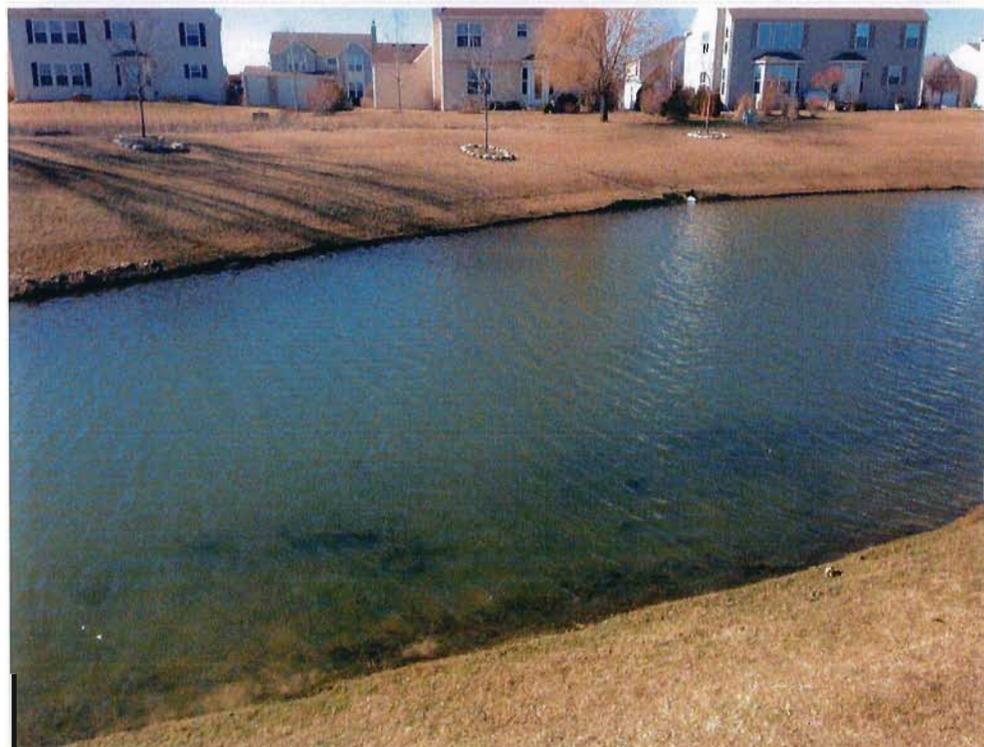
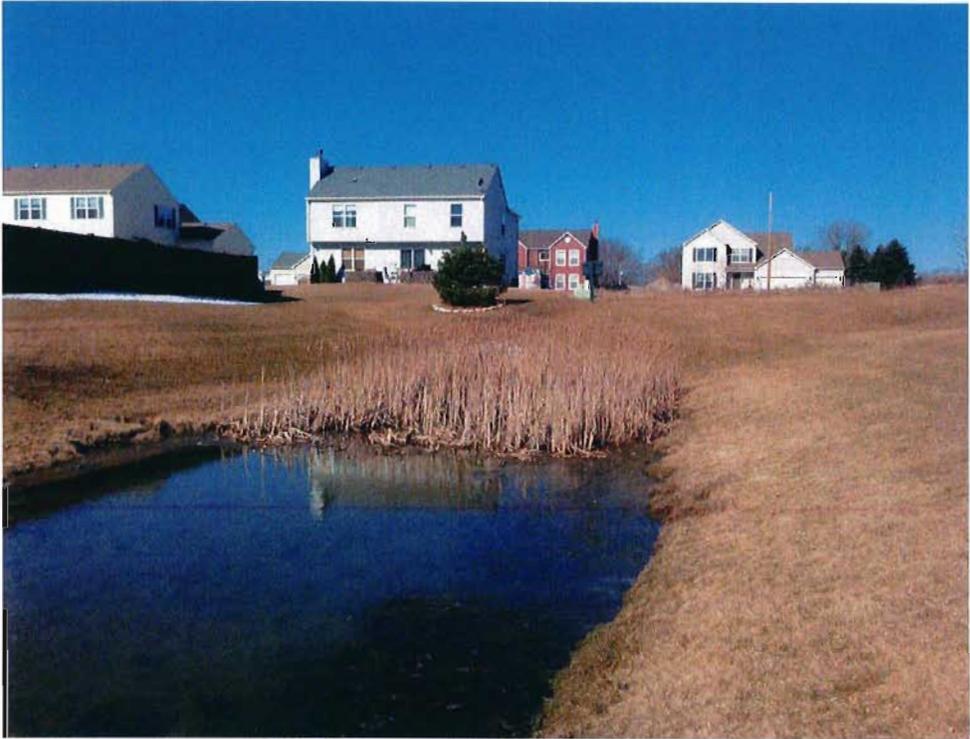
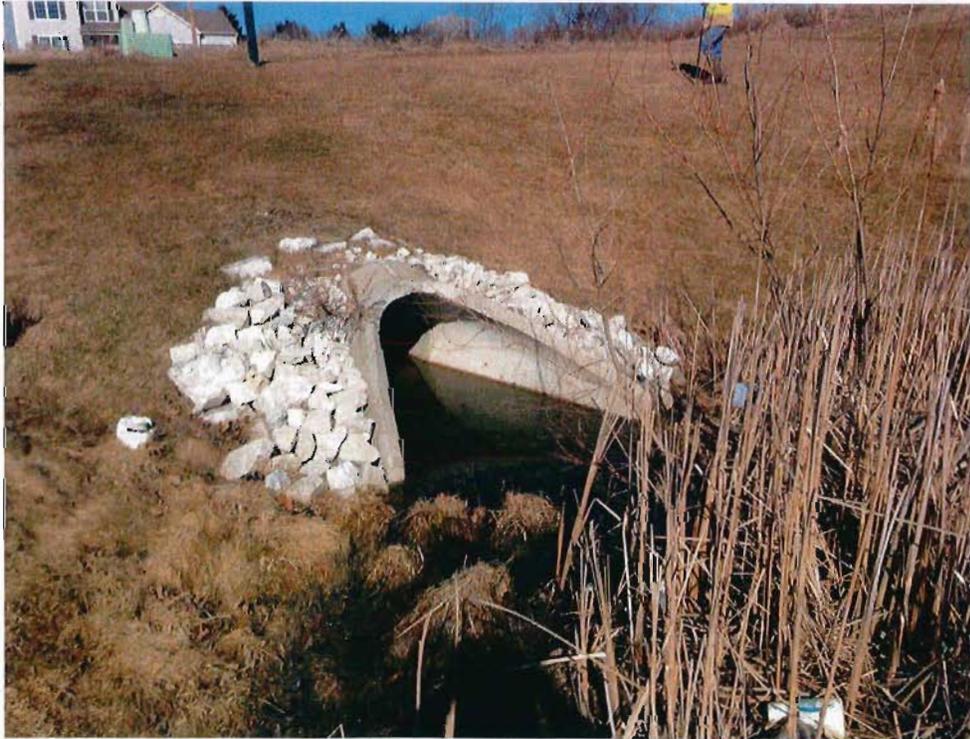
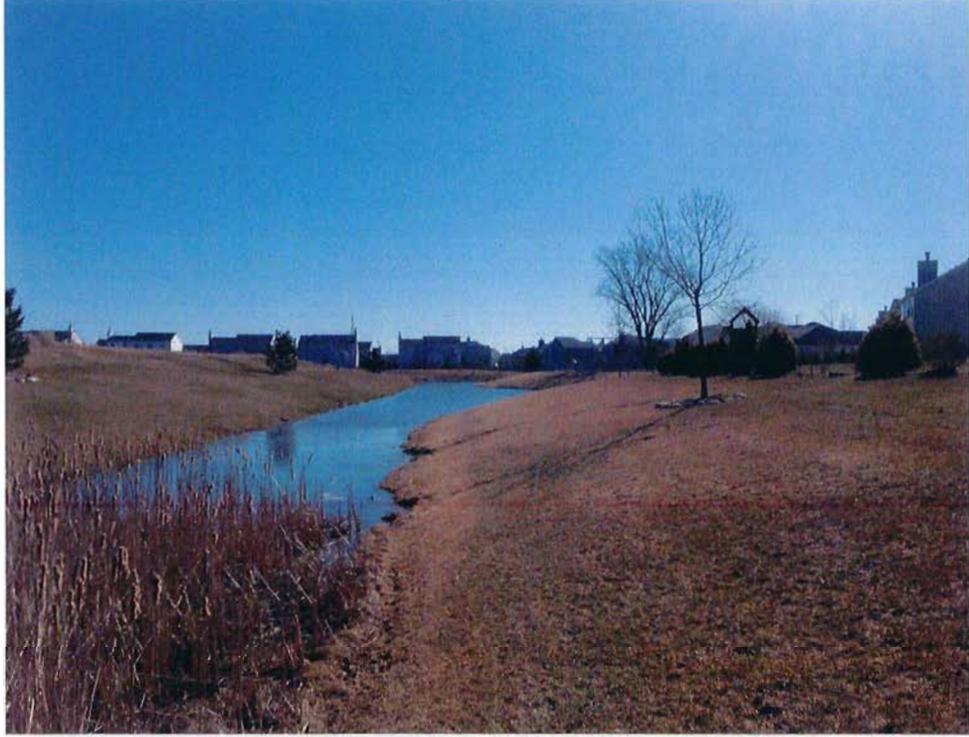
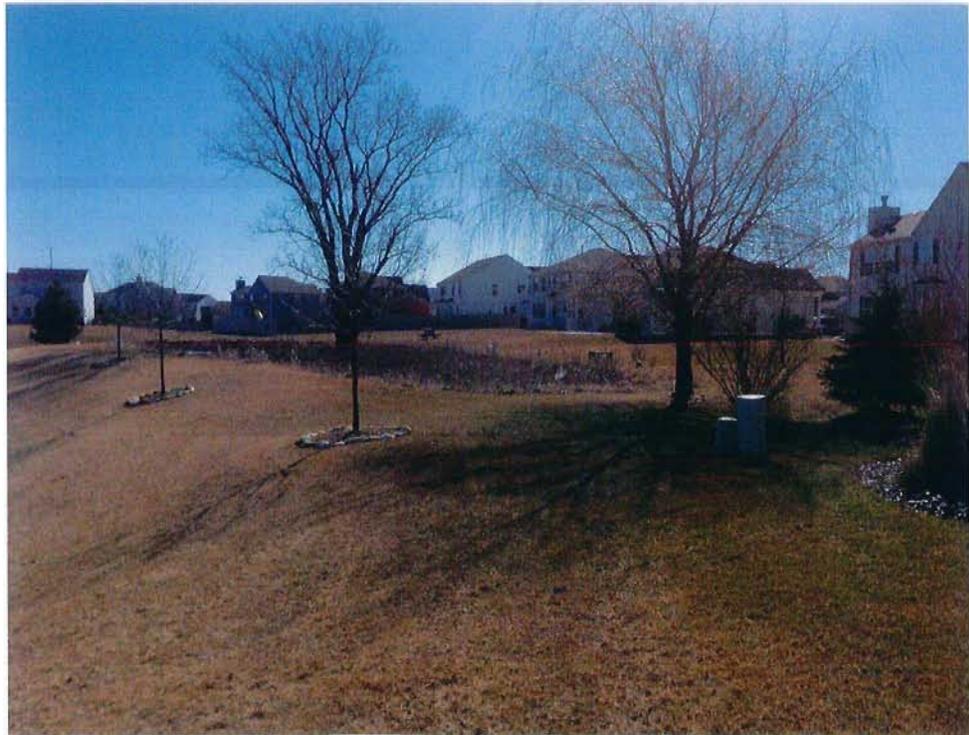
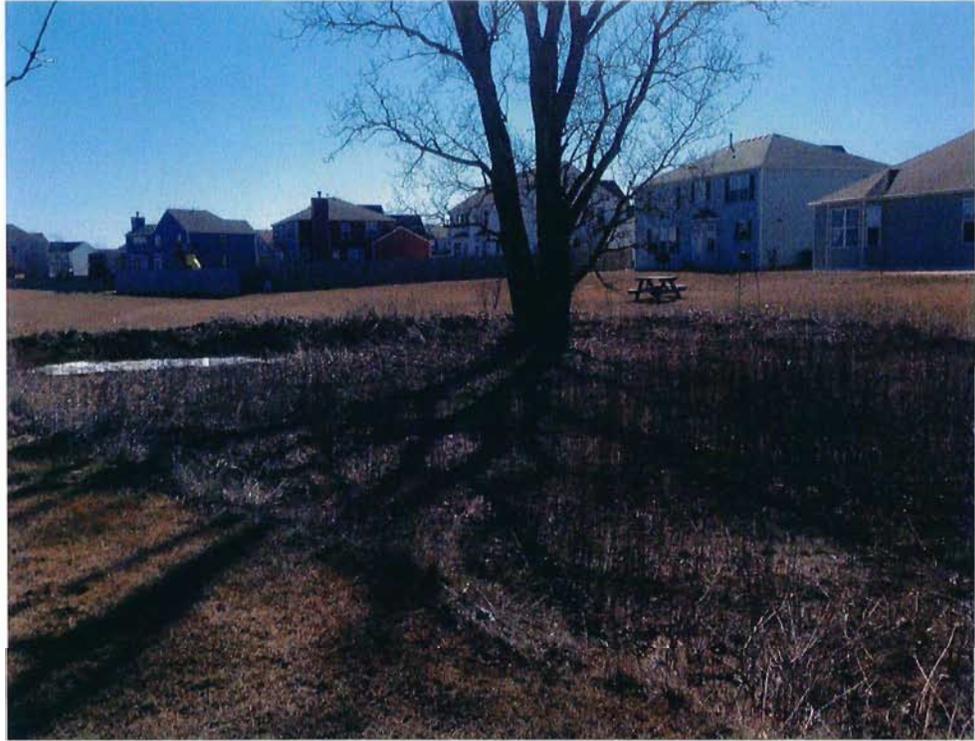
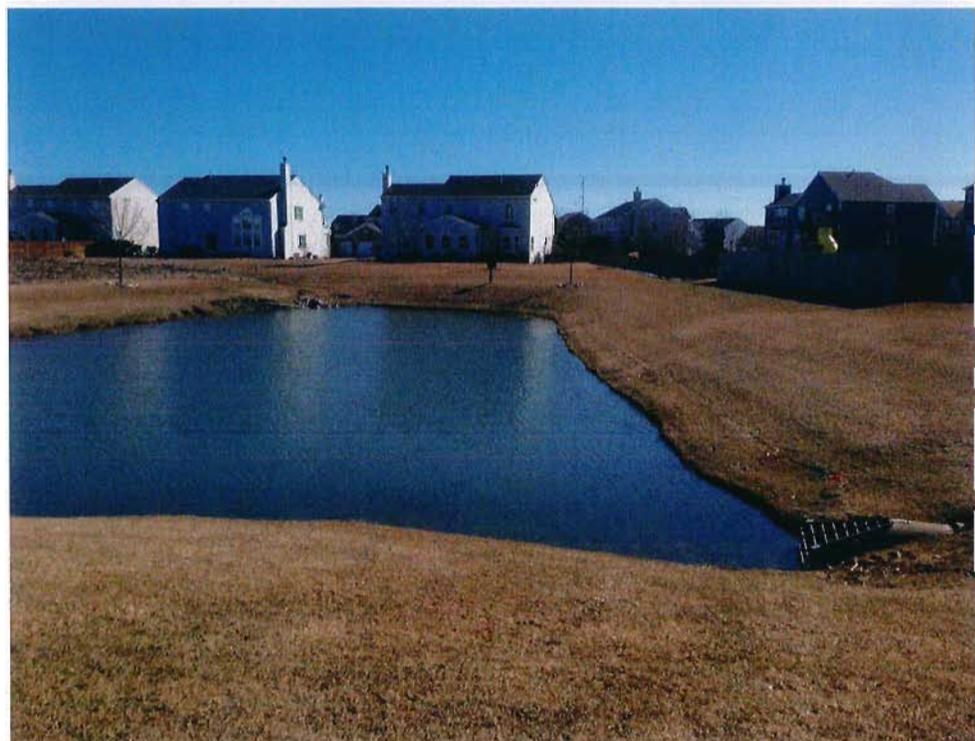
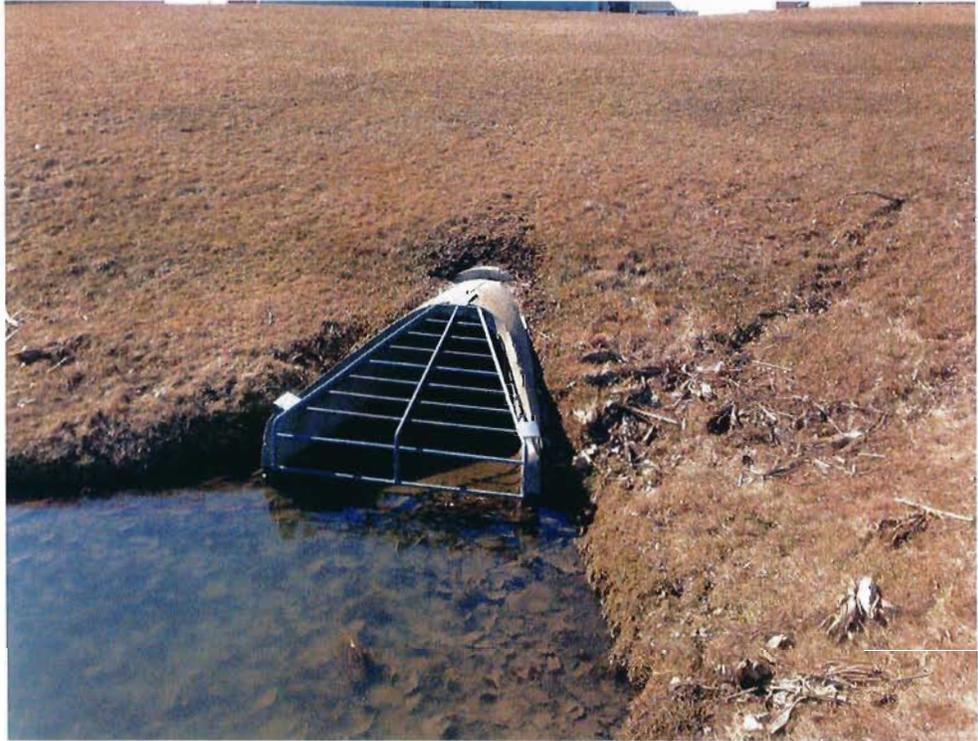
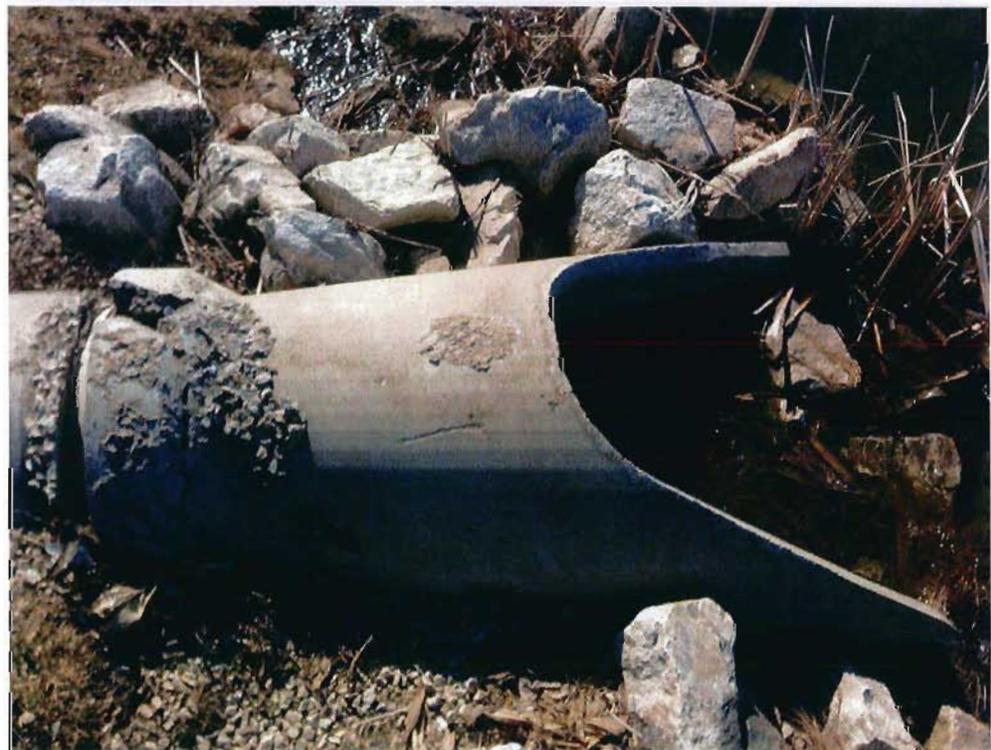
1. The designed water depth of the pond is 6 feet. The measured water depth in July of 2013 varied between 4.5 and 6.0 feet. We conclude that the pond was over-excavated at the time of construction but is now filling with sediment.
2. The inlet bells have some small chips. The outlet structure is in good condition.
3. Sediment build-up averages about 0.7 feet.
4. The whole pond perimeter is mowed. The rip-rap areas have a small amount of vegetation growing in them but are in good condition.
5. There is a growth of cattails in one end of the pond.

1. The water depth should be measured in 2018 to compare to the 2013 measurements. This will provide a comparable depth to determine the rate of sediment accumulation as well as an anticipated date for sediment removal.
2. Rip-rap should be kept free of vegetation.
3. The cattails should be cleared if they continue to extend into the pond.
4. A narrow strip around the pond should be left un-mowed to deter geese.
5. The pond should be dredged and restored to its design depth.

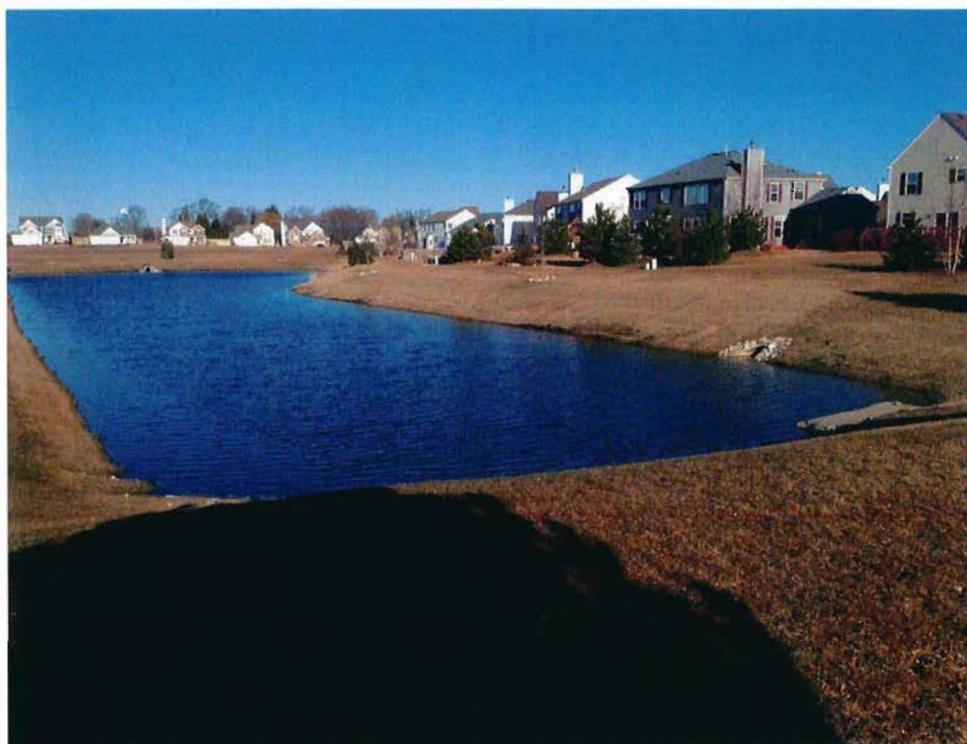
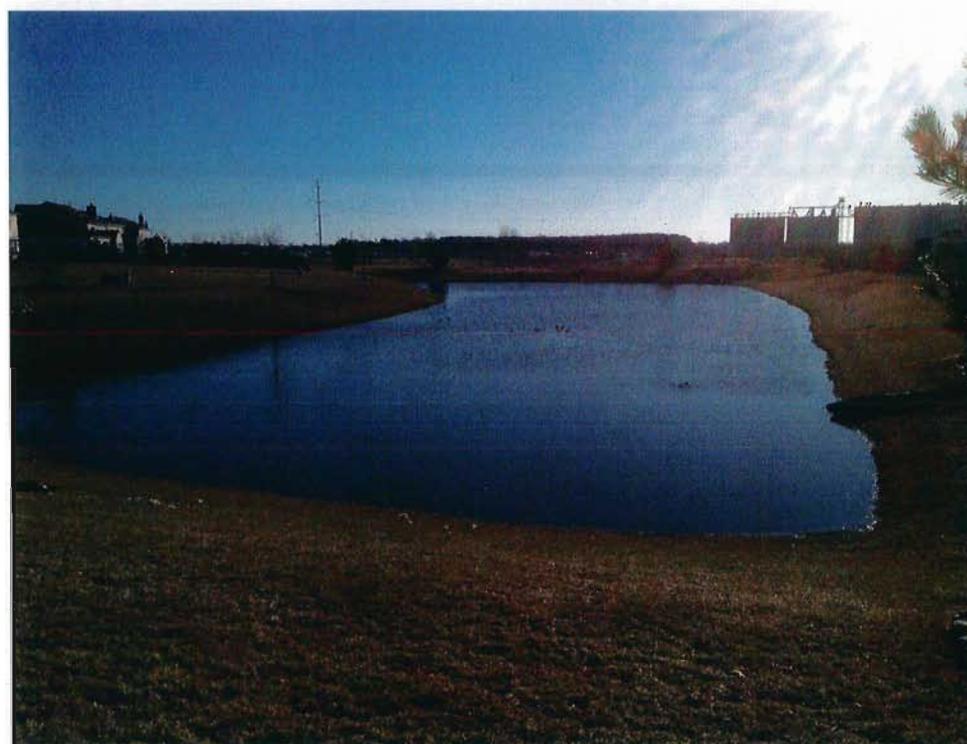
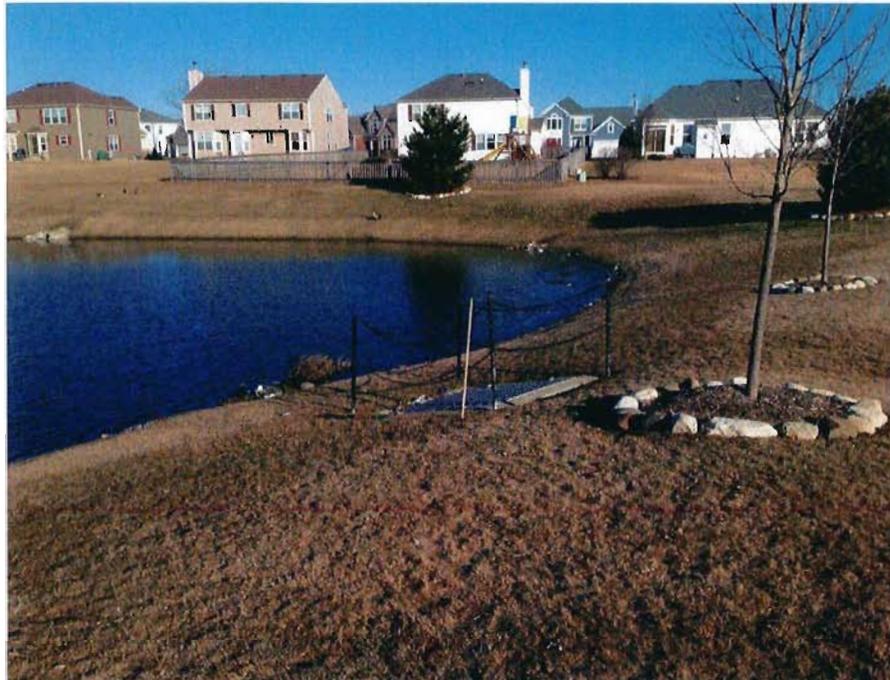
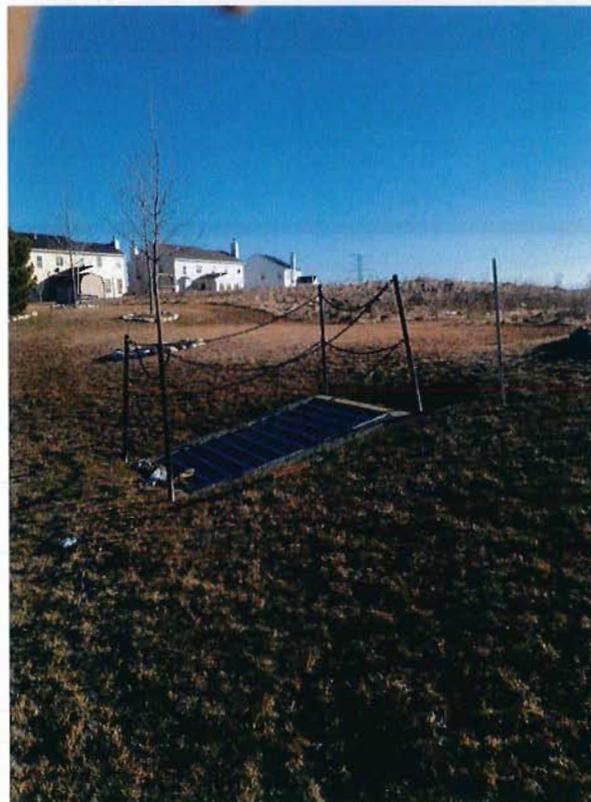
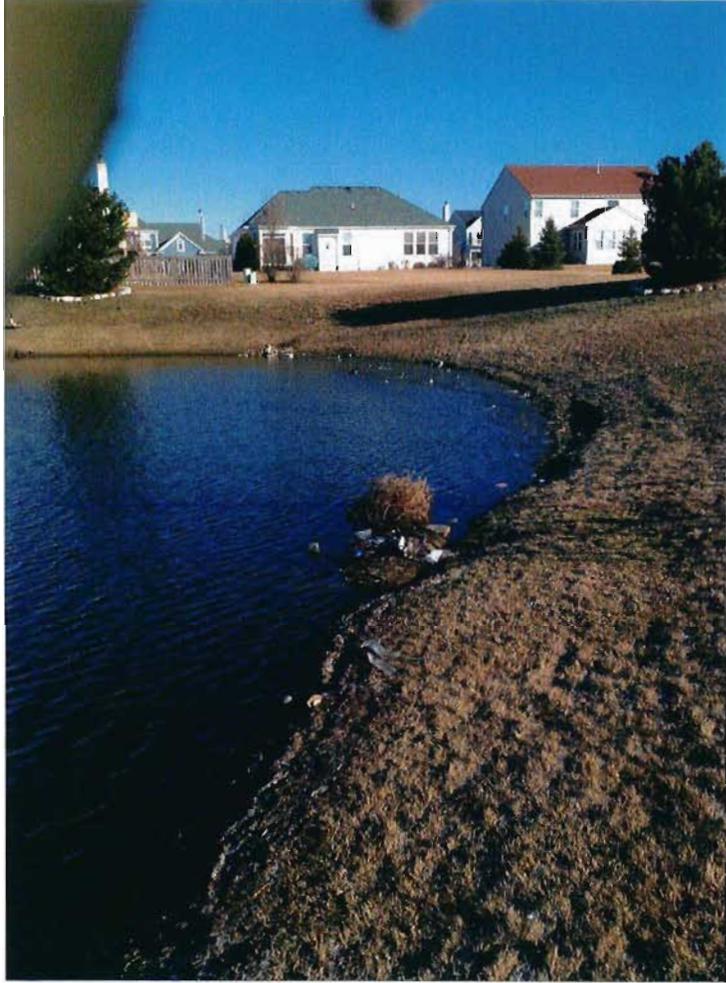
- \* LIGHT GRATE CLEANING PERIODICALLY
- \* POND SUMY BLOCK IN GRATE
- E/W DEPTHS
- ORIFICES?

\* RIVER OTTED STBLG 7-1-13  
TRACKS IN MARCH ON ICE

1. The water depth should be measured in 2018 to compare to the 2013 measurements. This will provide a comparable depth to determine the rate of sediment accumulation as well as an anticipated date for sediment removal.
2. The outlet grate should be cleaned periodically.
3. A strip of grass should be left around the edge of the pond to improve safety and help to prevent geese.
4. Perform dredging at the pond and excavate to the design depth.

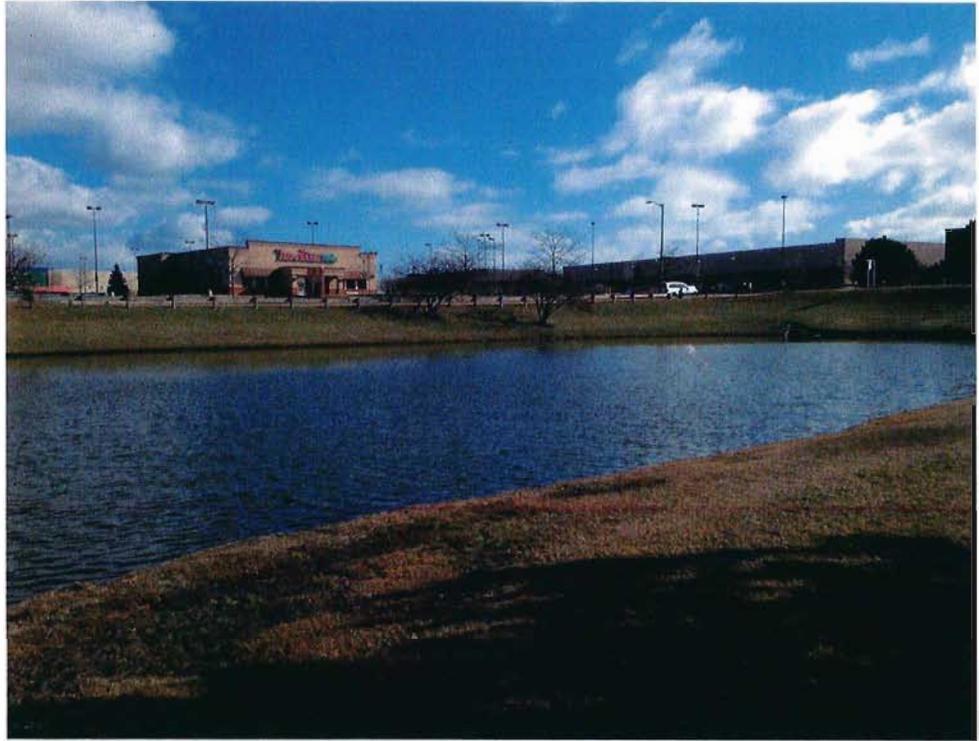
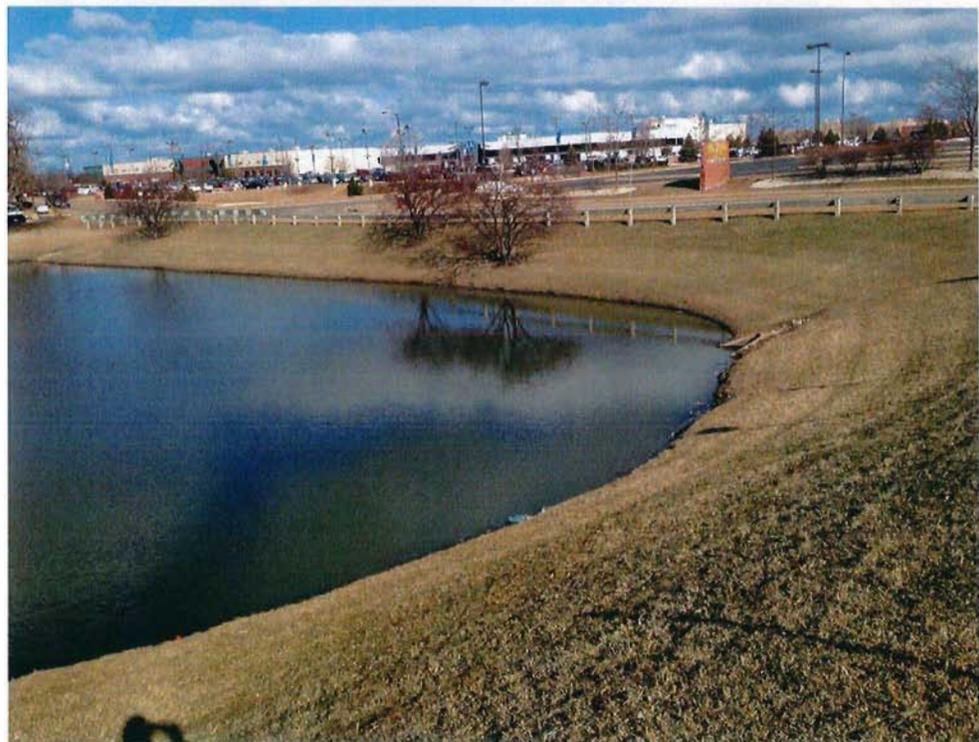
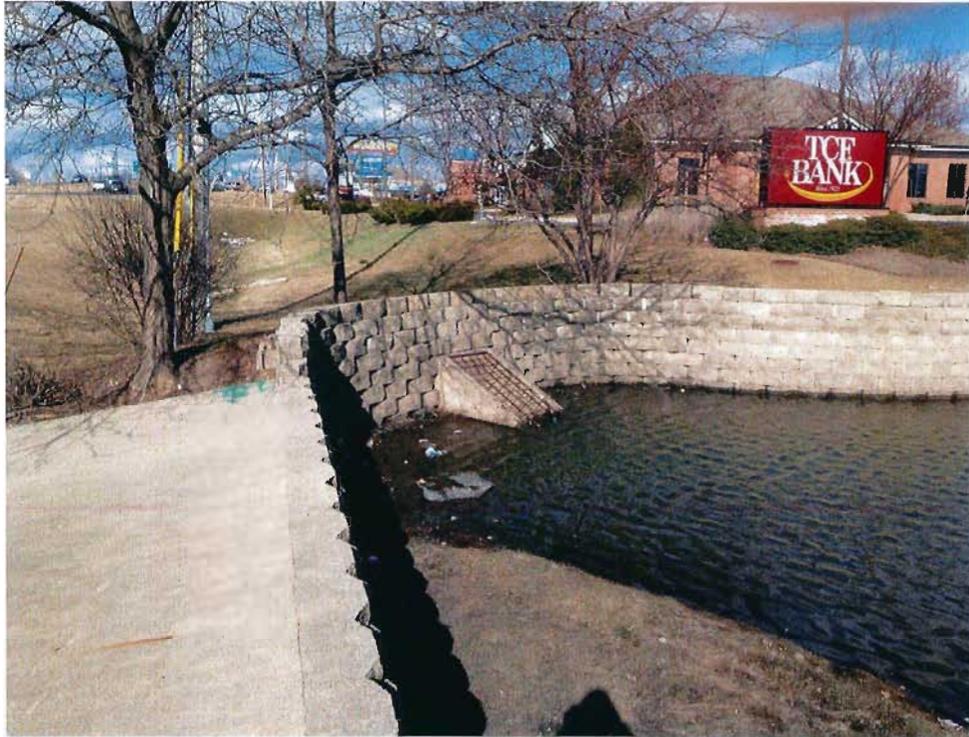
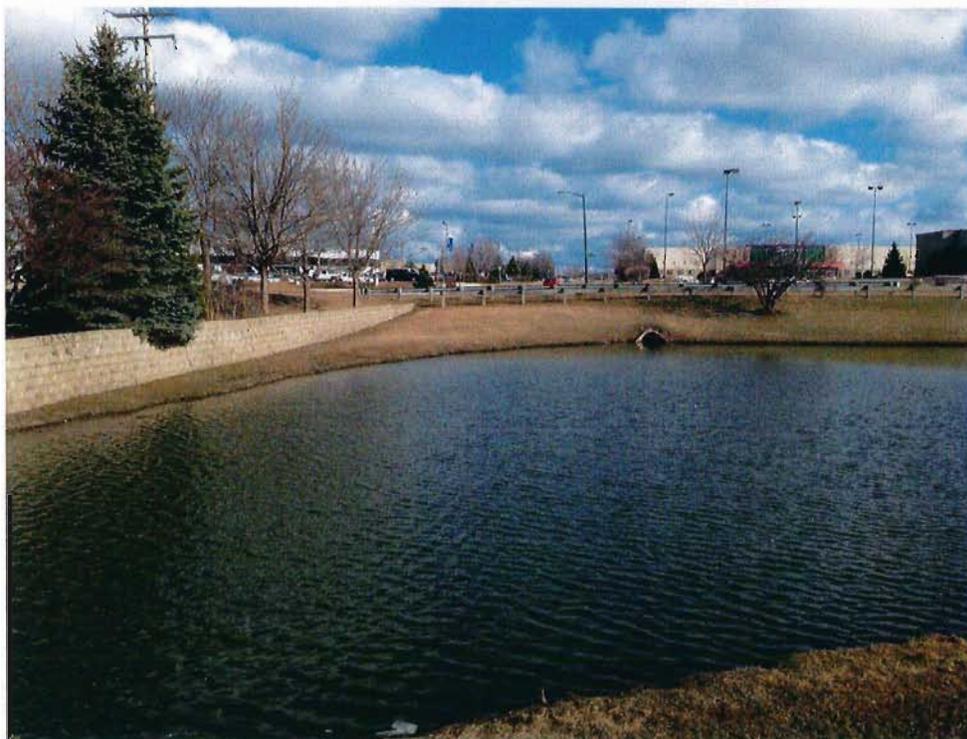
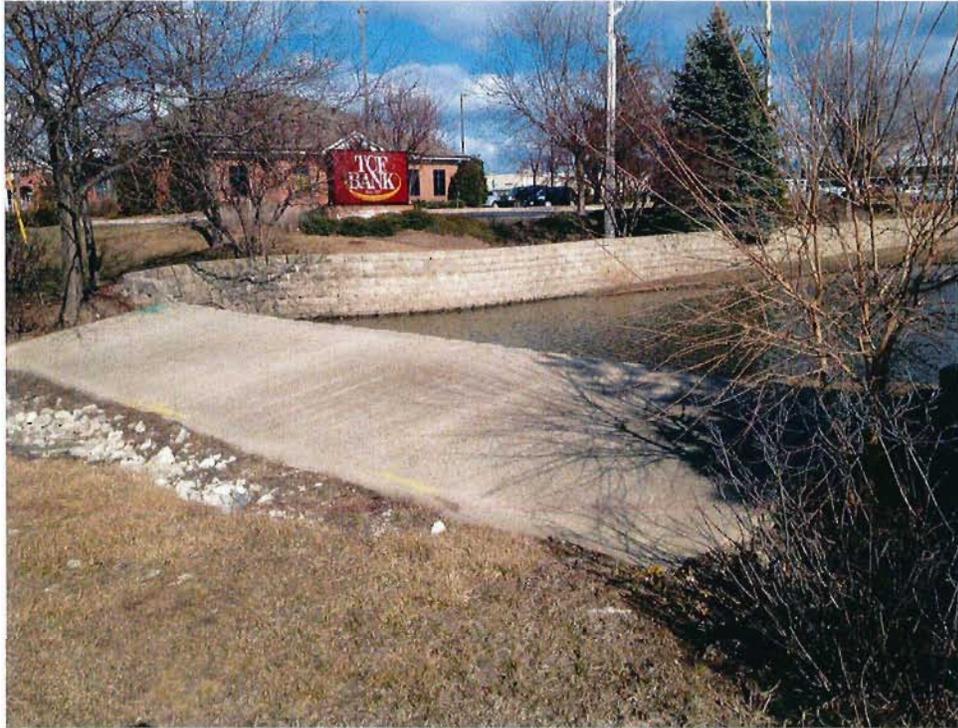
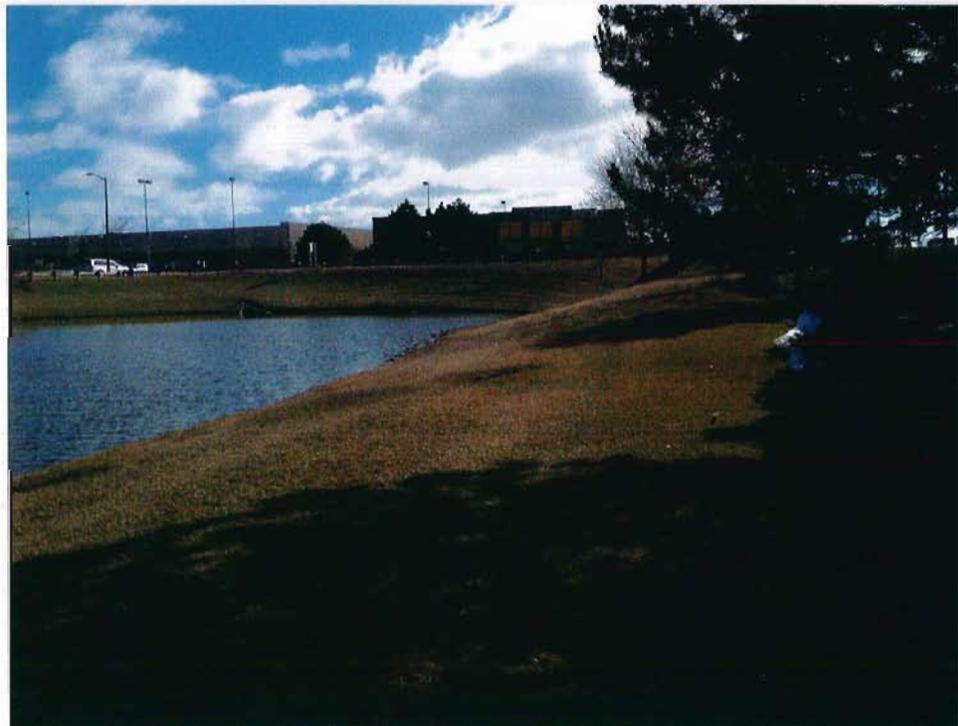
1. The designed water depth of the pond is unknown; the plans show that the outlet elevation is the same as the pond bottom. The pond holds water, so this is not accurate. The measured water depth in July of 2013 varied between 1.5 and 3.9 feet.
2. The inlet and outlet pipes were inspected and were found to be in good structural condition. The lower outlet chamber was full of mud, indicating that the lower orifice might be blocked.
3. Sediment build-up ranged between 0.5 and 2.4 feet.
4. The entire pond perimeter is mowed.

1. The water depth should be measured in 2018 to compare to the 2013 measurements. This will provide a comparable depth to determine the rate of sediment accumulation as well as an anticipated date for sediment removal.
2. Further investigations are needed to determine the design depth.
3. Sediment is deep in some areas and dredging may be necessary.
4. The outlet structure should be cleaned and inspected for obstructions.
5. When mowing, leave a grassy strip around the edge of the pond to deter geese.

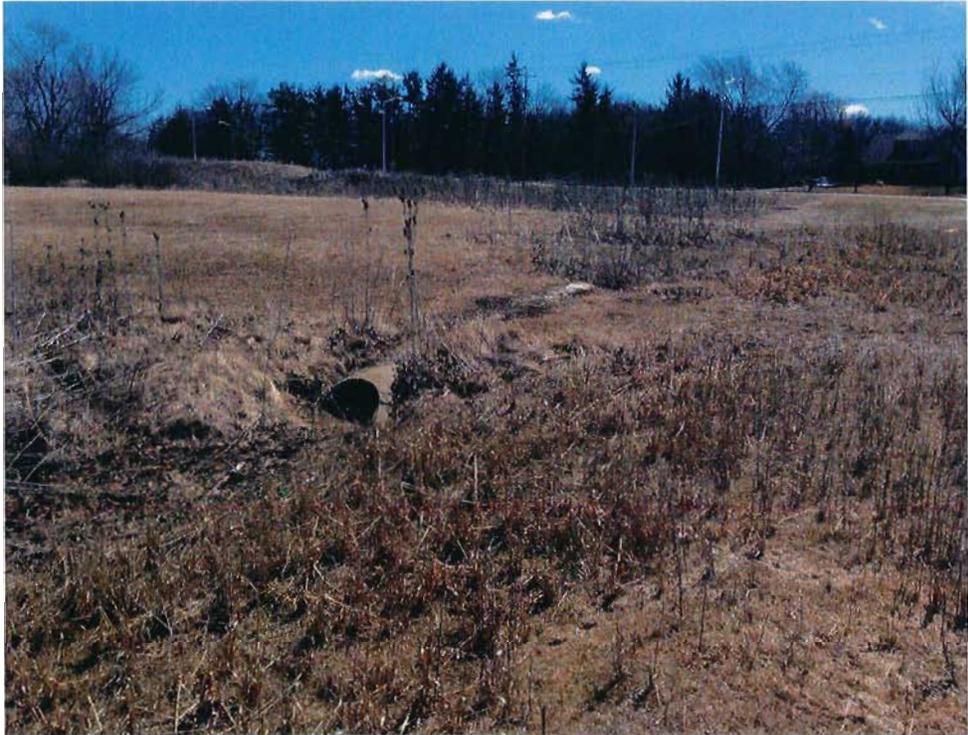
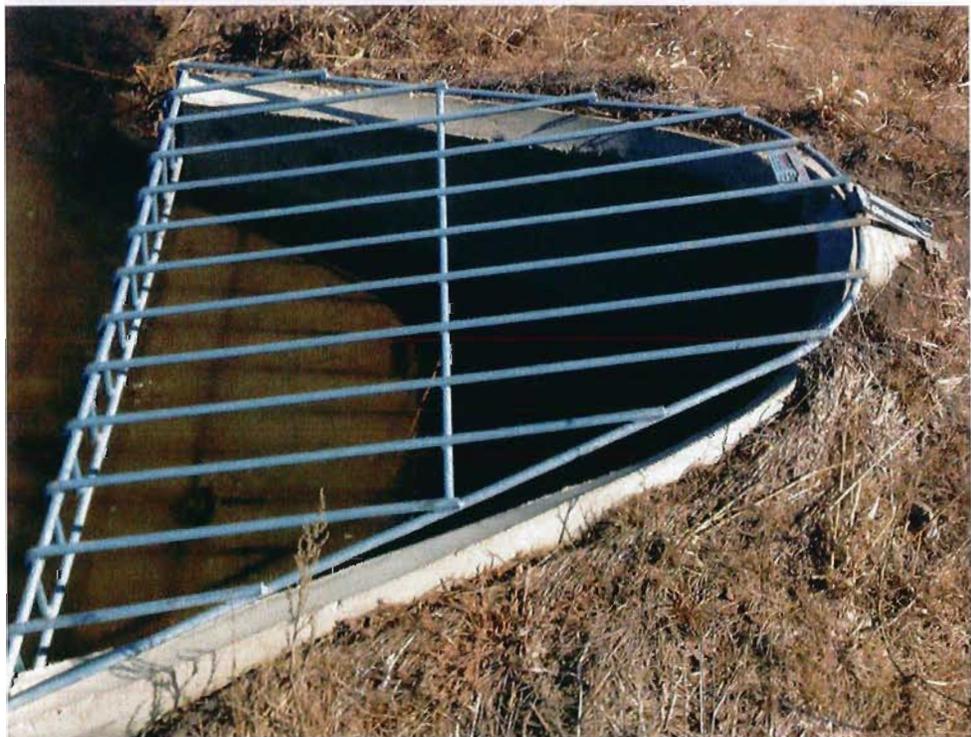
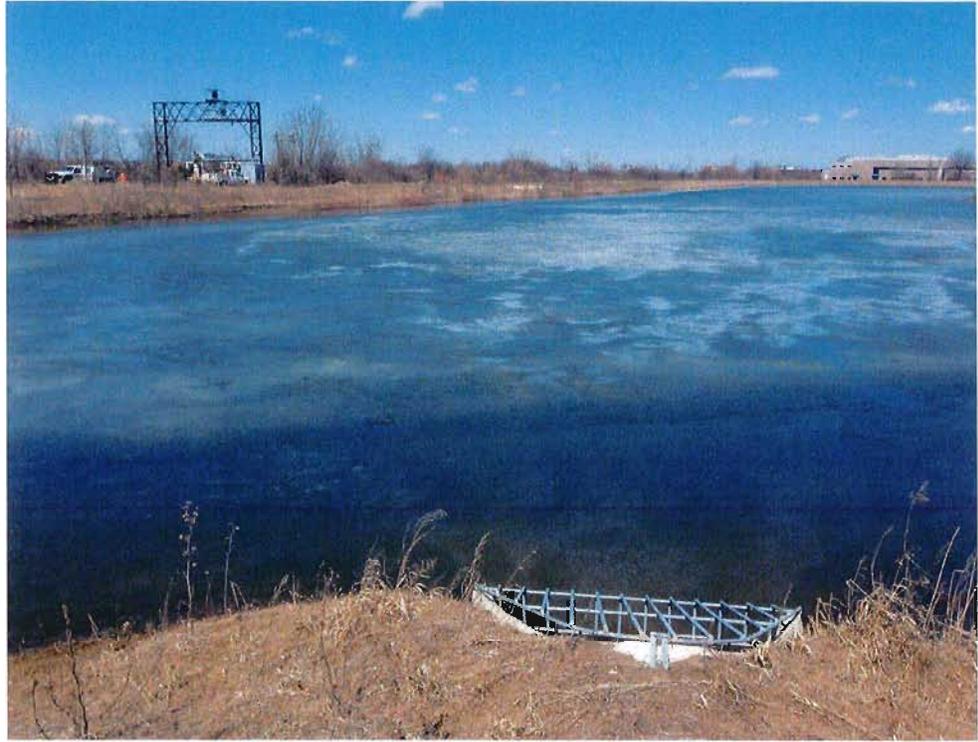
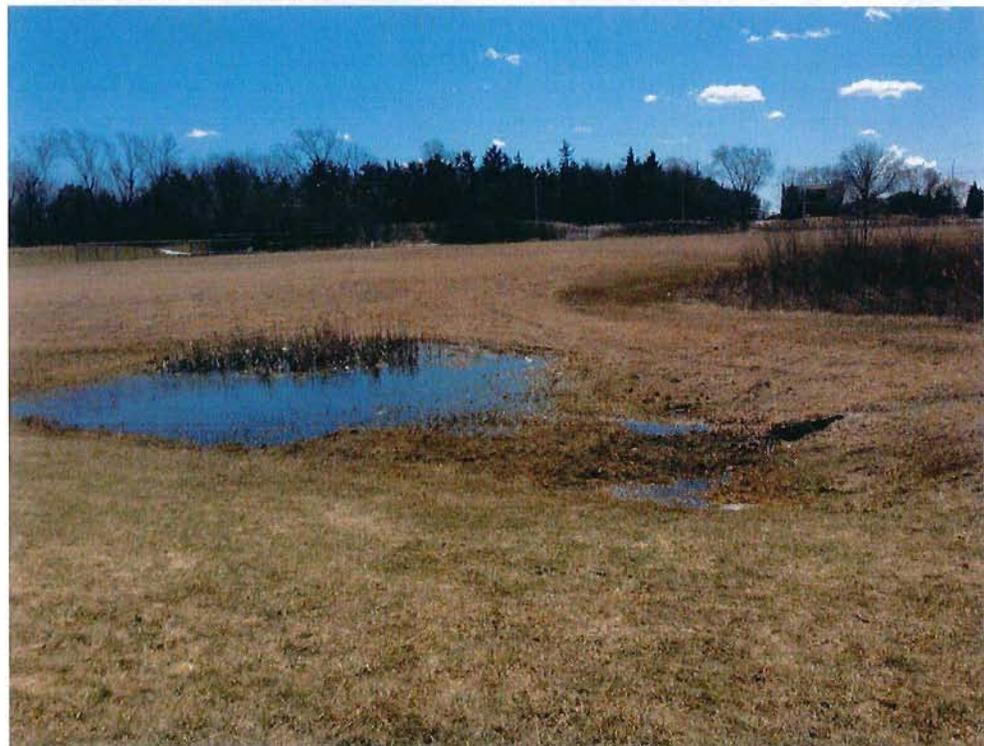
1. The designed water depth of the pond is unknown; the pond rehabilitation plans do not show a bottom elevation. The measured water depth in July of 2013 varied between 3.0 and 5.2 feet.
2. The inlet and outlet pipes were inspected and were found to be in good structural condition.
3. Sediment build-up ranged between 0 and 1.1 feet.
4. Weed growth is thick at the north end of the pond. Some rip-rap areas have vegetation growing in them. Vegetation has grown up around the majority of the pond perimeter, including near the inlets and outlets.

1. The water depth should be measured in 2018 to compare to the 2013 measurements. This will provide a comparable depth to determine the rate of sediment accumulation as well as an anticipated date for sediment removal.
2. Tree and shrub clearing is necessary at the inlets and outlets.
3. Weeds at the north end of the pond should be cleared.
4. The pond area should be mowed and cleared regularly.
5. Further investigation is necessary to determine the design depth of the pond, and whether dredging may be needed.

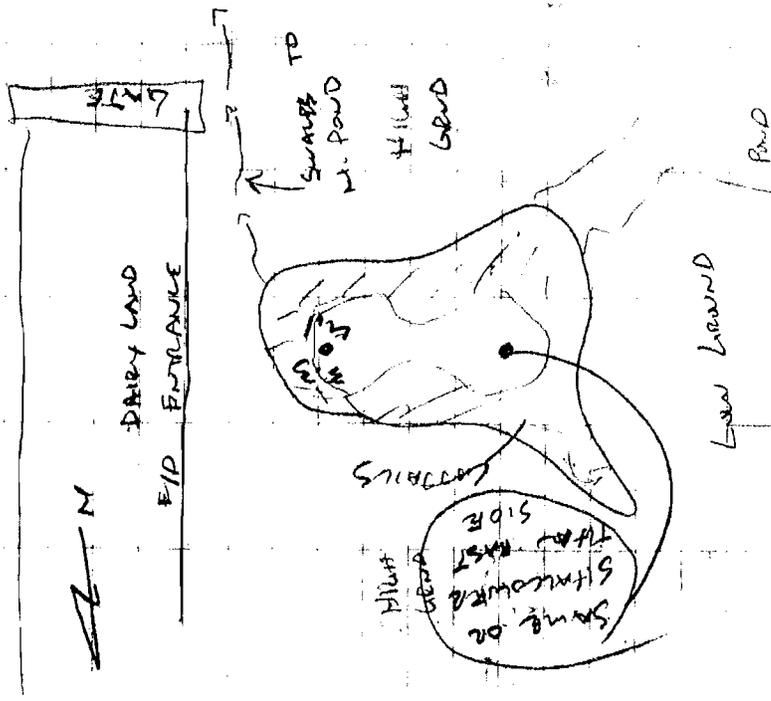
DAIRYLAND WEST

- \* NO VISIBLE PIPES
- \* NATURAL LOW AREA?
- 196-1974 FLDI = 4.5
- \* NO DEFINED "EDGE" OR "TOP"
- \* CATCHAL PERIMETER
- HI QUALITY WETLANDS

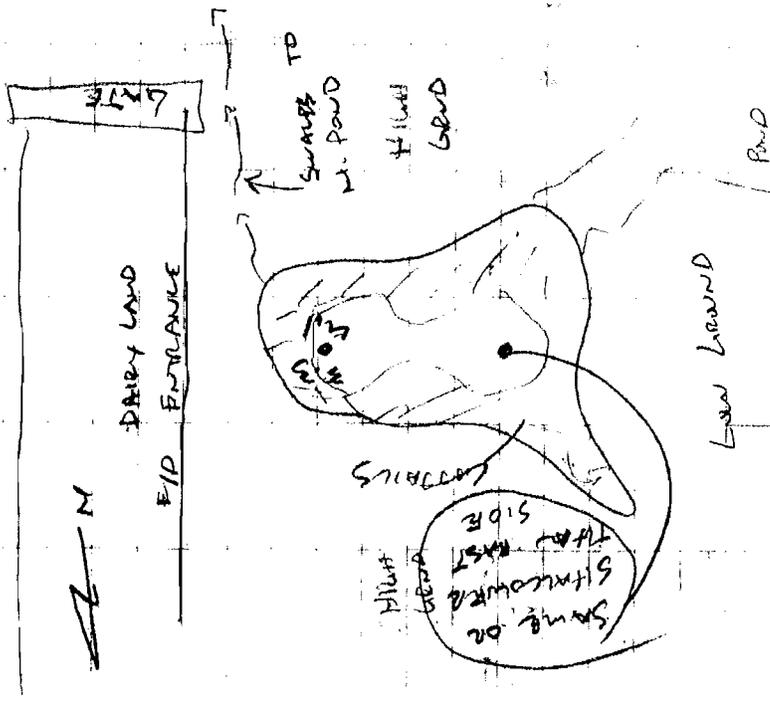
DAIRYLAND WEST

- \* NO VISIBLE PIPES
- \* NATURAL LOW AREA?
- 196-1974 FLDI = 4.5
- \* NO DEFINED "EDGE" OR "TOP"
- \* CATCHAL PERIMETER
- HI QUALITY WETLANDS

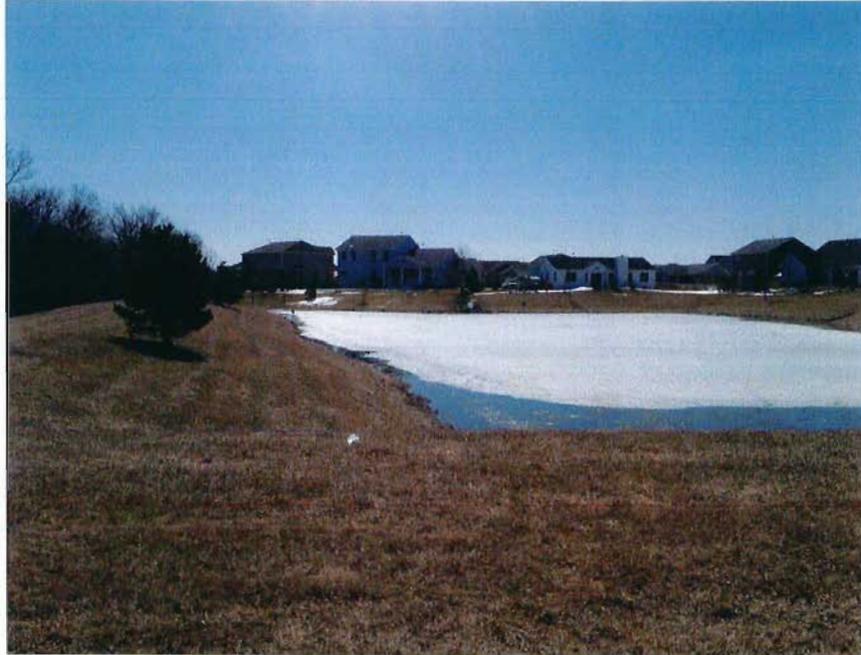
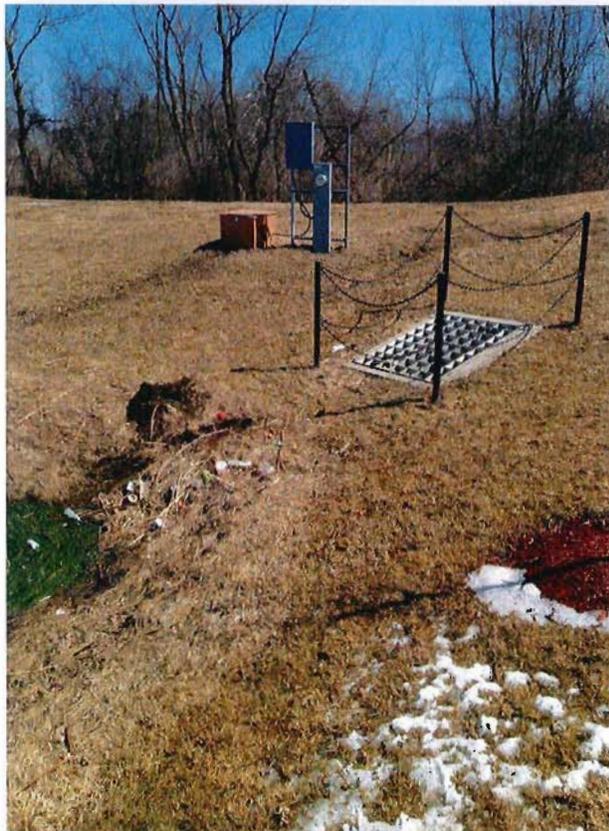
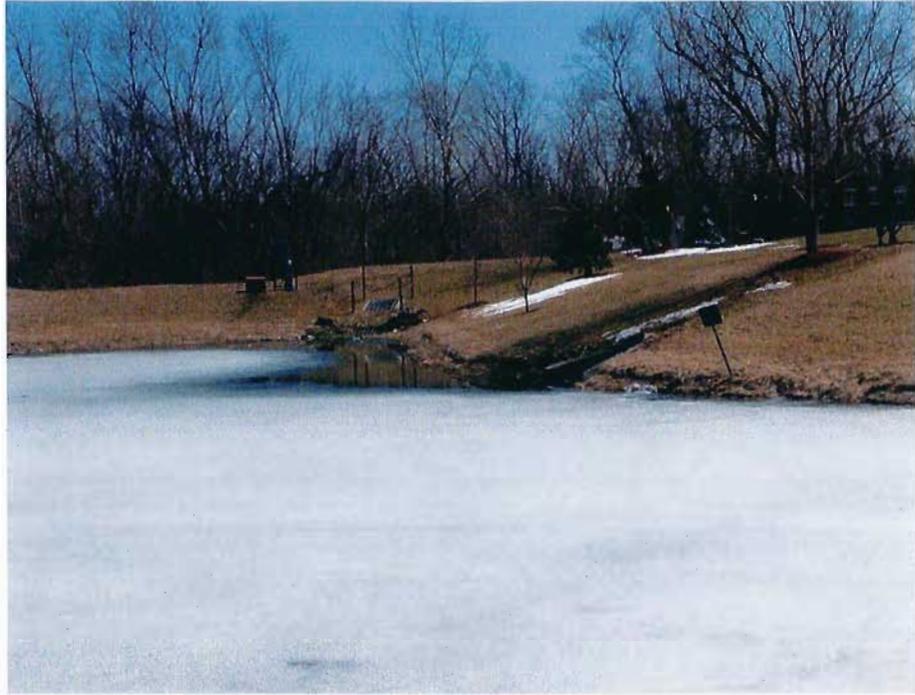
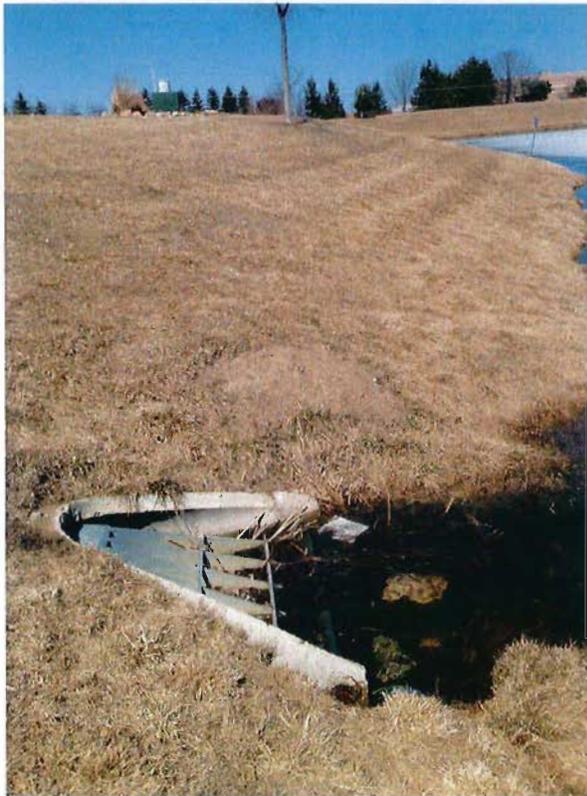
1. The designed water depth of the pond is 5 feet. The measured water depth in March of 2013 was 5.4 feet. We conclude that the pond was over-excavated at the time of construction.
2. The inlet and outlet pipes were inspected and were found to be in good structural condition. The grate on the 24" pipe was clogged with leaves.
3. Sediment build-up varied between 0 and 0.5 feet.
4. The whole pond perimeter area is mowed.
5. There is some erosion near the outlet structure.

1. The water depth should be measured in 2018 to compare to the 2013 measurements. This will provide a comparable depth to determine the rate of sediment accumulation as well as an anticipated date for sediment removal.
2. Clean out the lower outlet and the surrounding area.
3. When mowing, leave a strip of grass around the pond to improve safety and help to prevent geese.
4. Repair and stabilize the erosion near the outlet structure.

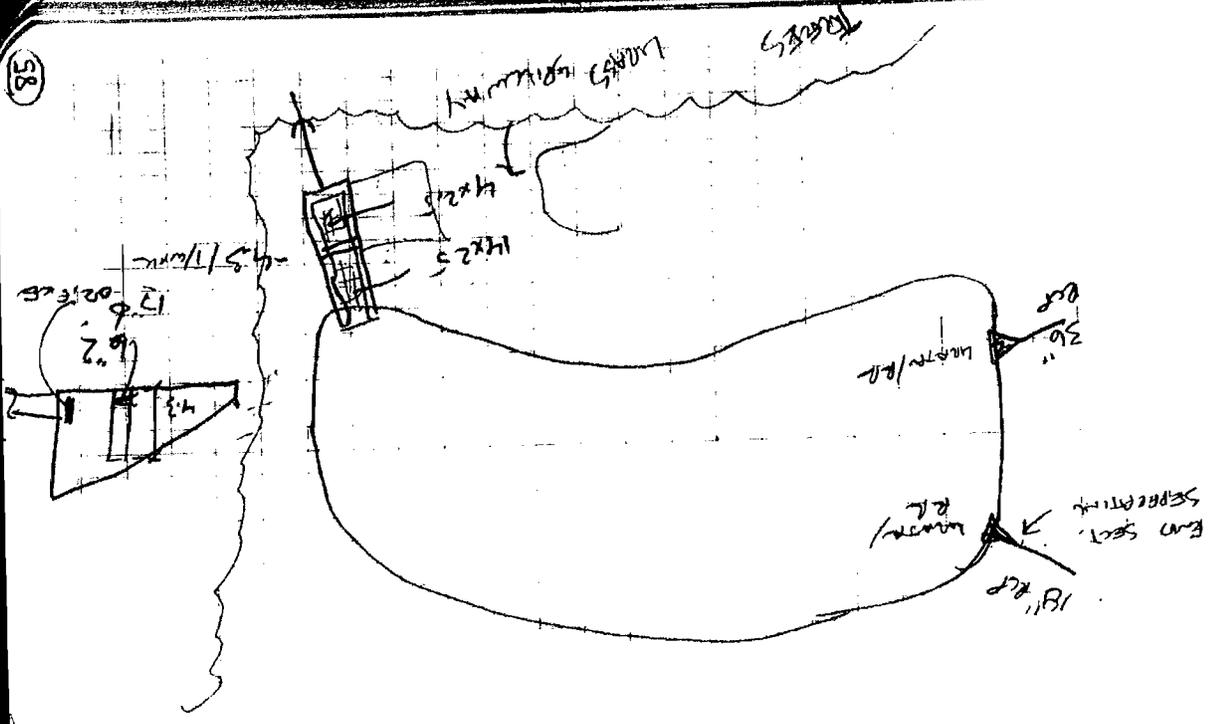
REGAL APTS

- \* mow & clear out BUCKETHEADS SIDE COURTYARD
- \* mow - DRIVEWAY
- \* REPAIR SECTION OF 18" SEPERATED.
- \* \_\_\_\_\_
