# 2013 Ponds Certifications

City of Kenosha, Wisconsin

July 9, 2014

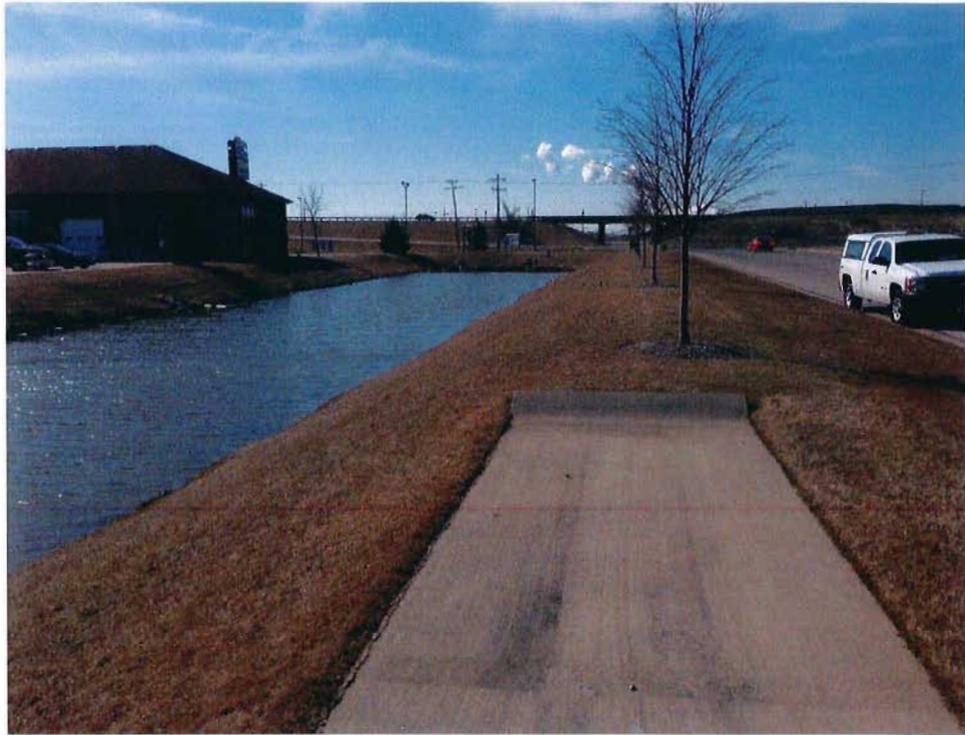
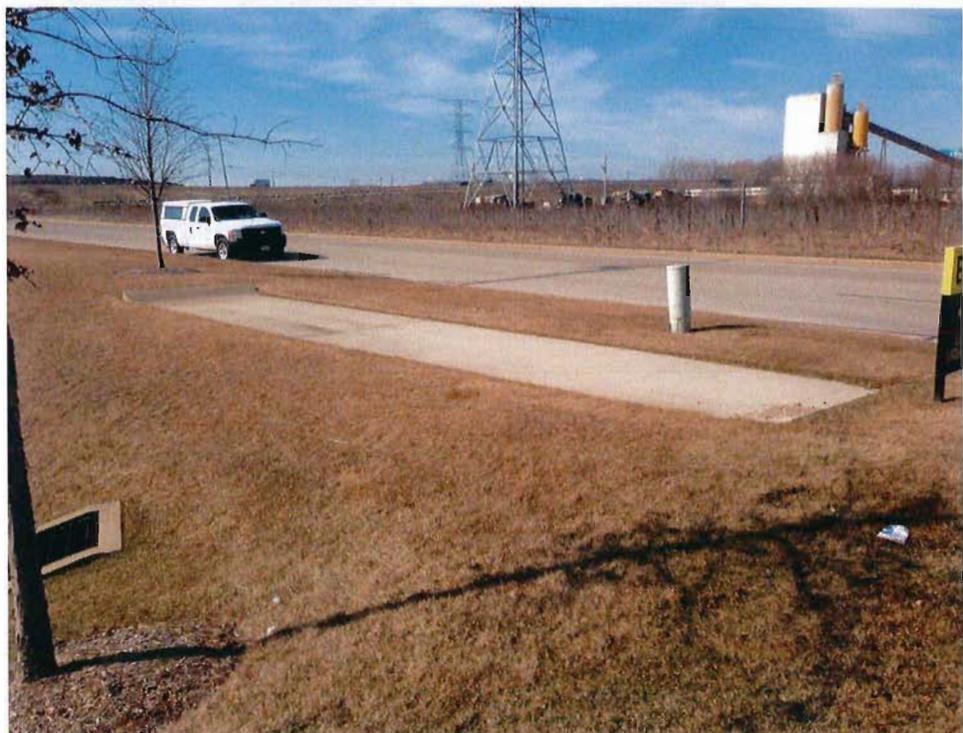
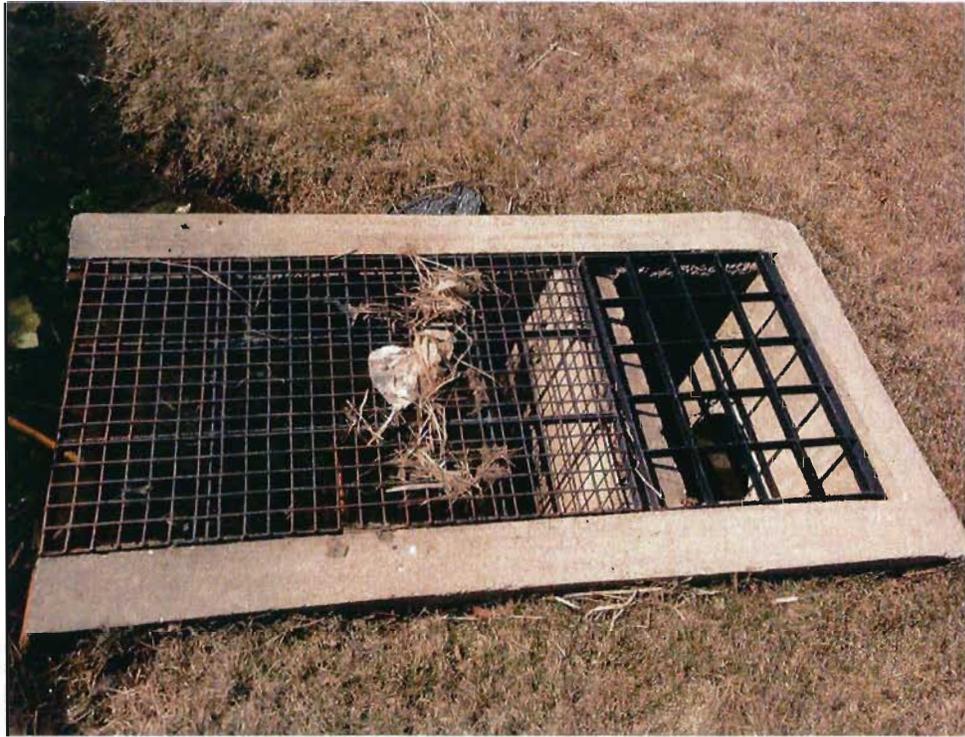
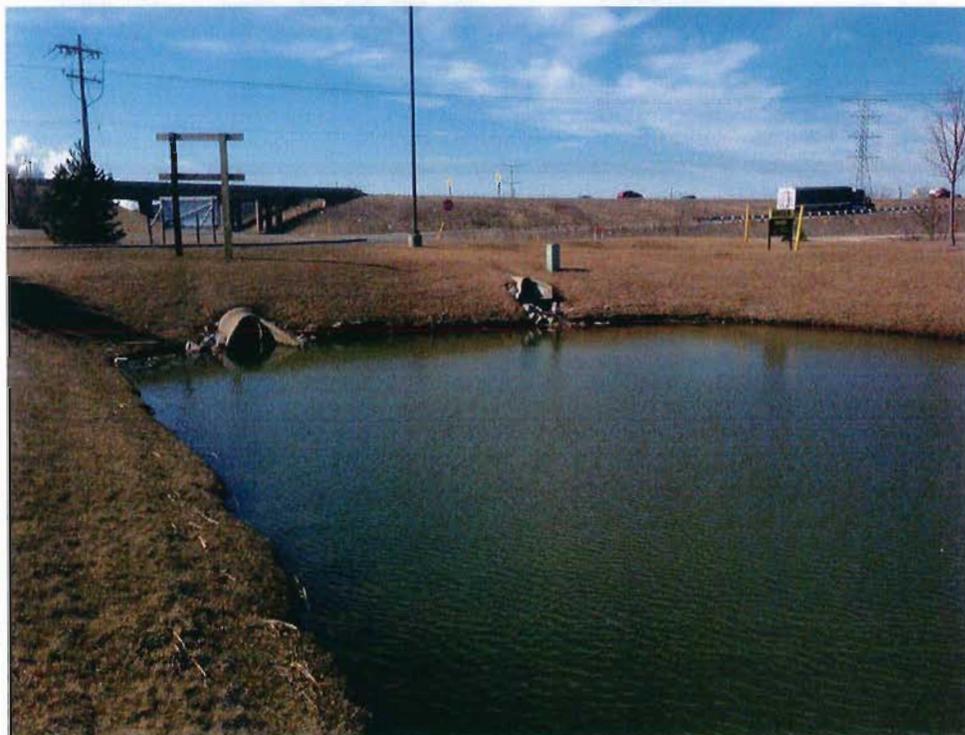
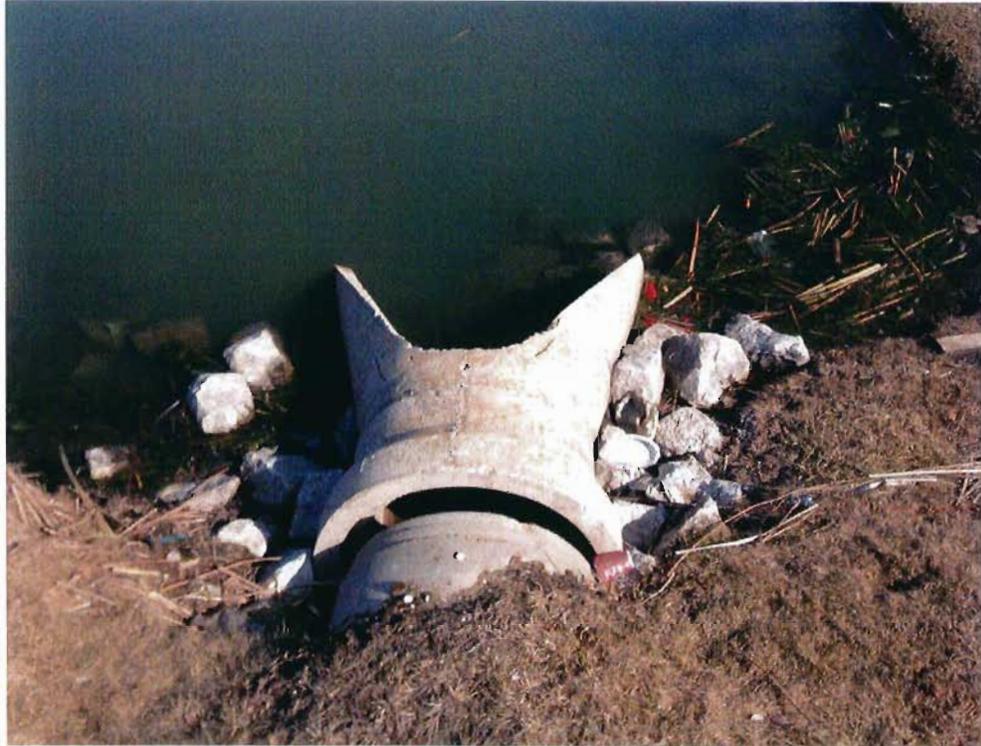
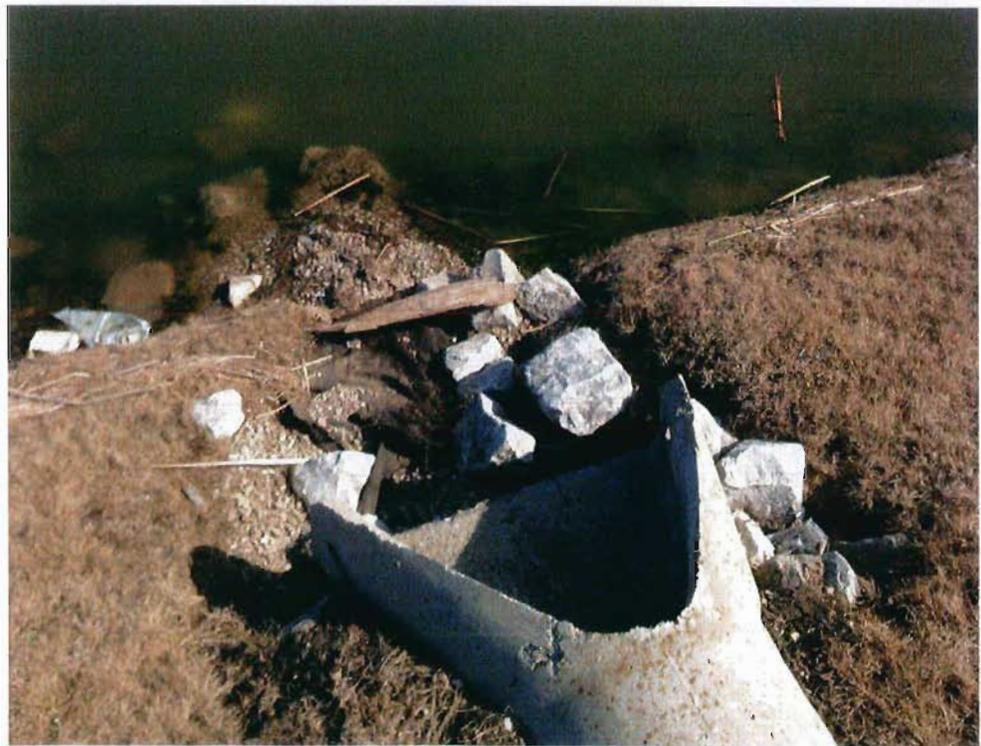
1. The designed water depth of the pond is 5.5 feet. The measured water depth in July of 2013 was approximately 5.4 feet. We conclude that the pond was over-excavated at the time of construction.
2. The inlet and outlet pipes were inspected and were found to be in good condition. The end section on the 27" inlet pipe on the south side of the pond was separated from the pipe.
3. Sediment build-up varied between 0.1 and 0.6 feet.
4. The whole pond perimeter is mowed. The entire pond area is in good condition.

1. The water depth should be measured in 2018 to compare to the 2013 measurements. This will provide a comparable depth to determine the rate of sediment accumulation as well as an anticipated date for sediment removal.
2. Consider not mowing a one-foot strip around the pond in order to deter geese.

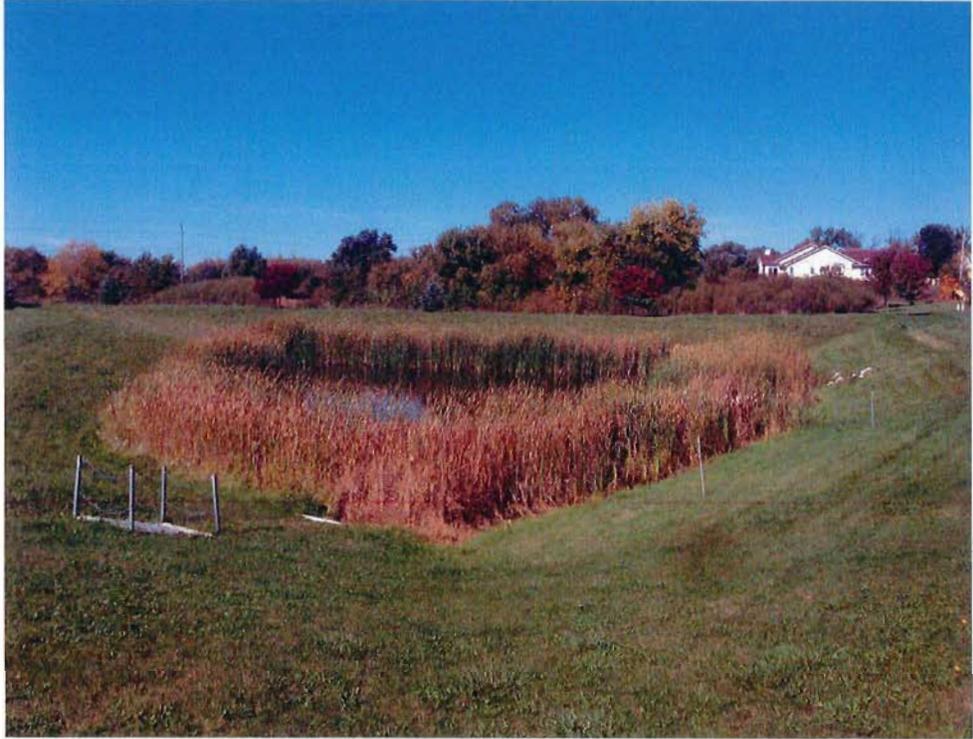
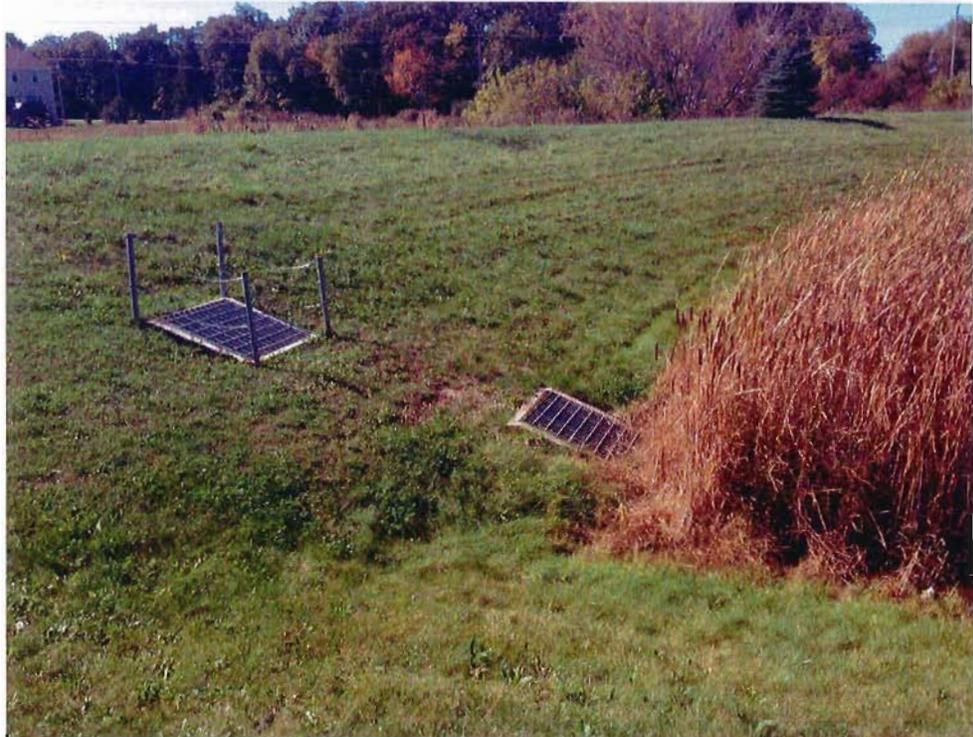
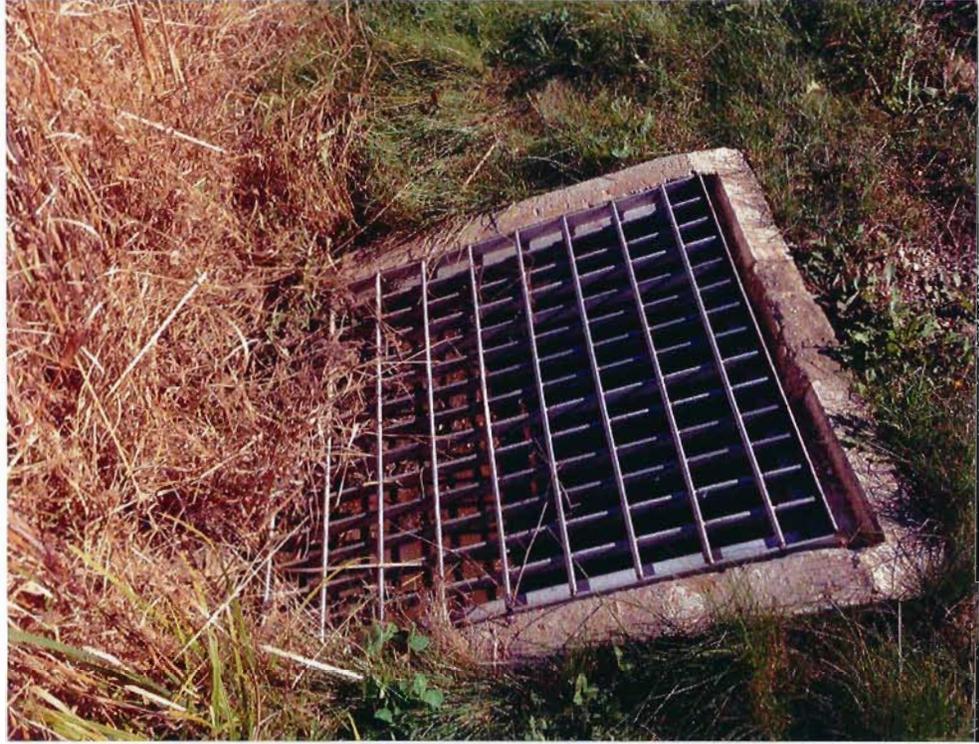
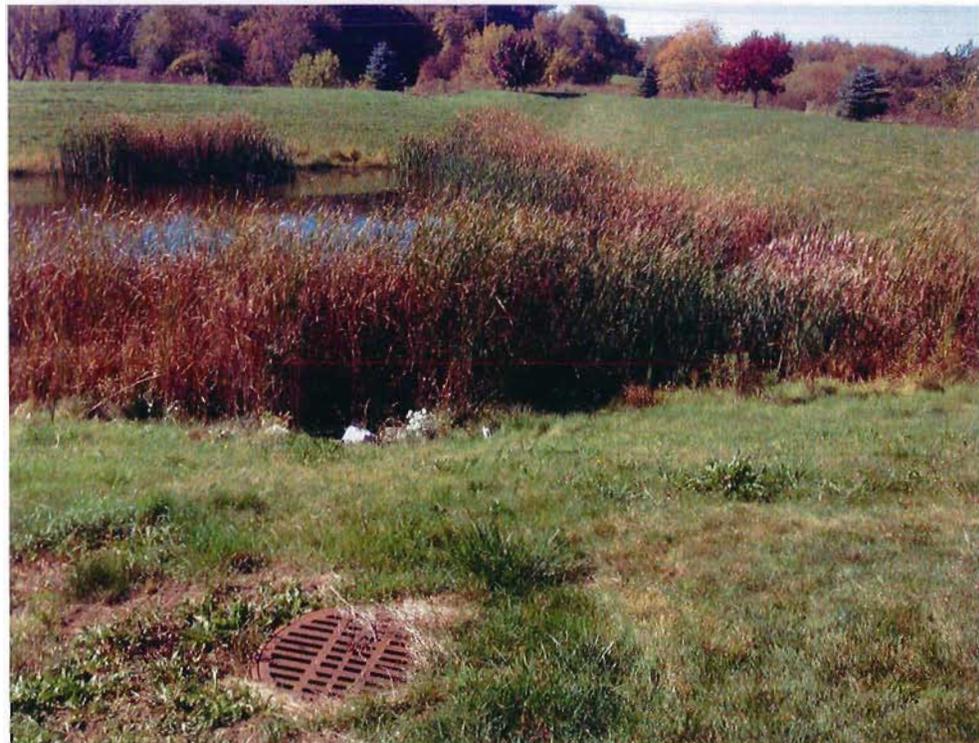
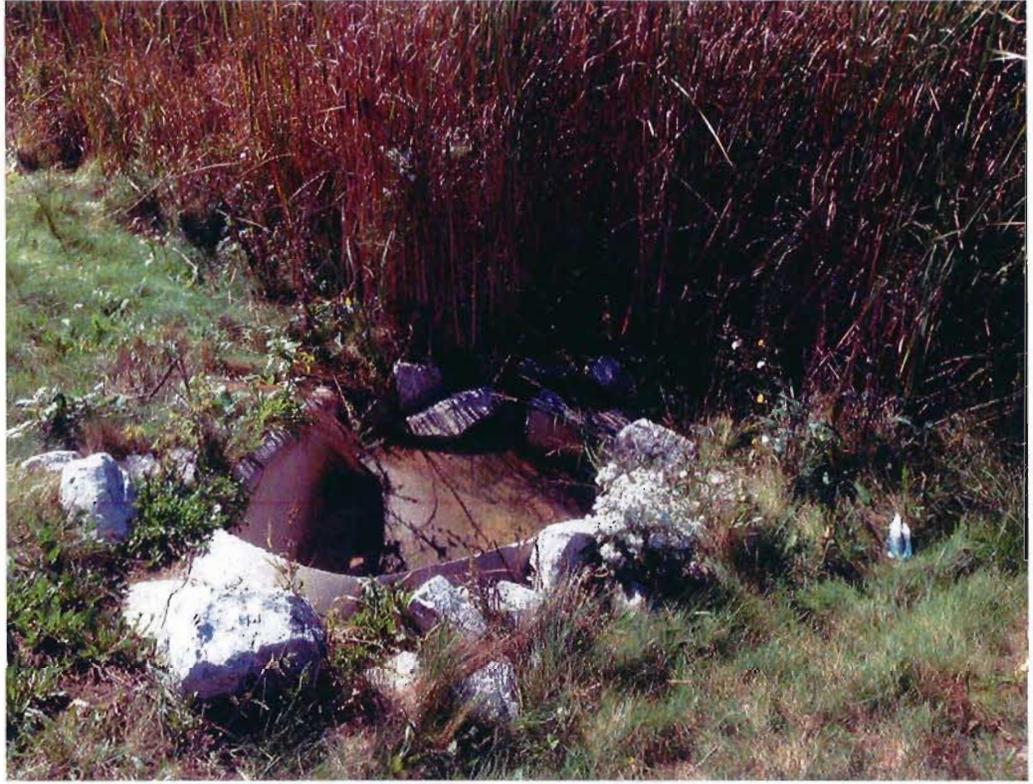
1. The designed water depth of the pond is 4 feet. The measured water depth in October of 2013 varied between 3.0 and 3.7 feet.
2. The inlet and outlet structures were inspected and are in good condition.
3. Sediment build-up varied between 0.5 and 1.3 feet.
4. The pond perimeter had been mowed.
5. Vegetation is growing within the inlet and outlet structures.
6. There is thick cattail growth all around the pond.

1. The water depth should be measured in 2018 to compare to the 2013 measurements. This will provide a comparable depth to determine the rate of sediment accumulation as well as an anticipated date for sediment removal.  
?- Sediment has already built up within the pond and dredging should be considered.
2. The cattails around the interior perimeter of the pond should be removed.
3. The pond perimeter should be mowed to within a foot of the water.
4. The inlet and outlet structures should be kept clear of vegetation.

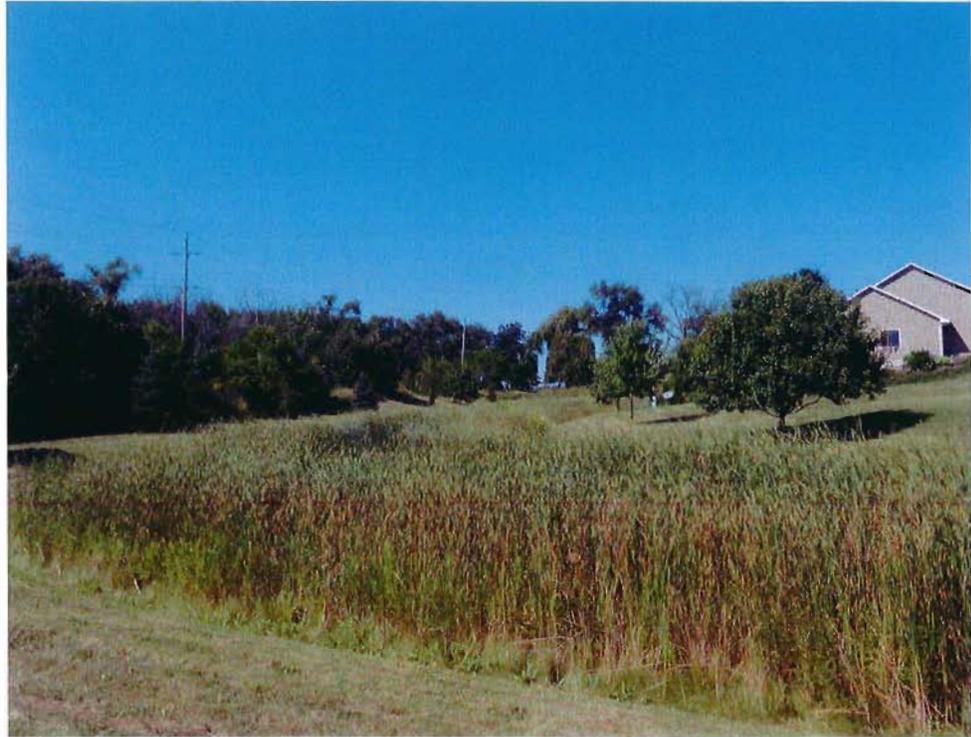
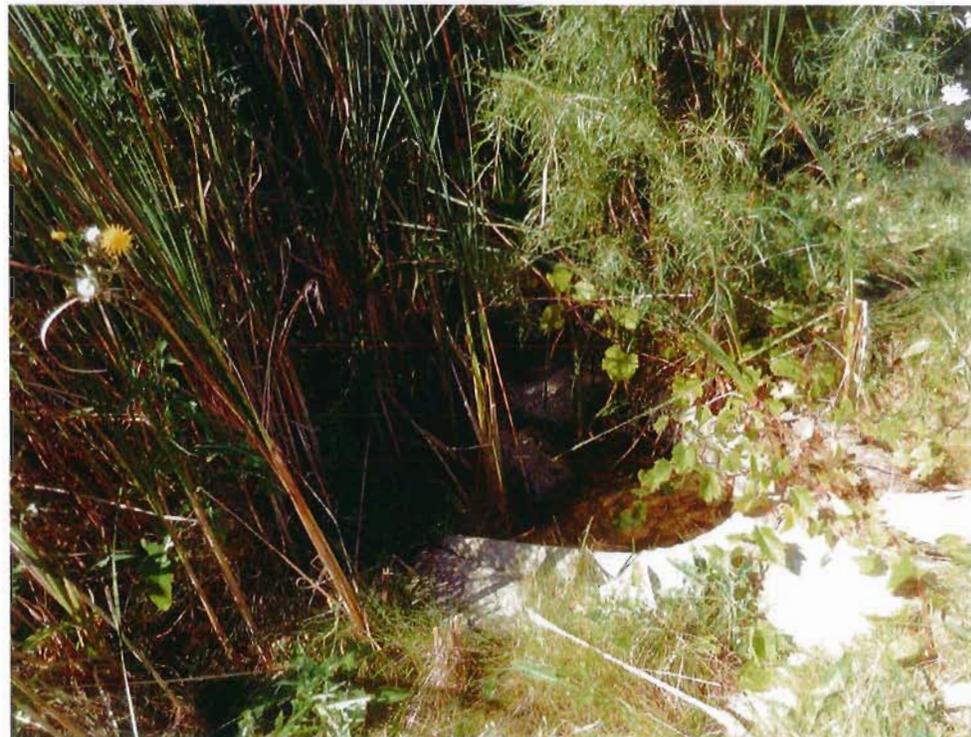
1. The designed water depth of the pond is 4 feet. The measured water depth in October of 2013 varied between 2.0 at the north end of the pond and 3.8 feet at the south end. The pond has apparently begun to fill up with sediment.
2. The inlet and outlet structures were inspected and are in good condition. There is thick vegetation growth at the structures and within the surrounding riprap.
3. Sediment build-up varied between 0.1 and 2.4 feet.
4. The pond perimeter had been mowed. There is thick cattail growth throughout the pond.

1. The water depth should be measured in 2018 to compare to the 2013 measurements. This will provide a comparable depth to determine the rate of sediment accumulation as well as an anticipated date for sediment removal. Dredging should be considered within the next five years due to the sediment buildup that has already occurred in the pond.
2. The vegetation at the inlet and outlet structures should be removed and kept clear of future growth.
3. The pond perimeter should be mowed to within a foot of the water.
4. The cattails throughout the pond should be cleared.

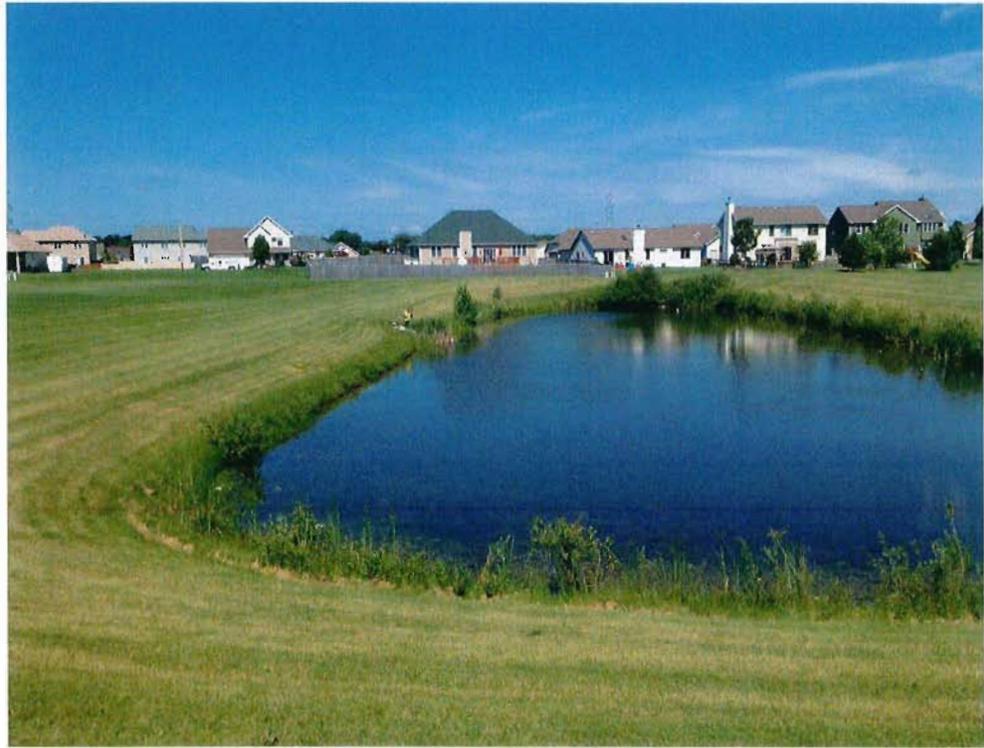
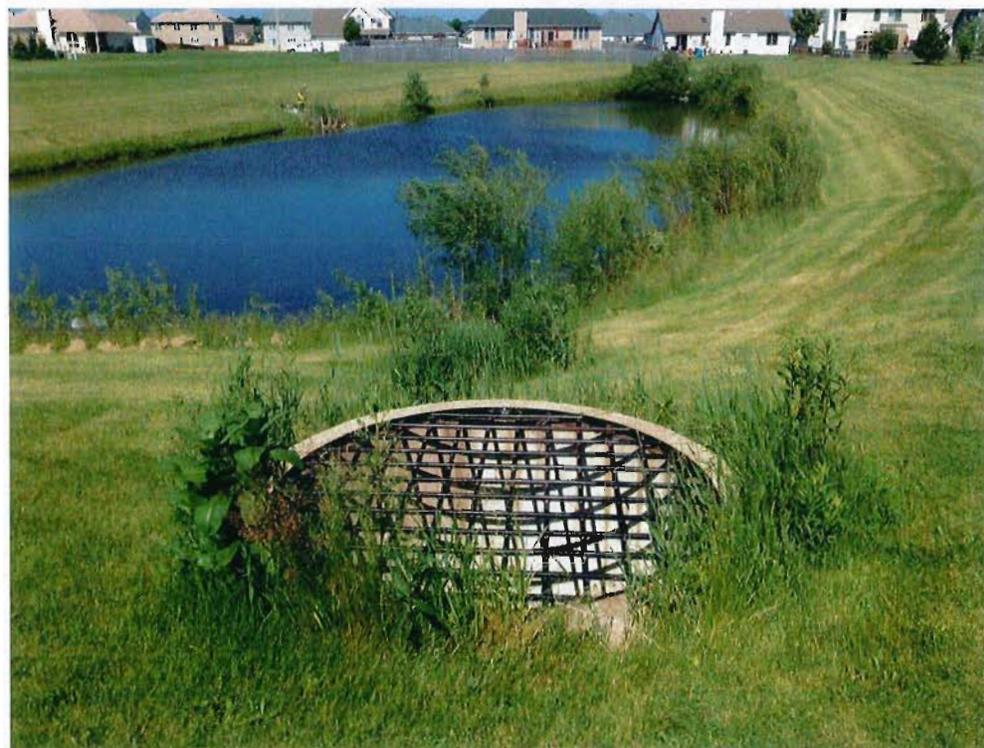
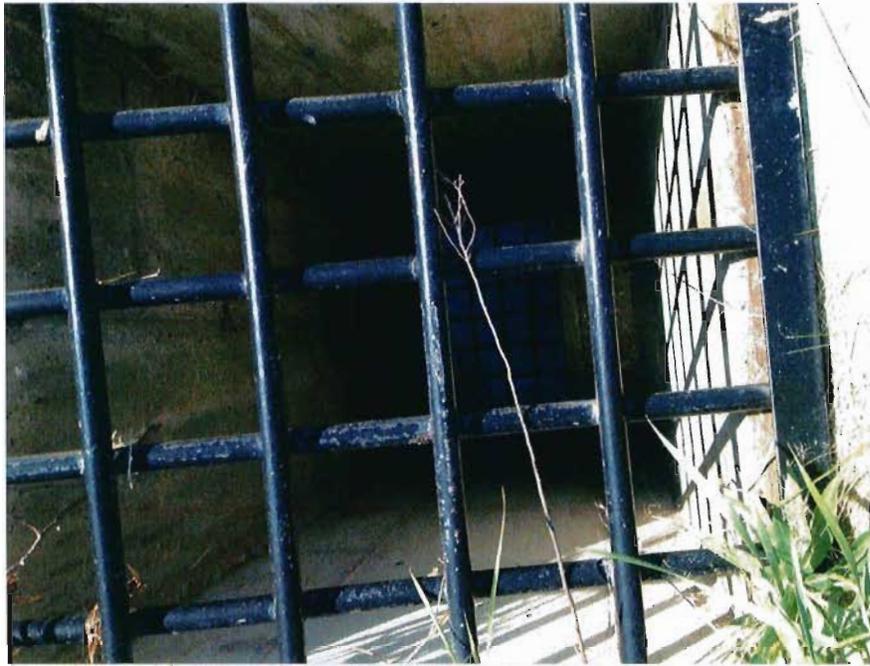
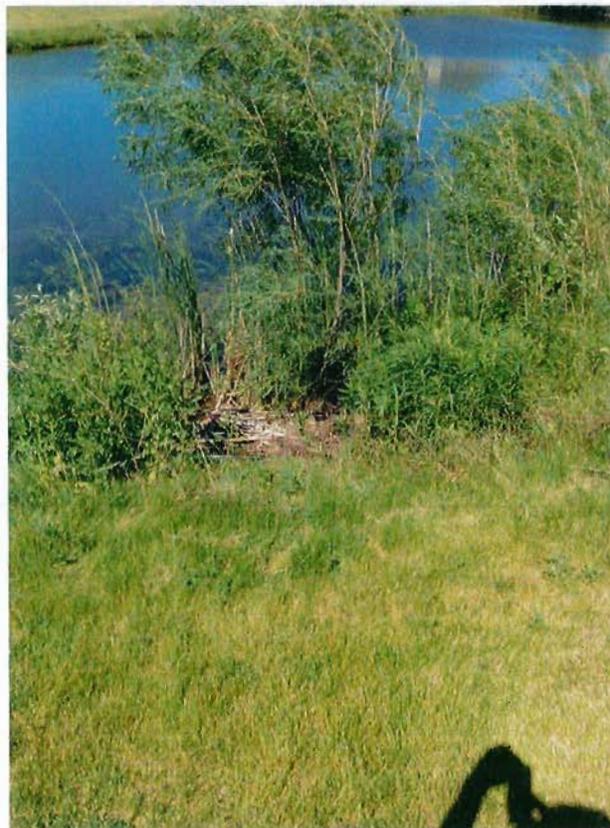
1. The designed water depth of the pond is 6 feet. The measured water depth in July of 2013 varied between 6.1 and 7.2 feet. We conclude that the pond was over-excavated at the time of construction.
2. The inlet and outlet pipes were inspected and were found to be in good condition. Brush is growing in some of the structures.
3. Sediment build-up varied between 0.5 and 0.9 feet.
4. The whole pond perimeter was mowed. Some rip-rap areas had vegetation growing in them.

1. The water depth should be measured in 2018 to compare to the 2013 measurements. This will provide a comparable depth to determine the rate of sediment accumulation as well as an anticipated date for sediment removal.
2. Brush and saplings should be removed from the inlet and outlet structures and the other areas where growth is heaviest.

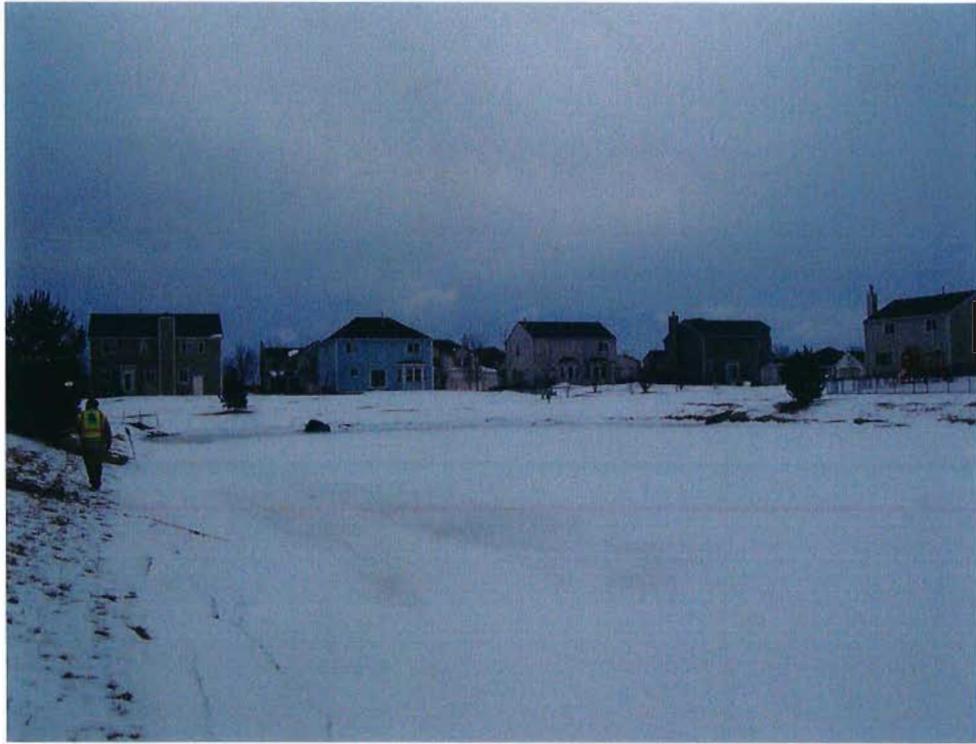
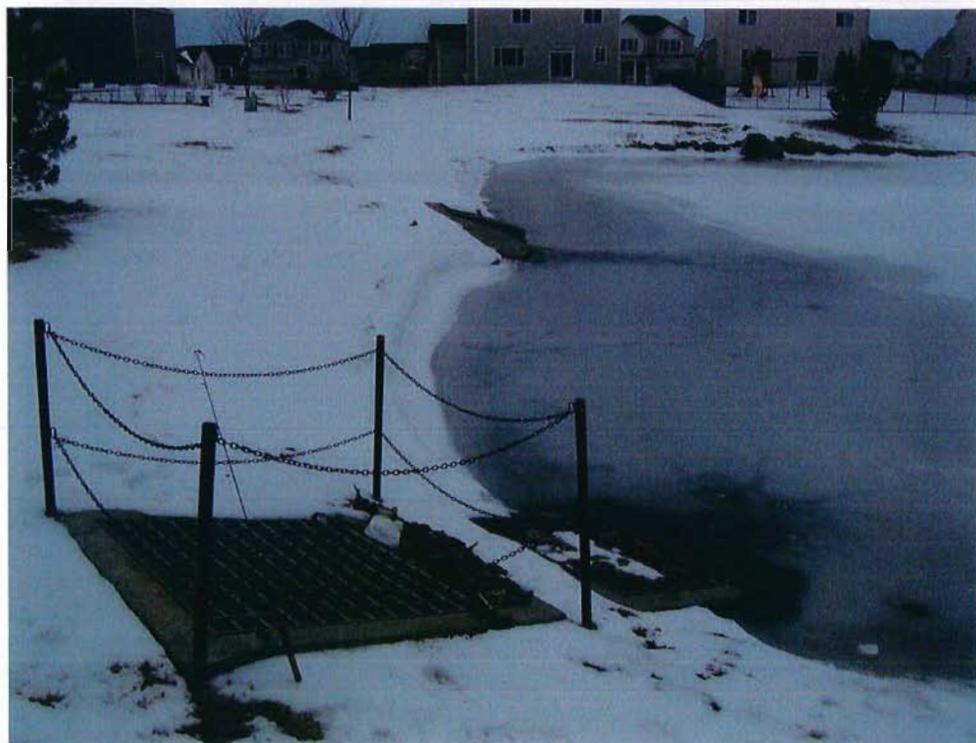
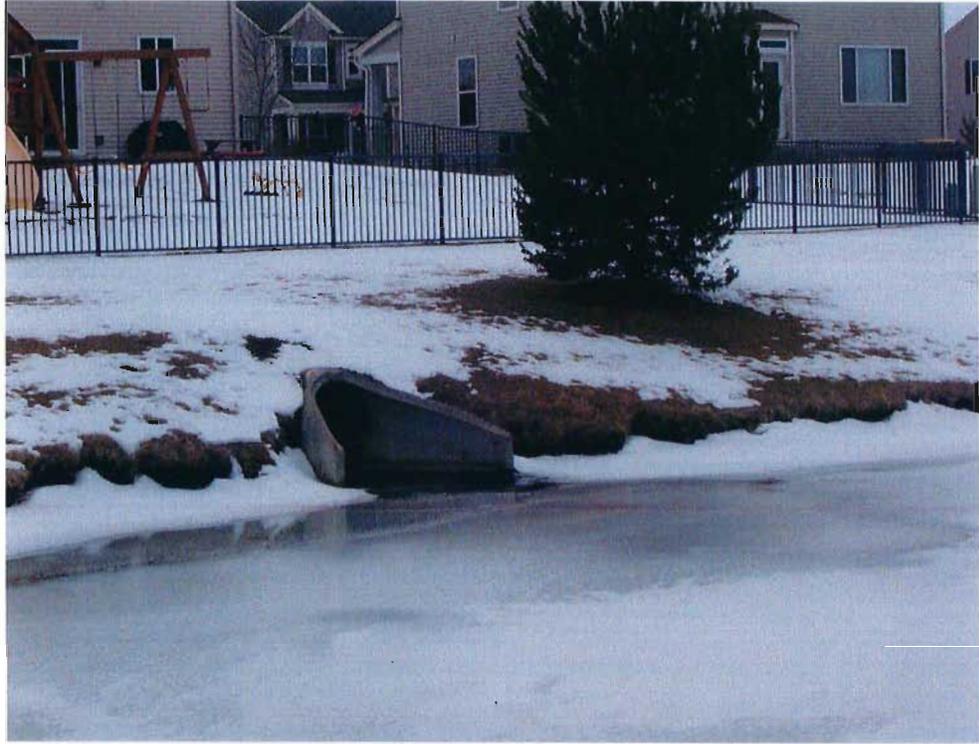
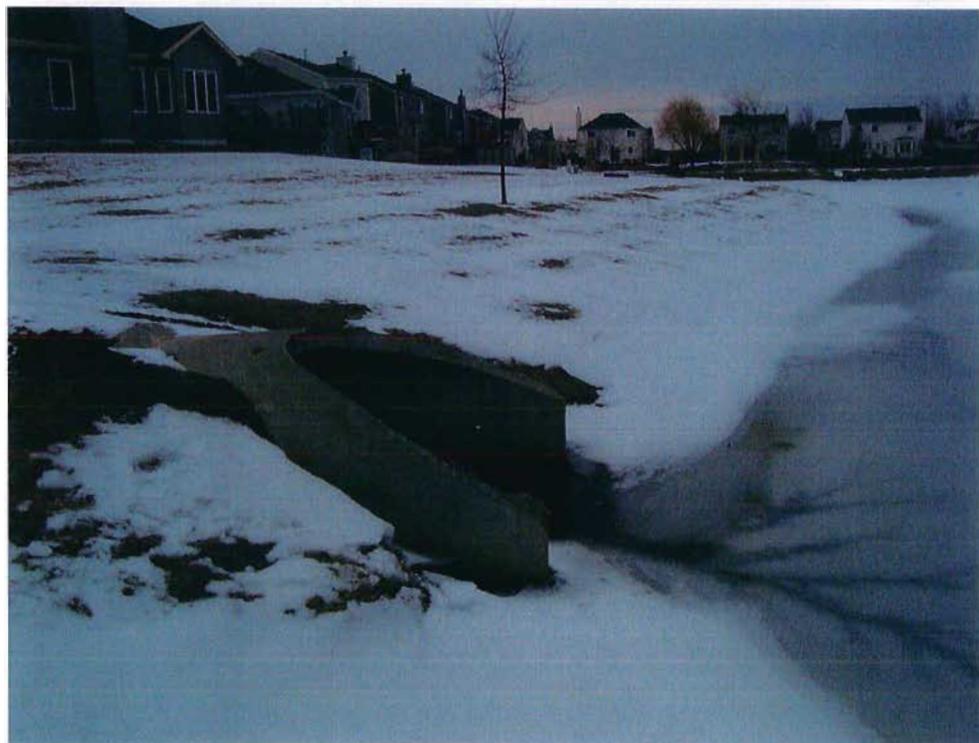
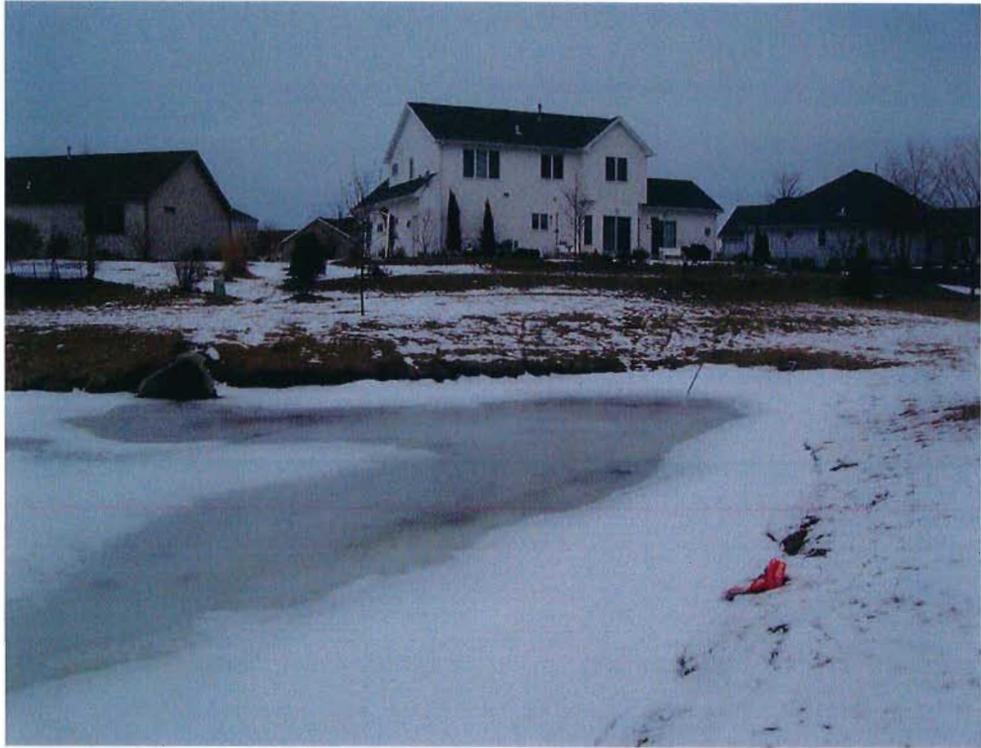
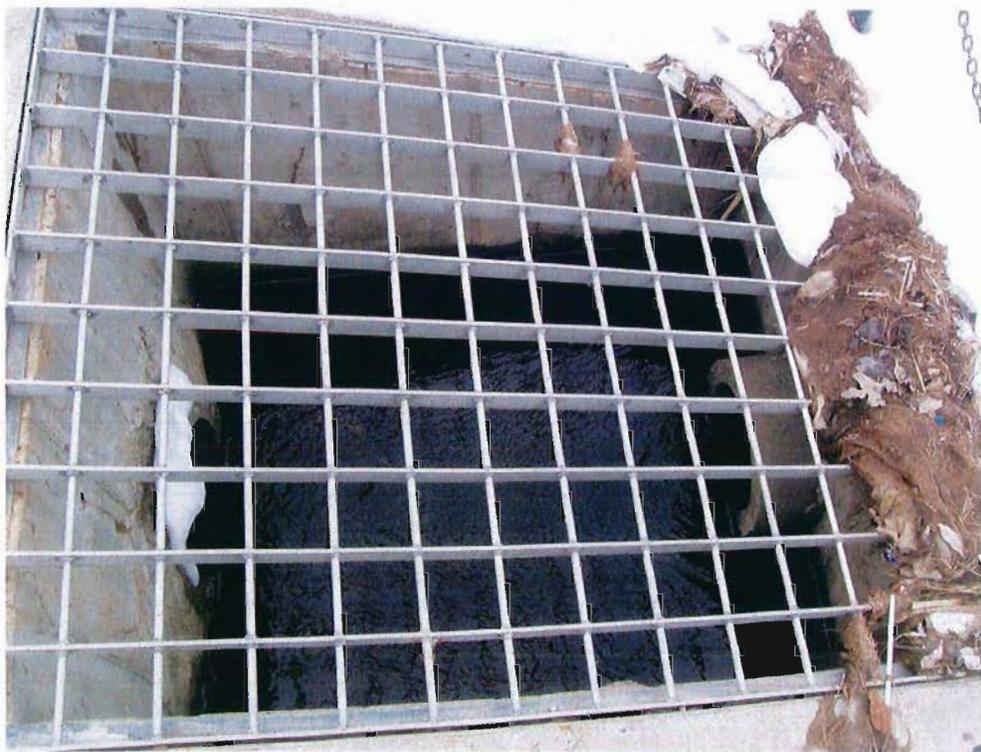
1. The designed water depth of the pond is 5 feet. The measured water depth in February of 2013 varied between 4.6 and 5.3 feet. We conclude that the pond was over-excavated at the time of construction and is be starting to fill with sediment in certain areas.
2. The inlet and outlet pipes were inspected and were found to be in good structural condition.
3. Sediment build-up varies between 0.5 to 0.8 feet.
4. The whole pond perimeter area is mowed.

1. The water depth should be measured in 2018 to compare to the 2013 measurements. This will provide a comparable depth to determine the rate of sediment accumulation as well as an anticipated date for sediment removal.
2. When mowing, leave a strip of grass around the pond perimeter to improve safety and help to deter geese.
3. Keep grates free of debris.

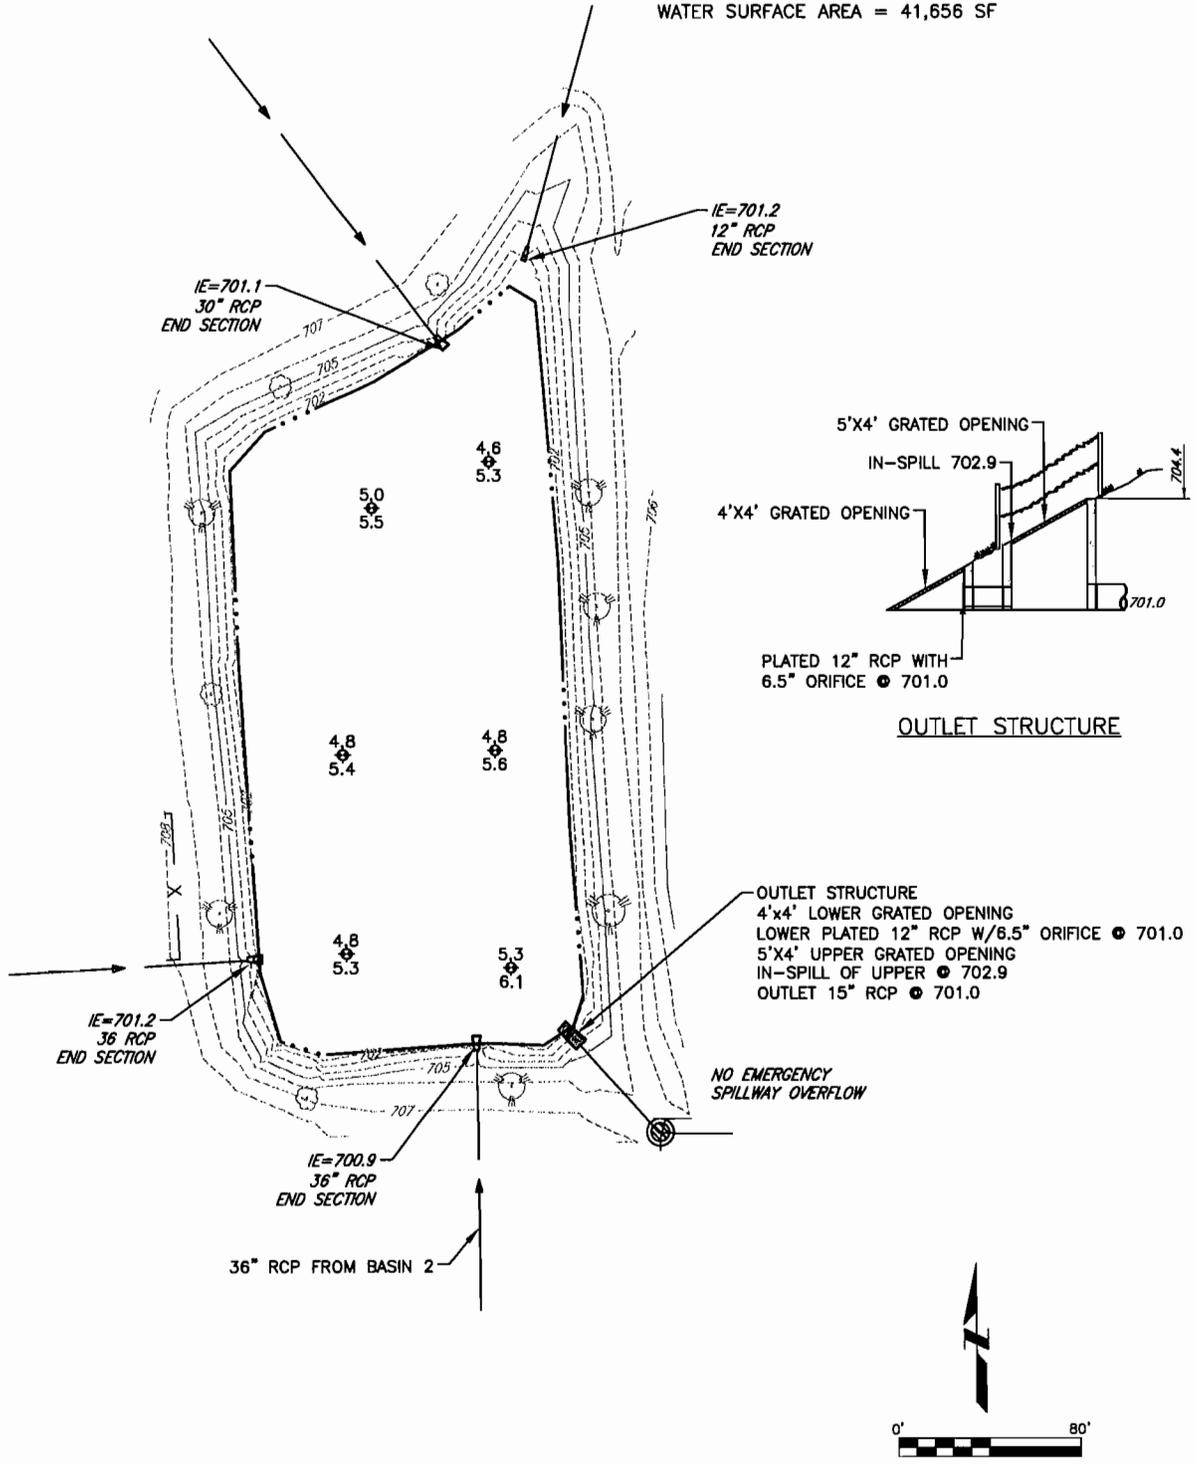
# PETERSONS GOLDEN MEADOWS BASIN B1

1. The designed water depth of the pond is 4 feet. The measured water depth in July of 2013 varied between 3.8 and 4.3 feet.
2. The inlet and outlet structures were in good condition.
3. No sediment build-up was found in the pond.
4. The pond area had been mowed.

1. The water depth should be measured in 2018 to compare to the 2013 measurements. This will provide a comparable depth to determine the rate of sediment accumulation as well as an anticipated date for sediment removal.
2. Keep the inlet structure clear of vegetation.

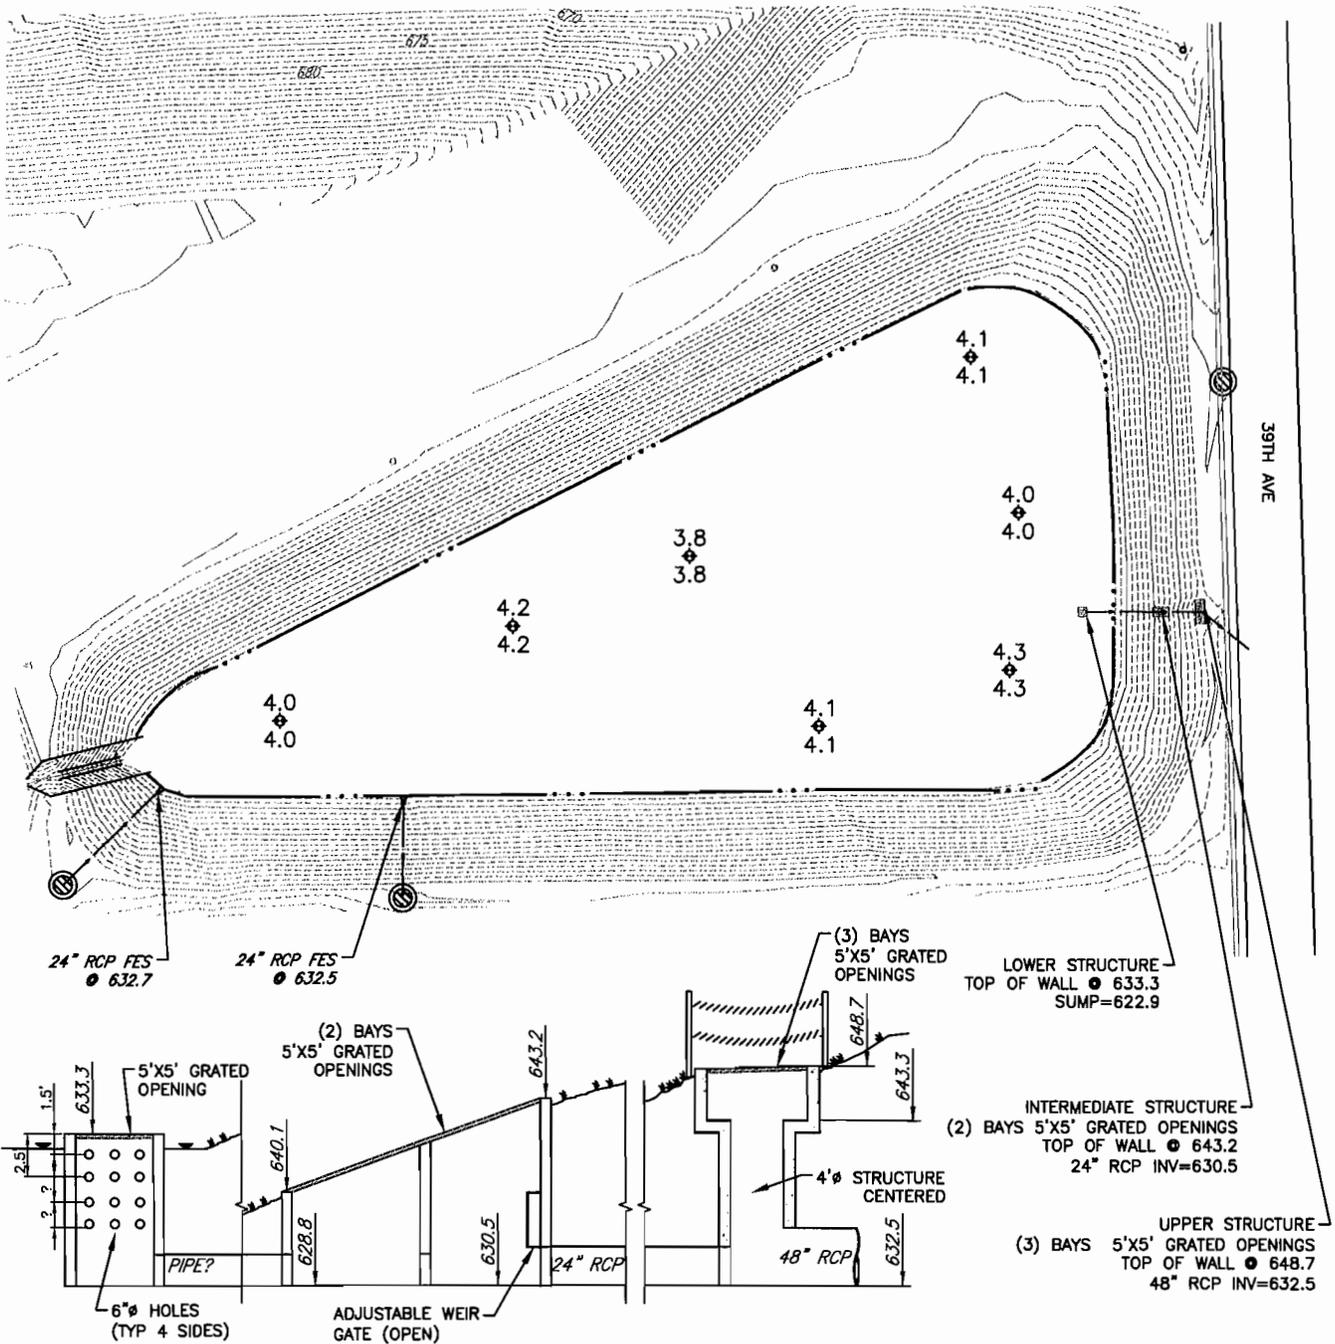
SHAGBARK  
 WATER ELEV.= 632.7  
 DEPTHS BELOW WATER

1. The designed water depth of the pond is 3.5 feet. The measured water depth in May of 2013 varied between 2.7 and 4.0 feet. The pond was likely over-excavated at the time of construction but is now starting to fill with sediment.
2. The inlet and outlet pipes were inspected and were found to be in good structural condition.
3. Sediment build-up ranged between 0 and 0.4 feet.
4. The whole pond perimeter is mowed. There is thick cattail growth on the east and west sides of the pond, including around the outlet.

1. The water depth should be measured in 2018 to compare to the 2013 measurements. This will provide a comparable depth to determine the rate of sediment accumulation as well as an anticipated date for sediment removal.
2. Clear cattails from the pond, especially around the outlet structure.
3. When mowing, leave a grassy strip around the pond to deter geese and improve safety.
