# 2013 Ponds Certifications

City of Kenosha, Wisconsin

July 9, 2014

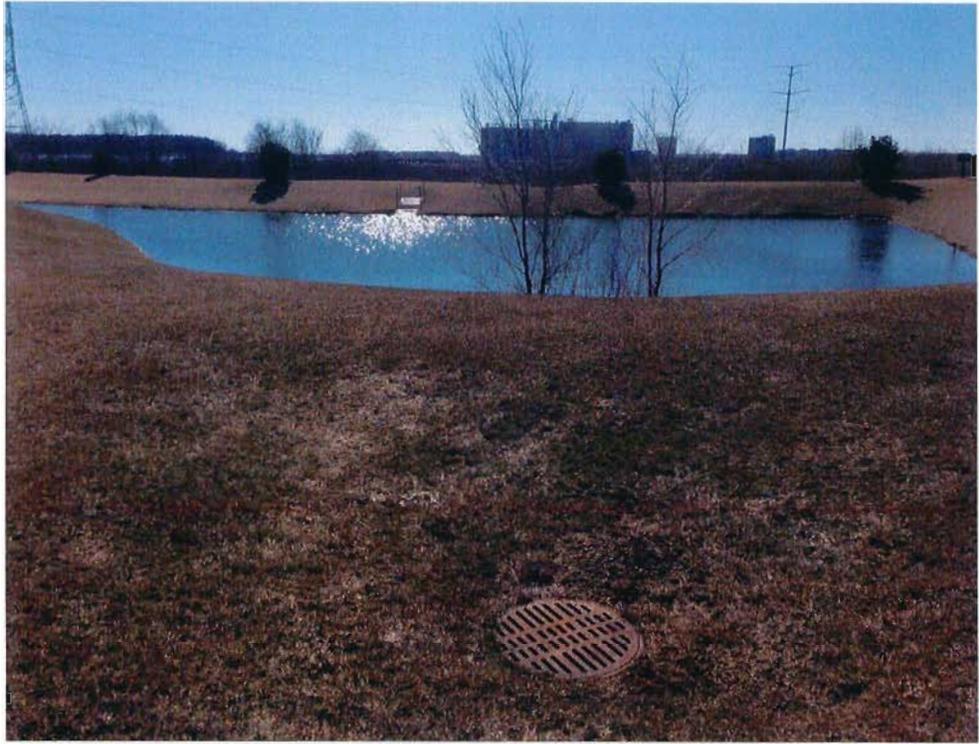
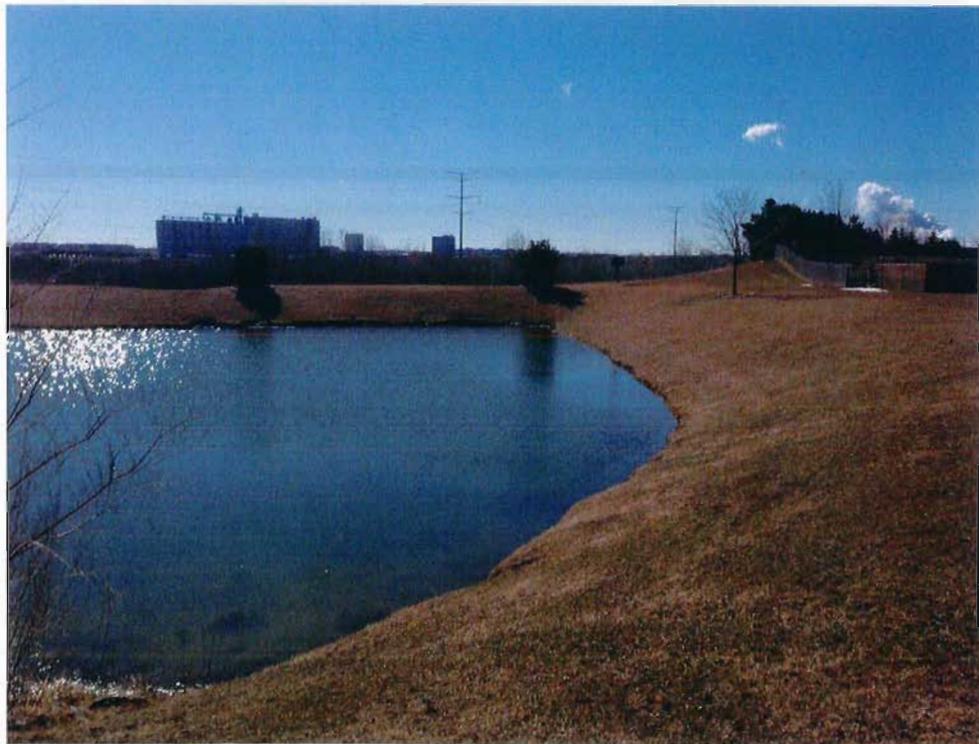
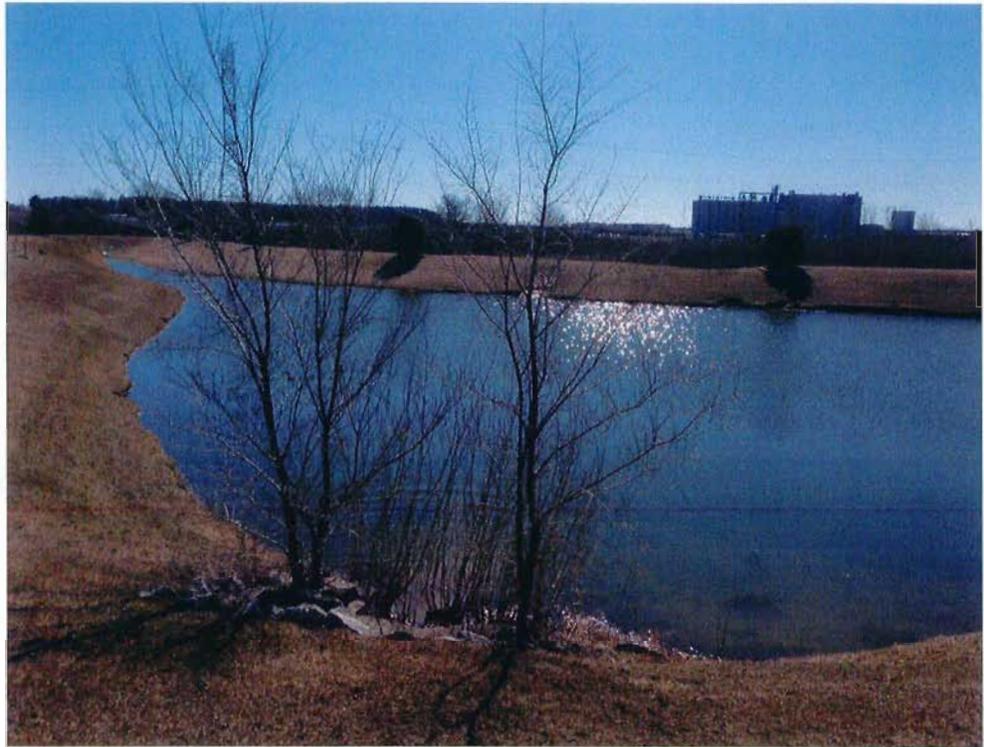
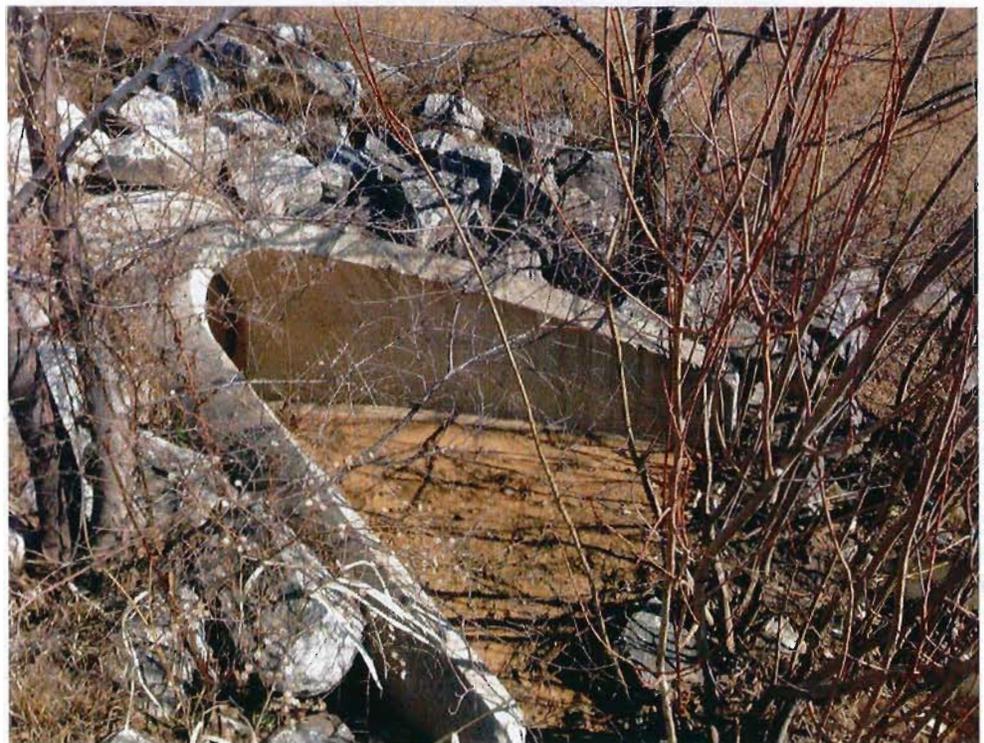
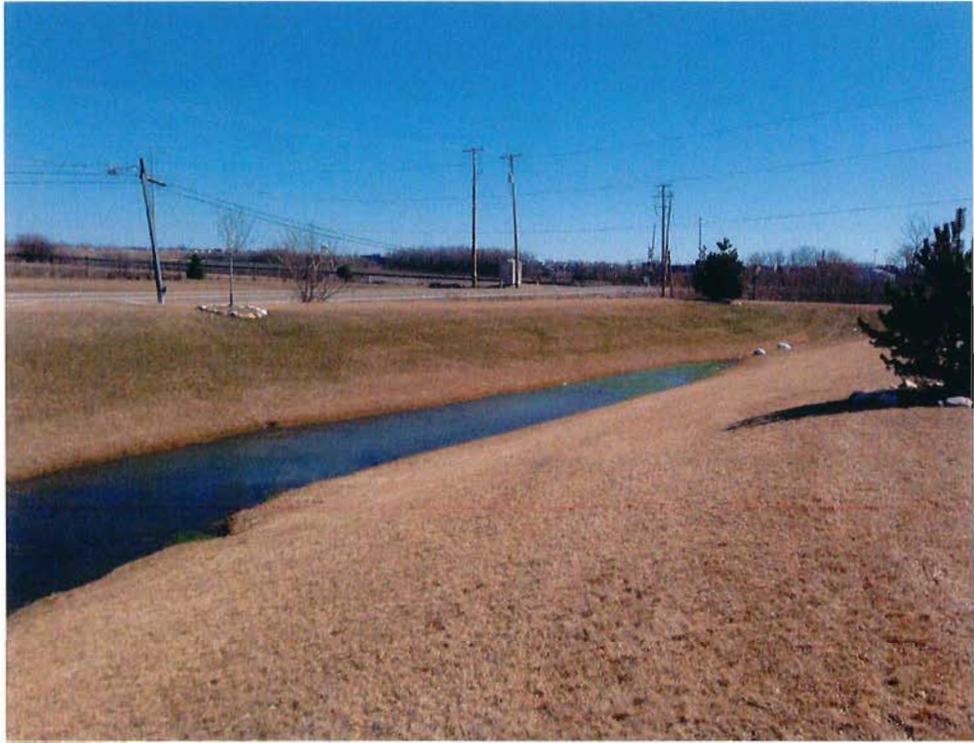
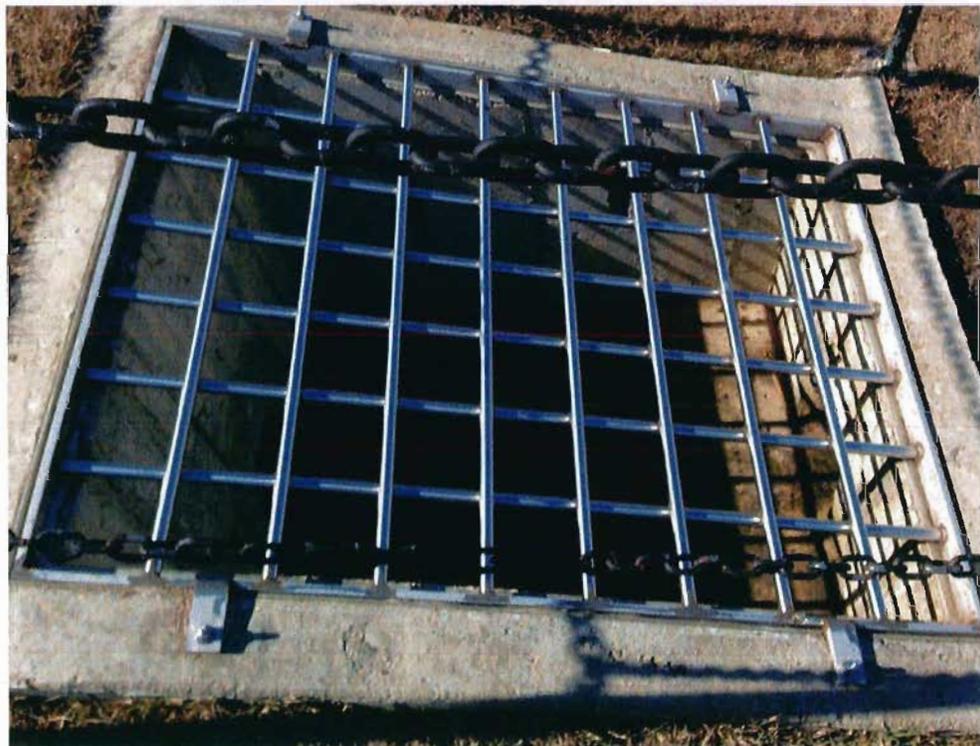
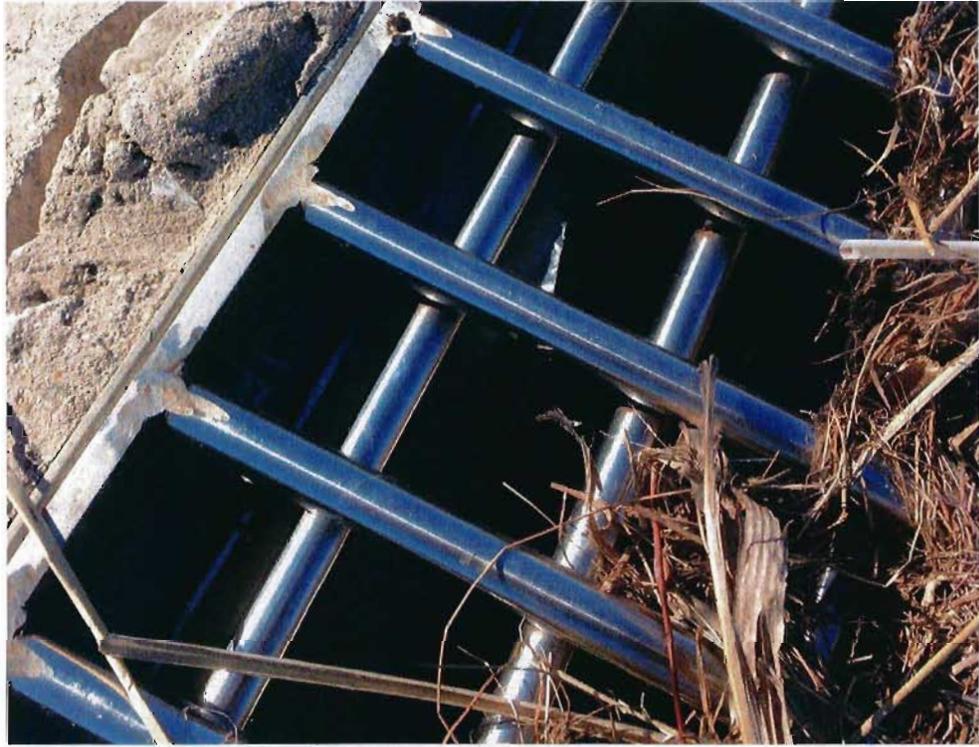
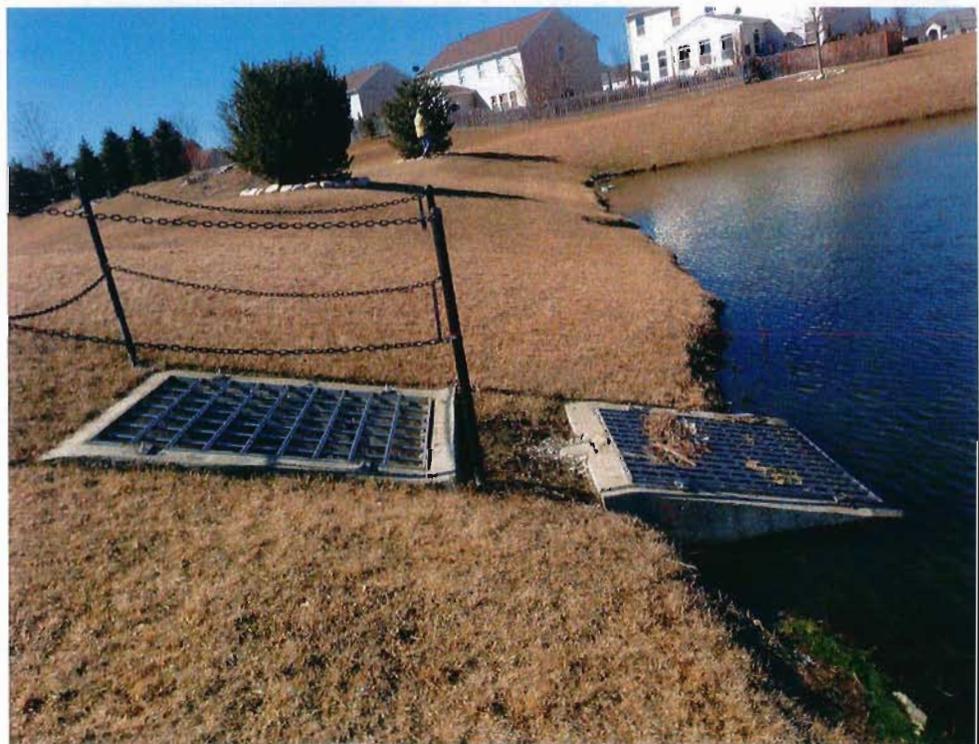
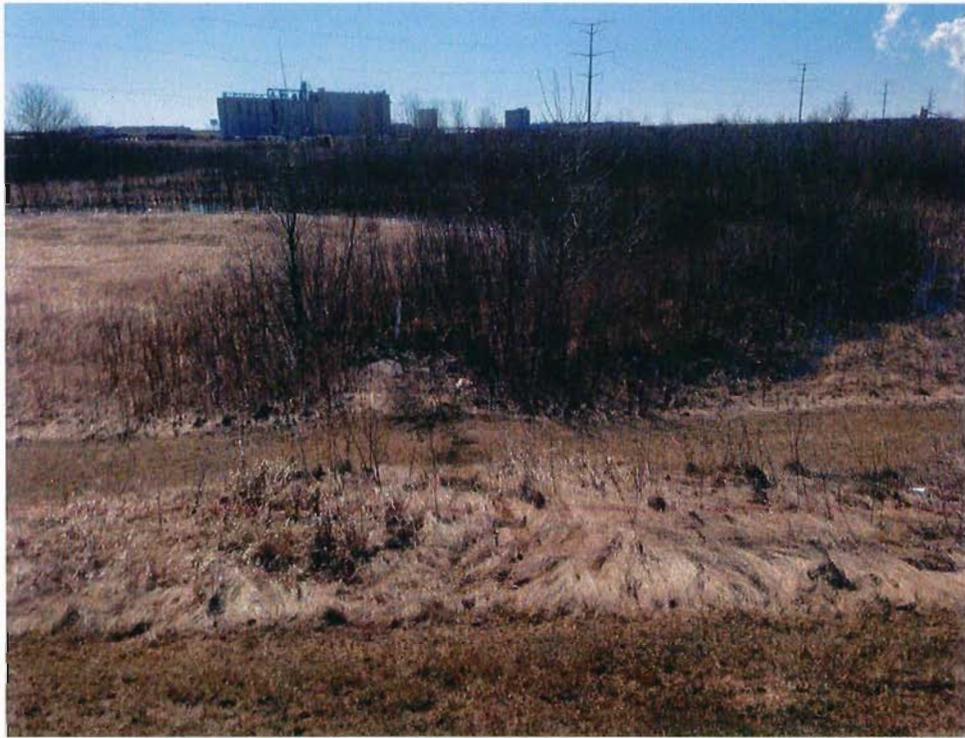
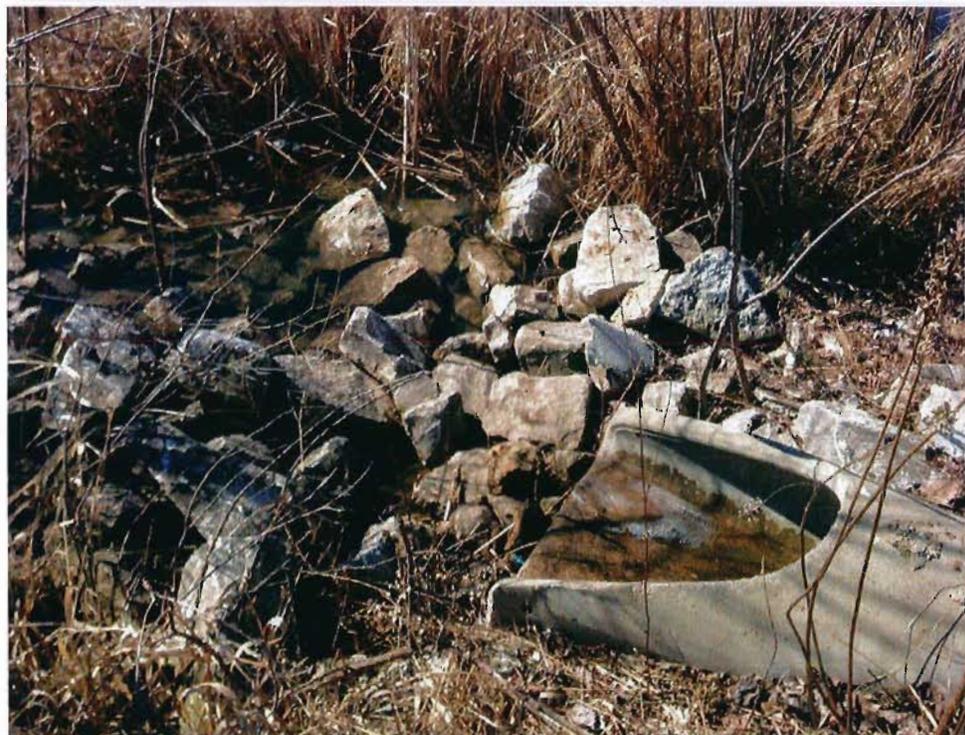
1. The designed water depth of the pond is 6 feet. The measured water depth in April of 2013 varied between 5.7 and 7.0 feet. We conclude that the pond was over-excavated at the time of construction.
2. The inlet and outlet pipes were inspected and were found to be in good structural condition.
3. The outfall RCP is higher than the orifice.
4. Sediment build-up averaged 0.25 feet.
5. The whole pond perimeter is mowed. Rip-rap areas have vegetation growing in them.

1. The water depth should be measured in 2018 to compare to the 2013 measurements. This will provide a comparable depth to determine the rate of sediment accumulation as well as an anticipated date for sediment removal.
2. The brush growing in the rip-rap around the structures should be cleared.
3. A strip of grass should be left around the edge of the pond to improve safety and help to prevent geese.

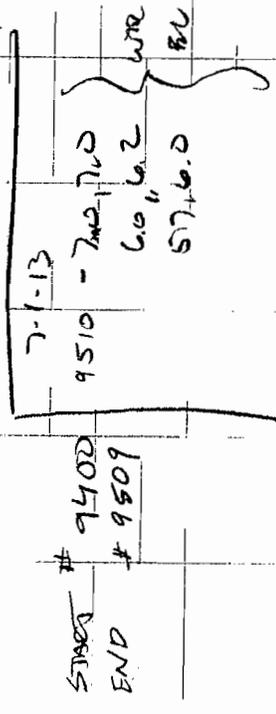
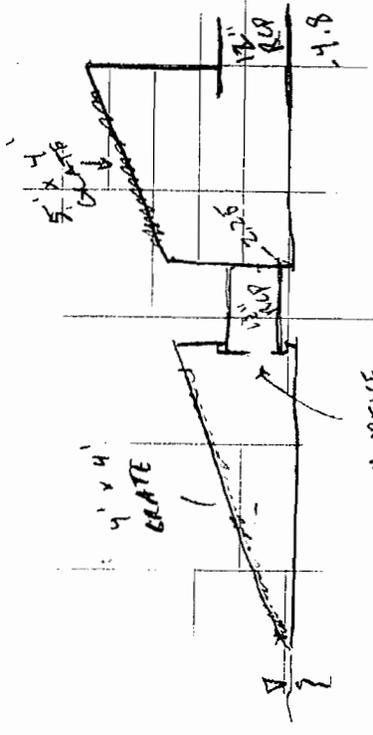
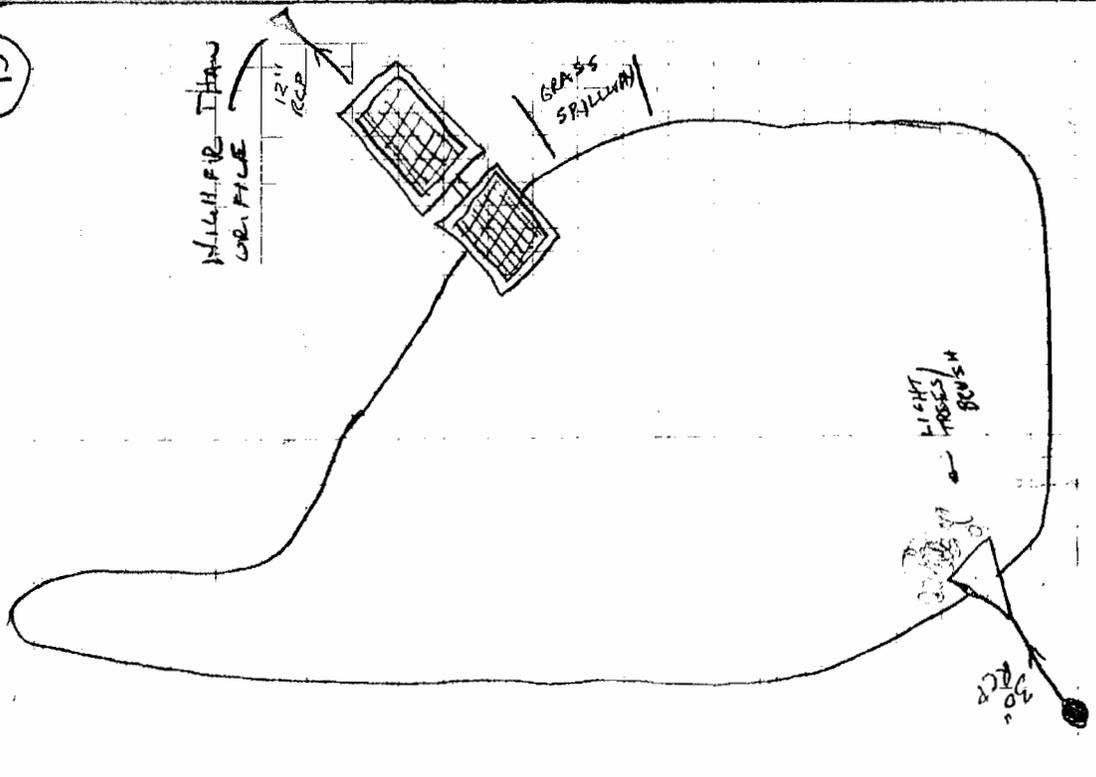
LEDNA'S MEADOWS BASIN F

- \* NEED LIGHT CLEARING @ 30" FES
- \* NEED POND BOTTOM DEPTHS
- NOTE: OUTFALL RUP MUST BE 0.15-0.20' HIGHER THAN ORIFICE.

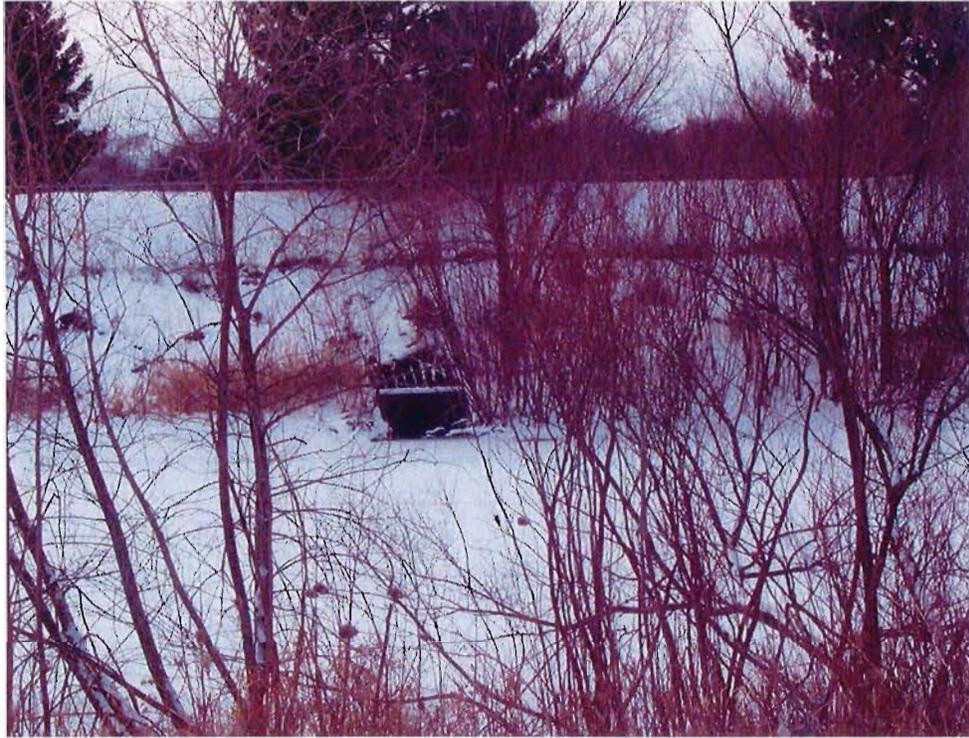
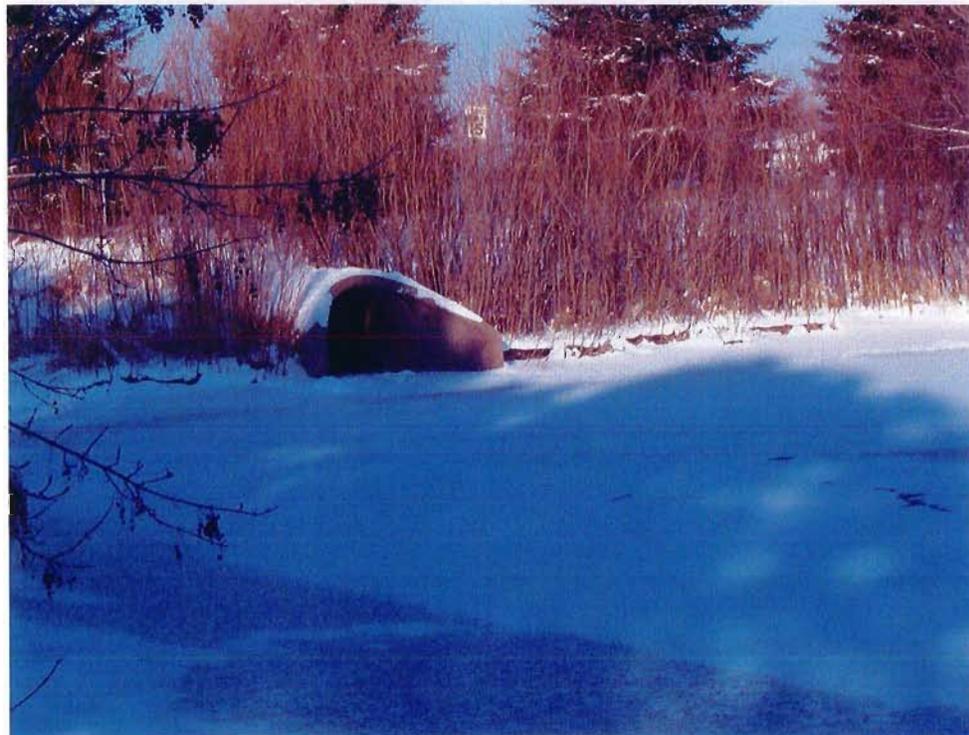
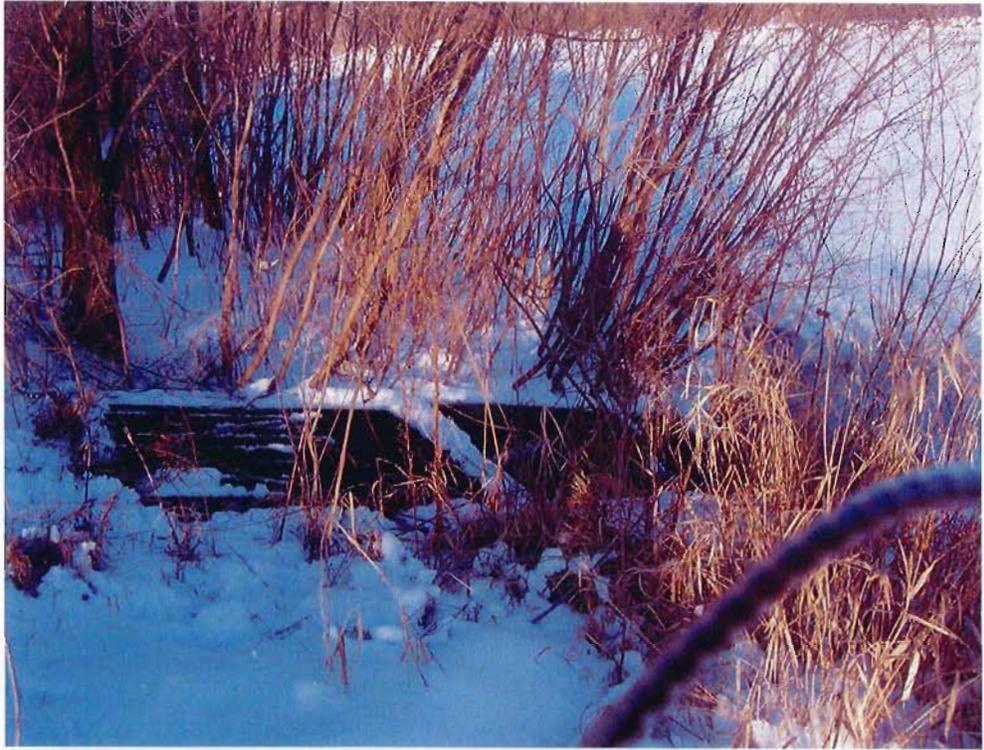
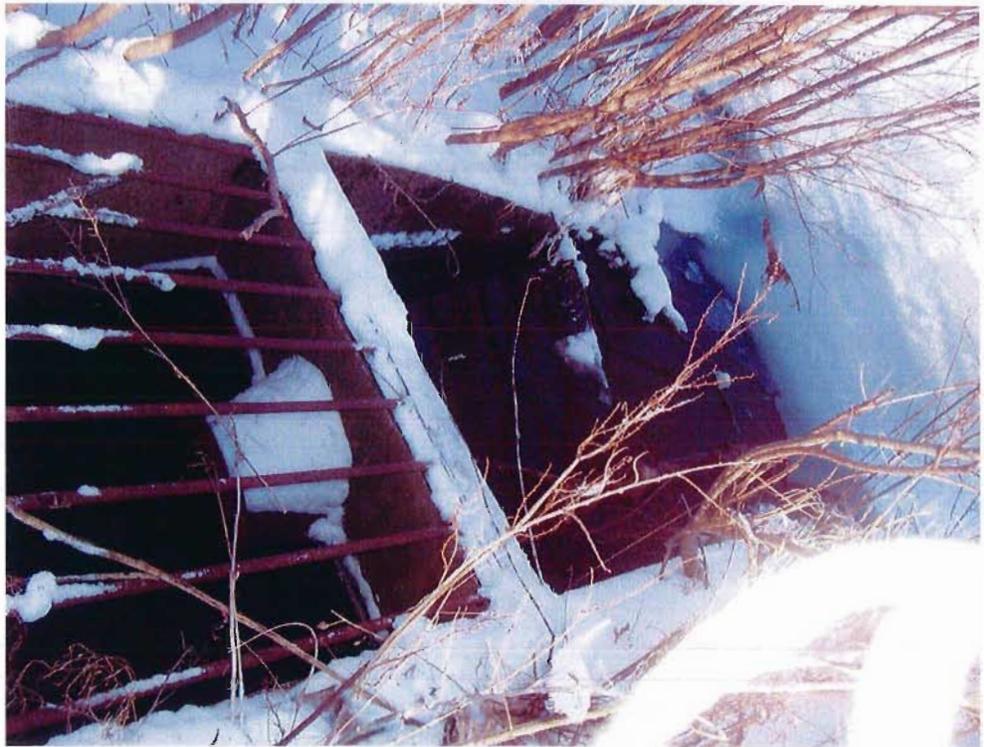
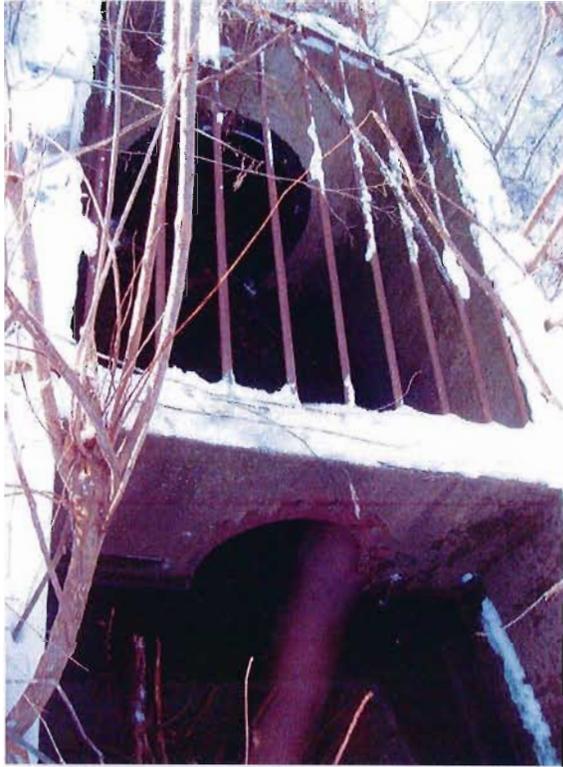
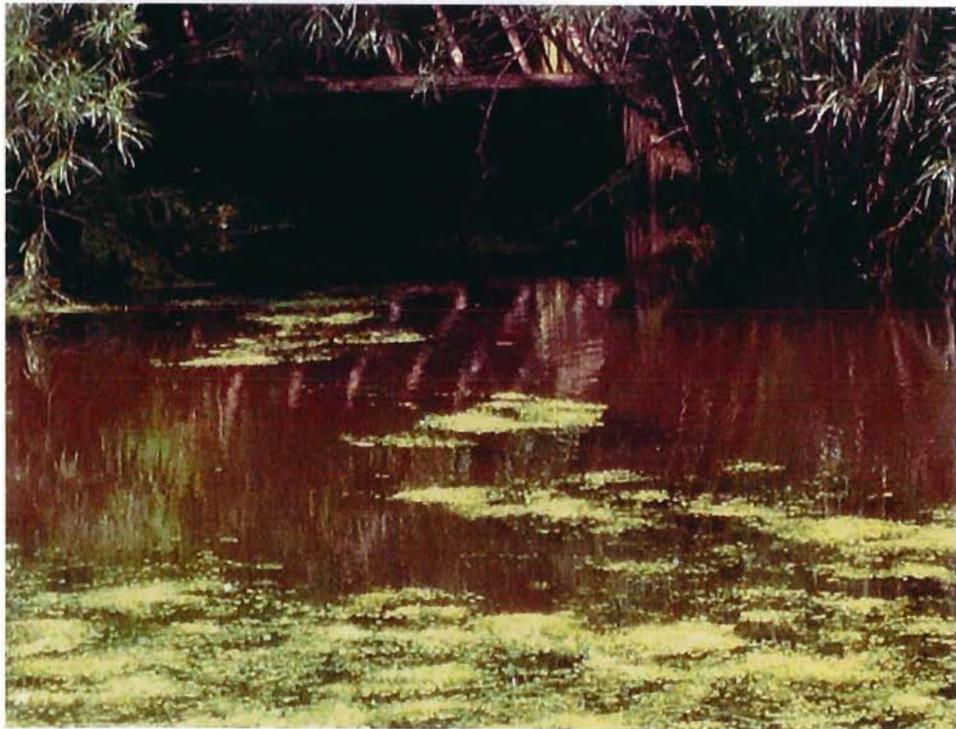
1. The original pond design plans were not available. The measured water depth in February of 2013 varied between 3.4 and 4.2 feet.
2. The inlet and outlet pipes were inspected and were found to be in good structural condition. The pipe joints are also in good condition.
3. Sediment build-up varied between 0 and 0.8 feet.
4. Vegetation has grown up around the entire pond perimeter; some areas are thick with willow brush.
5. There was a layer of duckweed on the pond in June 2013.

1. The water depth should be measured in 2018 to compare to the 2013 measurements. This will provide a comparable depth to determine the rate of sediment accumulation as well as an anticipated date for sediment removal.
2. Some willow brush and other vegetation should be cleared around the pond perimeter.

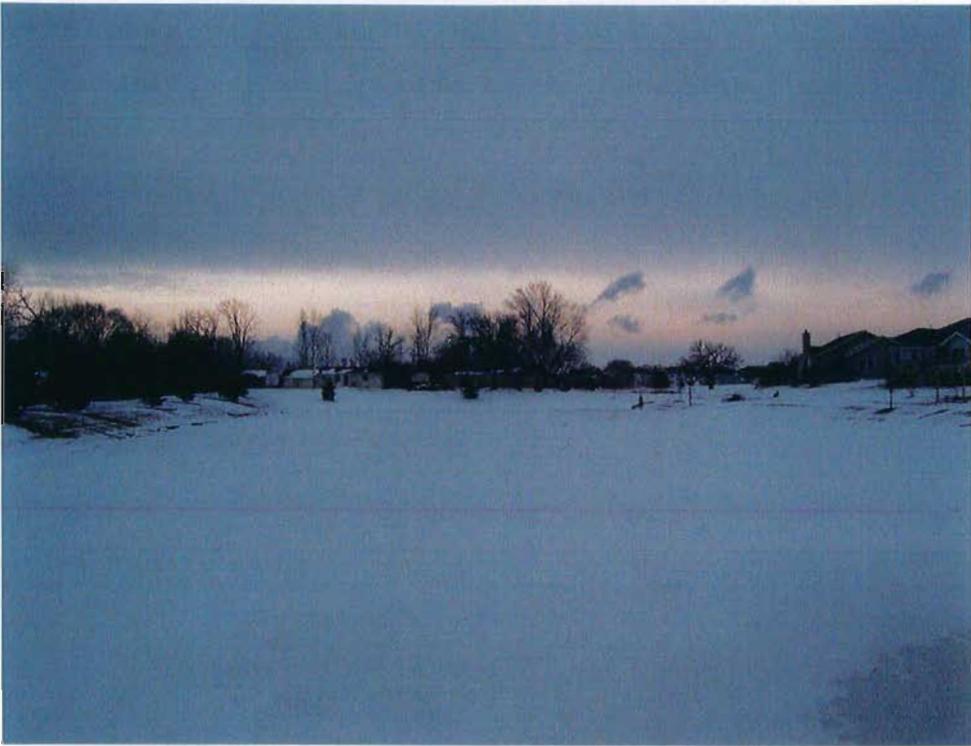
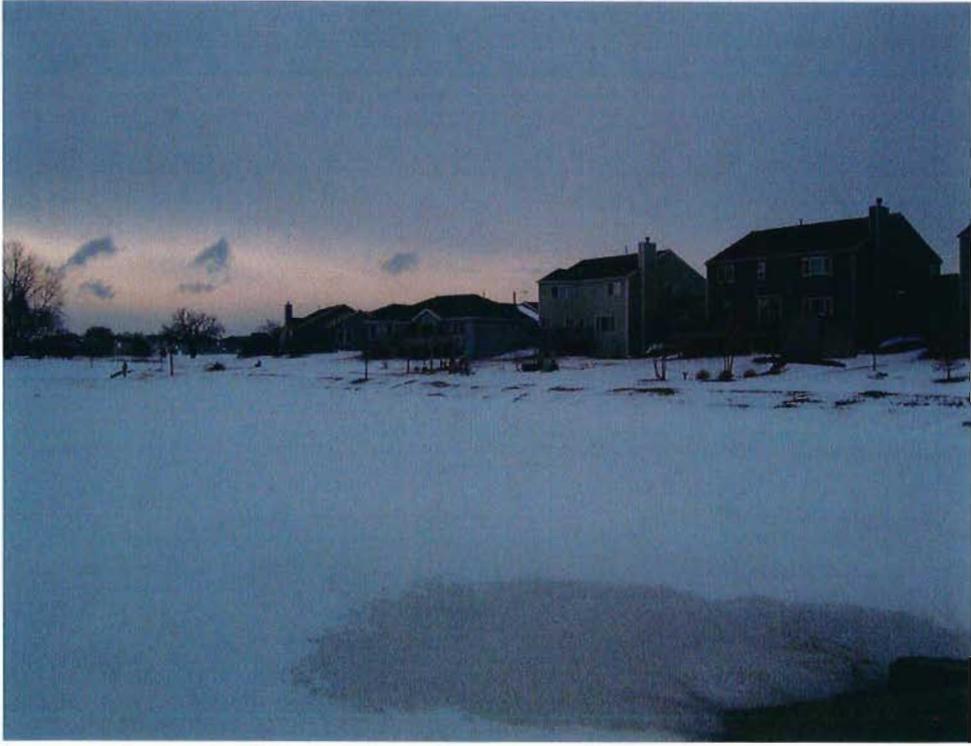
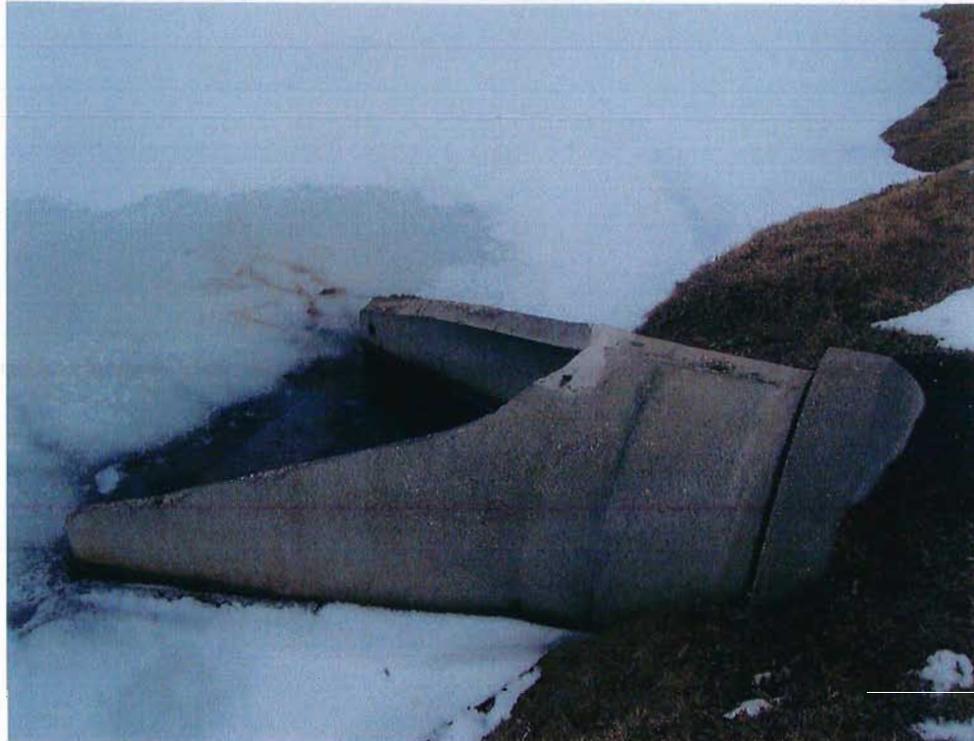
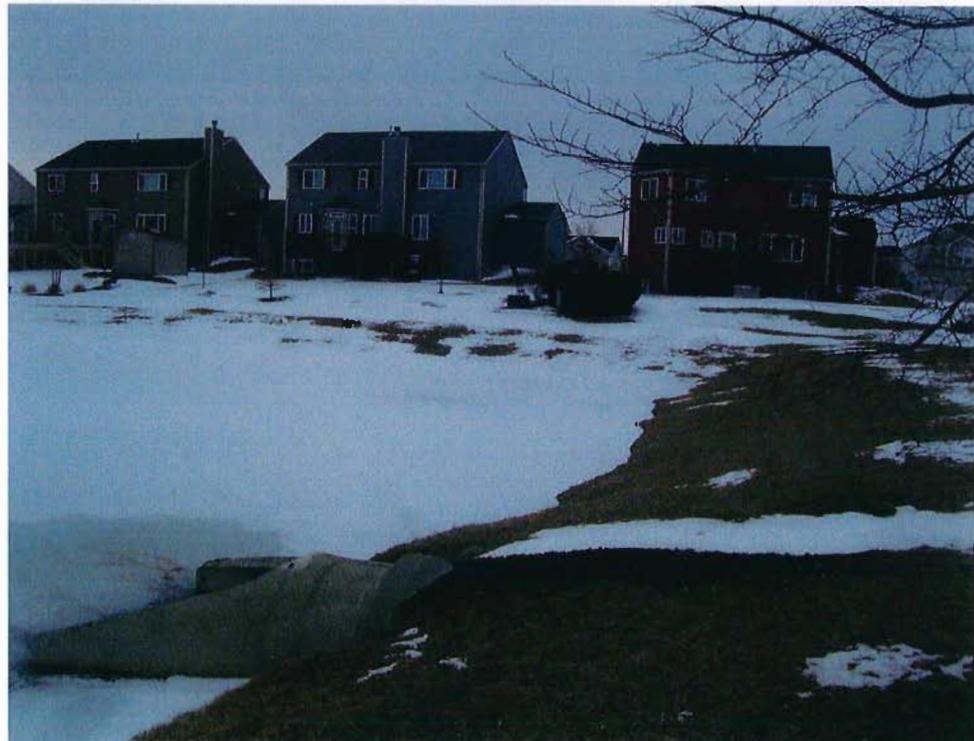
1. The designed water depth of the pond is 5 feet. The measured water depth in February of 2013 varied between 5.0 and 5.9 feet. We conclude that the pond was over-excavated at the time of construction.
2. The inlet and outlet pipes were inspected and were found to be in good structural condition.
3. Sediment build-up varies between 0 and 0.4 feet.
4. The whole pond perimeter is mowed.
5. The pond is in like-new condition.

1. The water depth should be measured in 2018 to compare to the 2013 measurements. This will provide a comparable depth to determine the rate of sediment accumulation as well as an anticipated date for sediment removal.
2. When mowing, leave a strip of grass around the pond perimeter to improve safety and deter geese.

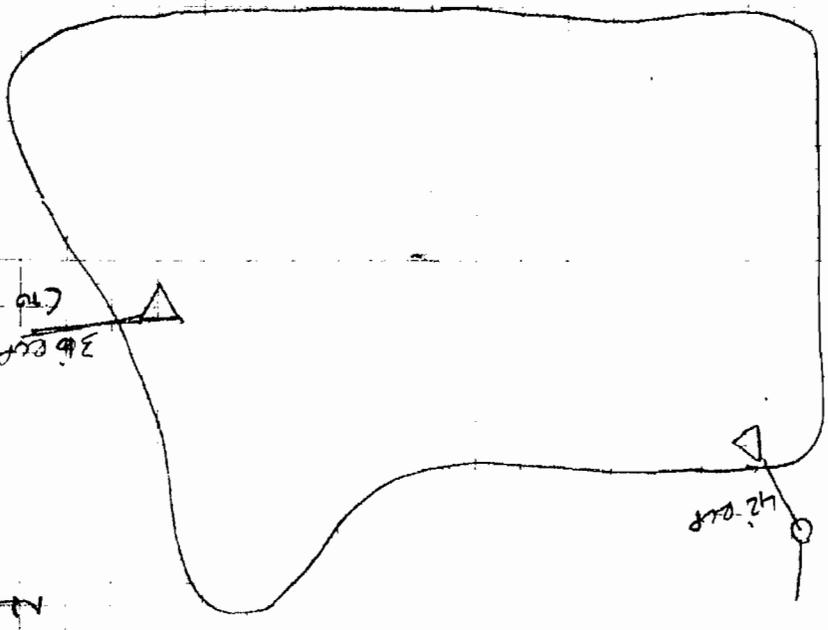
PETERSONS BOWEN MEADOW BASIN 2

NEW CONDITION  
- NO MAINTENANCE NEEDED
